# ASSESSMENT OF SEAWALL STRUCTURAL INTEGRITY AND POTENTIAL FOR SEAWALL OVER-TOPPING

## *for Balboa Island and Little Balboa Island*

Prepared for  
**City of Newport Beach**

Prepared by  
**Everest International Consultants, Inc.**

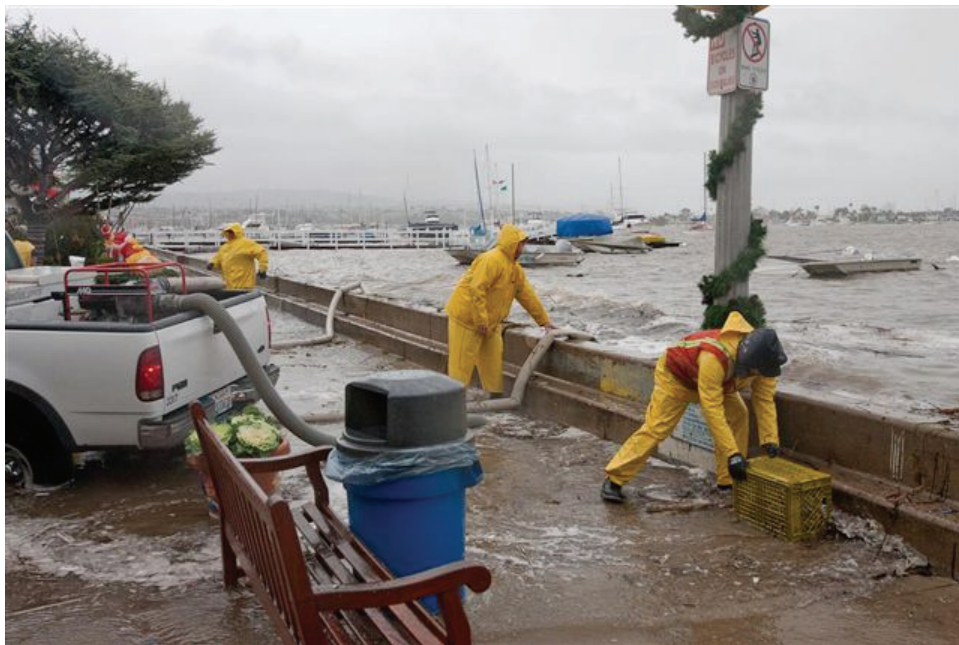
out water that was collected at the storm drain outlet junction structure located at a bay-front street in a high water and high wave event in December 22, 2010.

**Figure 1.2 City Personnel Pumping Flood Water Back into the Bay**

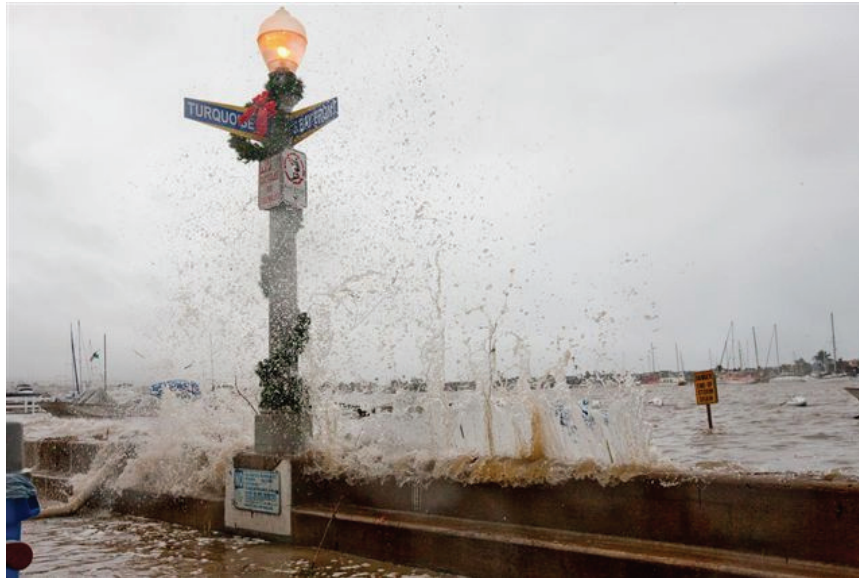
**Figure 1.3 Waves Splashing over the Balboa Island Seawall at Turquoise and South Bay Front**

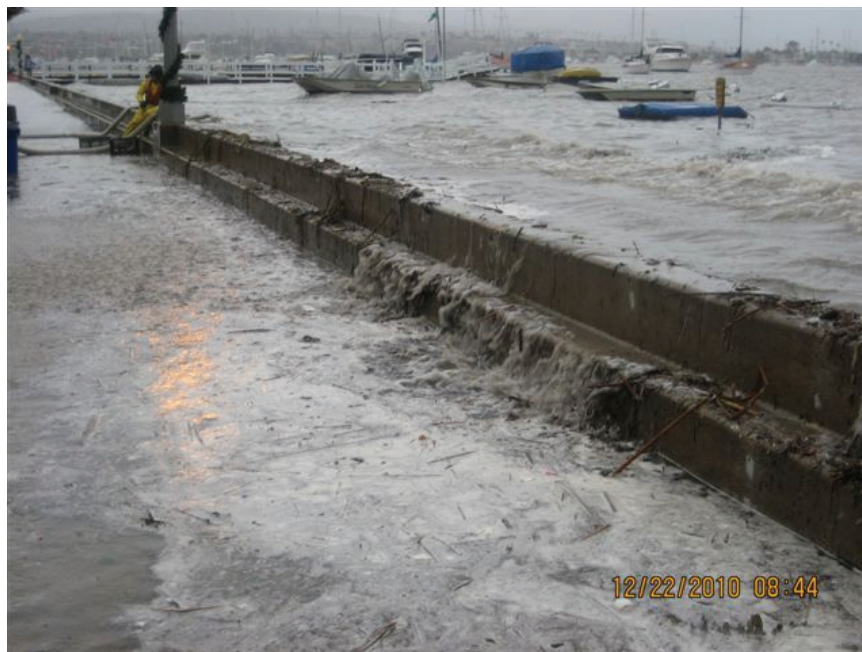
**Figure 1.4 Bay Waters Overtopping the Seawall**

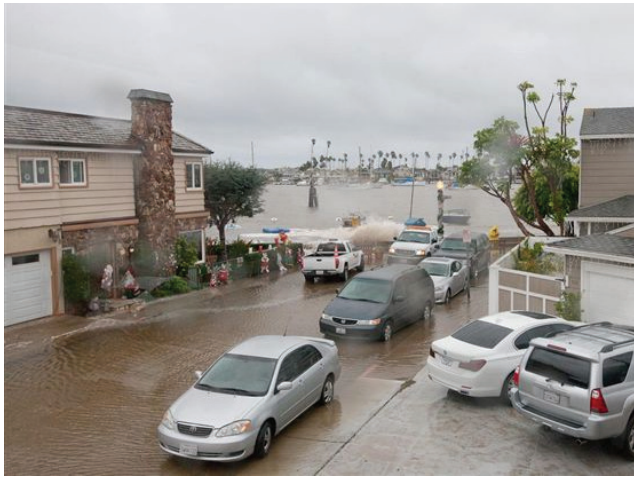
**Figure 1.5 Street Flooding**

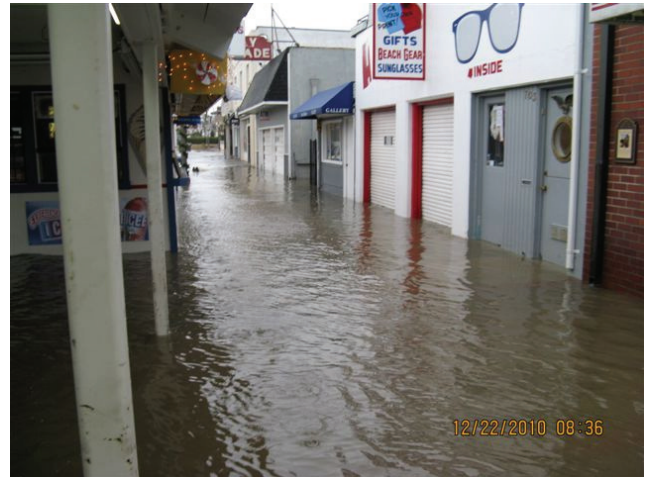
**Figure 1.6 Flooded Businesses**

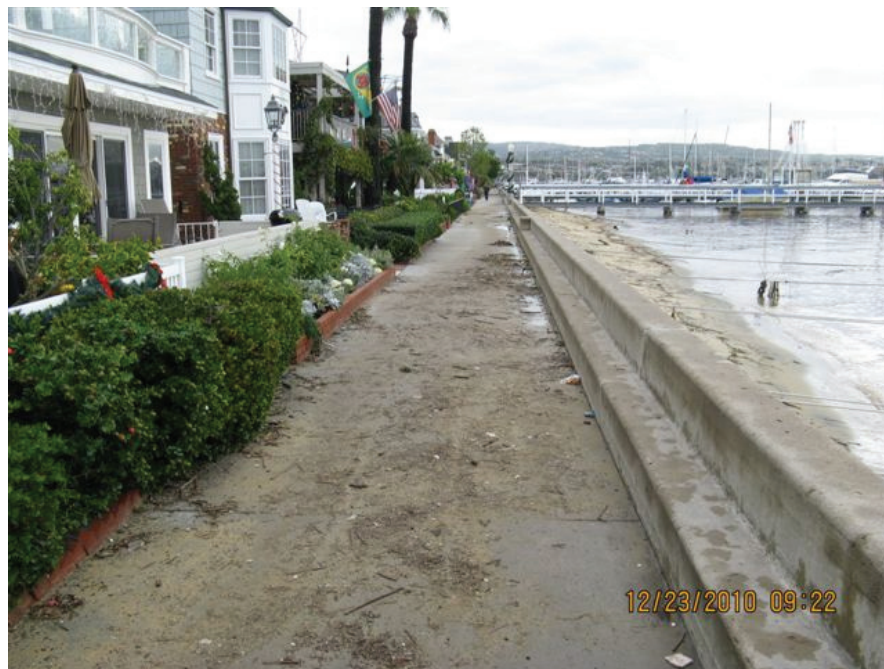
Additional photos from this event depicting wave overtopping and flooding of the Balboa Island seawall and the resulting damage are shown in Figures 1.3 to 1.7. As shown in Figure 1.3 and 1.4, water overtopped the seawall at Turquoise and South Bay Front flooding the boardwalk. Flood waters spilled into adjacent streets as seen in Figure 1.5 and some businesses were inundated as shown in Figure 1.6. After the tide ebbed and the flood waters drained, the boardwalk was covered with sand and debris as shown in Figure 1.7, clogging the boardwalk drainage system.

**Figure 1.7 Accumulated Sand and Debris, Post-Storm**

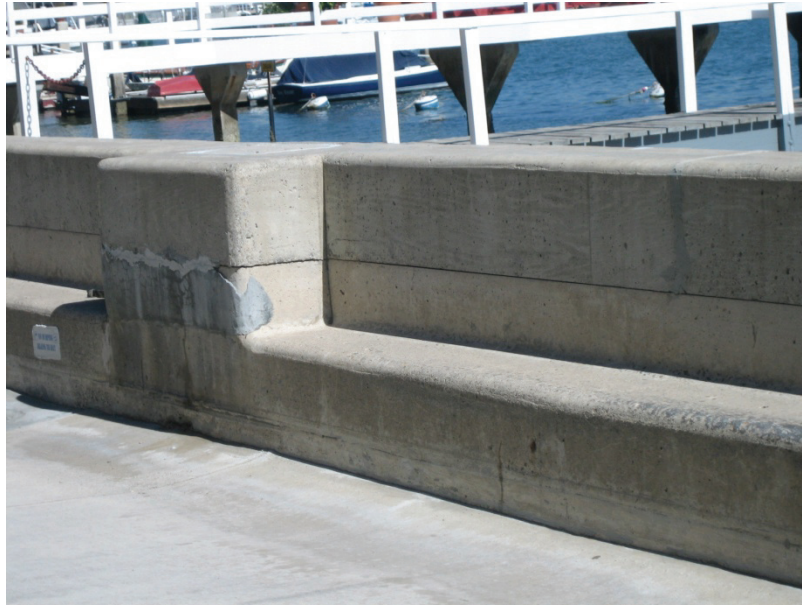
During the visual survey of the seawall, seawall cap extensions were observed in the Little Balboa Island. The extension raises the top of wall elevation by between 6 and 12 inches depending on location around Little Balboa. An example of this cap extension is shown in Figure 4.4. Although this extension provides a defense against high water events, the limited remaining useful life and the existing condition of the underlying seawall make further extensions questionable.

**Figure 4.4 Little Balboa Seawall Cap Extension**

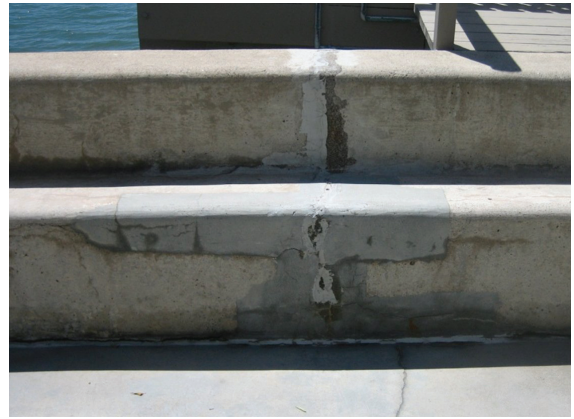
The visual survey also found universal distresses in the cap, specifically multiple cracks, coinciding with the locations of the soldier piles. The development of these cracks at the specific locations of the soldier piles is likely due to a reduced structural cross-section and a concentration of load ultimately relating to concrete stress. Despite a concentration of cracks at the soldier piles, cracking also can be found at many locations along the concrete cap including the structural cap along the Grand Canal. Coupled with similar cracks found on the exposed portions of the soldier piles and panels, the evidence portends to universal distress throughout the seawall. The shot-creted piles and panels along the Grand Canal walls (see Figure 4.5) are of particular concern because the condition of the original concrete is hidden by the shot-crete repairs. Despite repairs to cracks over the years, cracks are still prevalent in the seawall cap (see Figures 4.6 and 4.7).

**Figure 4.6** Typical Crack and Spall Repairs

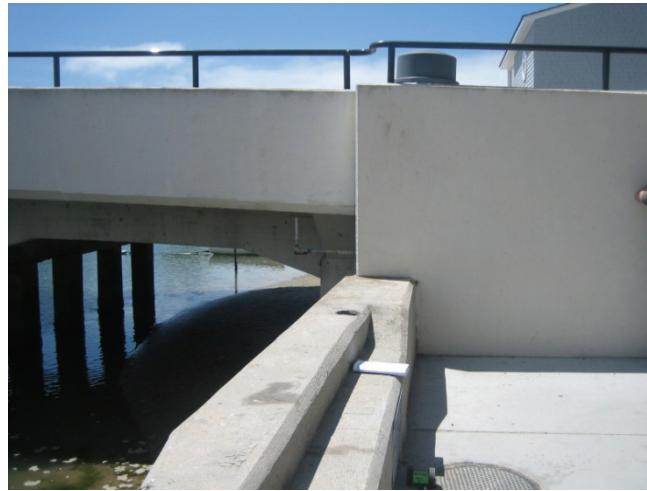
**Figure 4.12 Park Avenue Bridge Interface at Big Balboa Seawall**

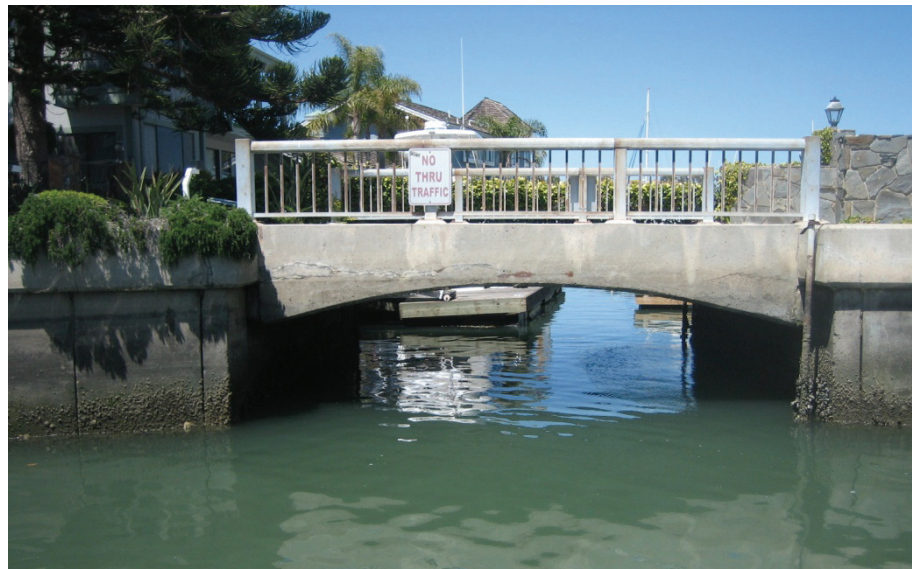
sealed to the seawall to prevent it from becoming a source of flooding. The seawalls on Collins Island will need to be retrofitted or replaced in concert with Balboa Island, to prevent flooding of that island and to prevent seawater from flanking the Balboa Island barriers.

**Figure 4.13 Collins Island Bridge Interface at Seawall Abutment**

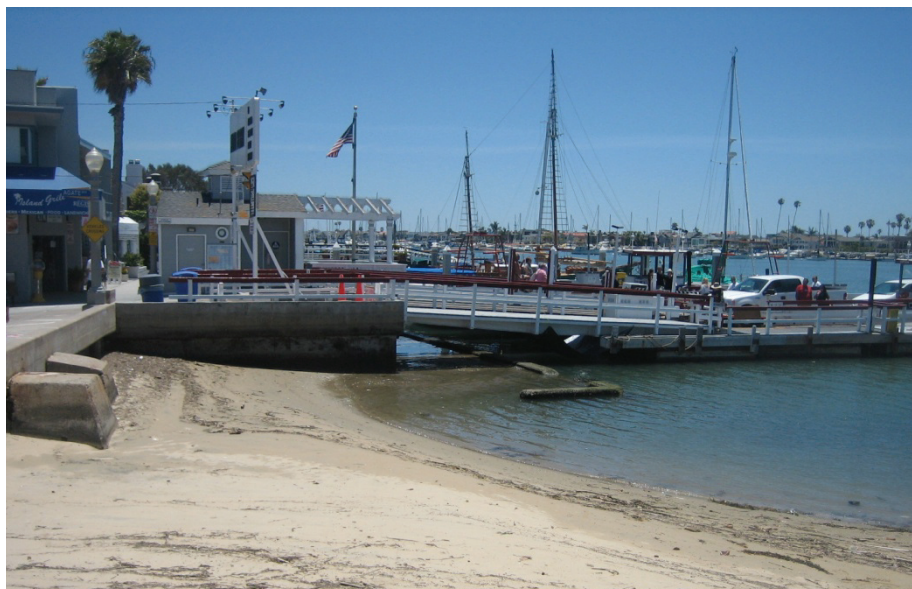
**Figure 4.15 Balboa Island Ferry Boat Landing as Viewed from Side**
