<b>ACTIVITY</b> Balboa Island Bulkhead Inspection	<b>CASH &amp; ASSOCIATES</b> Engineering and Architecture

Cash & Associates Engineering and Architecture 1712 Ave. 100 Mission Viejo, CA
<b>STREET LOCATION</b> Grand Canal East Between South Bay Front and Park Ave	INSPECTOR: ASSISTANT:	CTM	INSPECTION DATE: December 21, 2004	REVISION

The City of Newport Beach retained COWI North America (COWI) to perform a Condition Assessment Inspection of the bulkhead wall at the West End of Balboa Island, City of Newport Beach Contract No. 8088-1. The reach of the wall extended from Emerald Avenue at North Bay Front, west and south, then southeast to Emerald Avenue at South Bay Front as indicated by the highlighted area in the figure below.

Figure 1 - Inspection Location and Limits, West End of Balboa Island, Newport Beach, CA

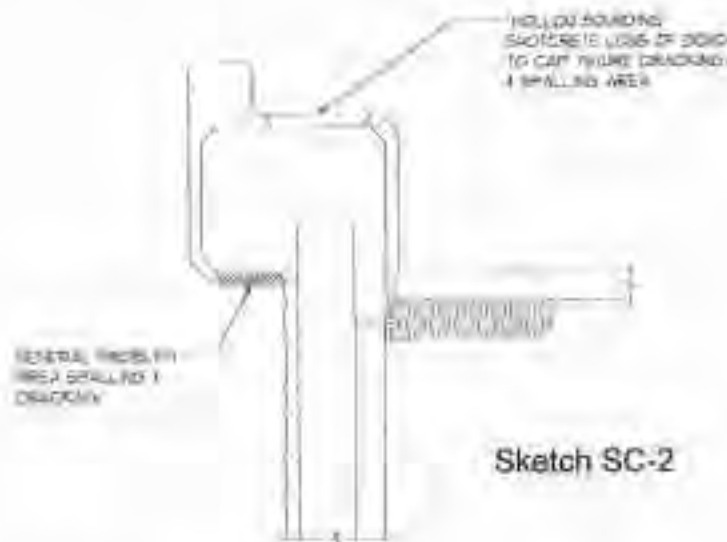
#### **5.1.4.1 Shotcrete Repair, Bulkhead Cap**

The Grand Canal bulkhead cap has additional problems associated with it. Hollow sounds were detected during the investigation along the top of the cap. These hollow sounds are due to the concrete cover delaminating from the base material. Outwardly, these areas might not show any signs of failure or perhaps a longitudinal crack along the top of the cap. However, these areas pose the greatest potential for spalling and loss of material. There are several methods of repair for this situation. The first is to take a wait and see approach to the hollow areas. The second approach is to remove the spalled area and replace the material with new concrete. The last approach is to use the crack injection method to bond the exterior shell of the shotcrete to the base material.

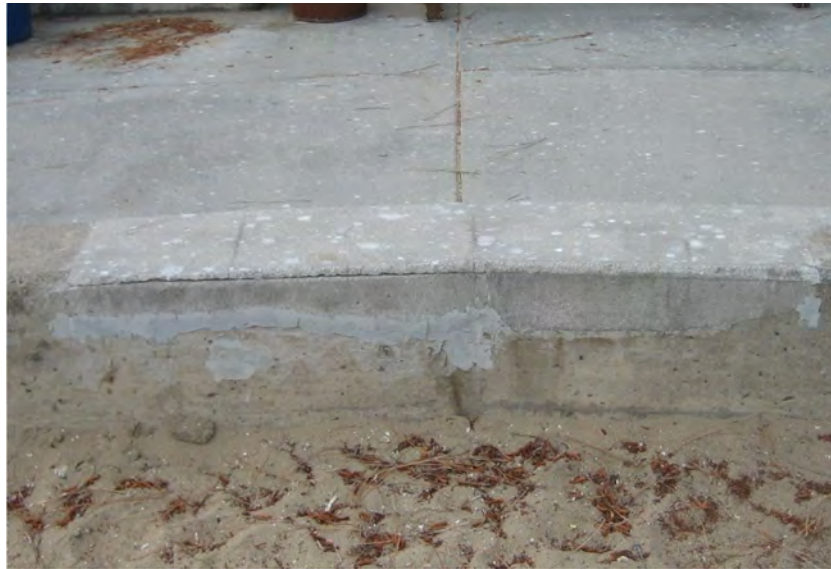
Photo 3: Use of elastomeric filler to seal cracks to prevent seawater intrusion

The City of Newport Beach also pursued a repair and maintenance program in response to the 2005 Report which detailed extensive distress (i.e., cracks and spalls) in the Balboa Island seawalls. Most of the noted distresses in the seawall cap and soldier piles were repaired (see Photo 3 for an example of a typical repair). Work as part of this project included an elastomeric material strictly used to seal the joints in the cap from water intrusion (see Photo 4).

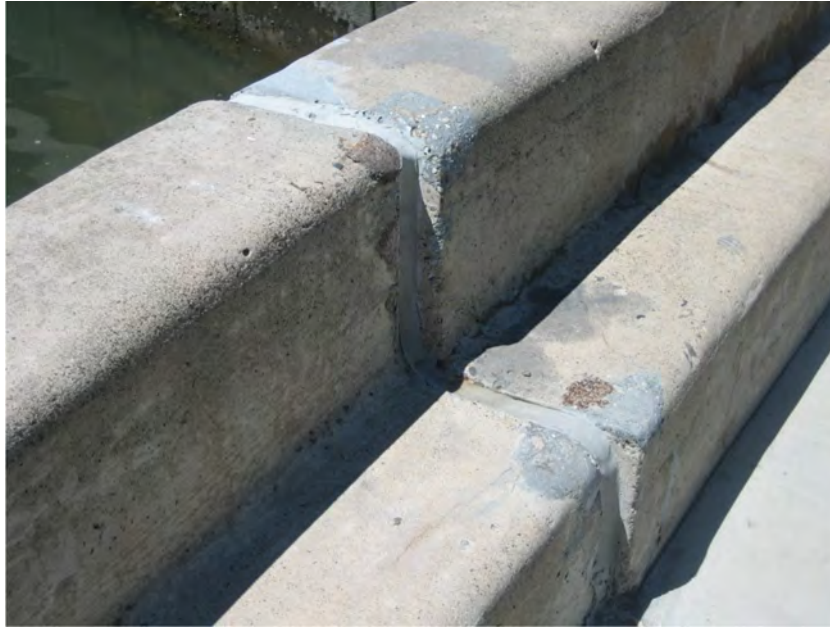
Photo 4: Use of elastomeric filler at joint

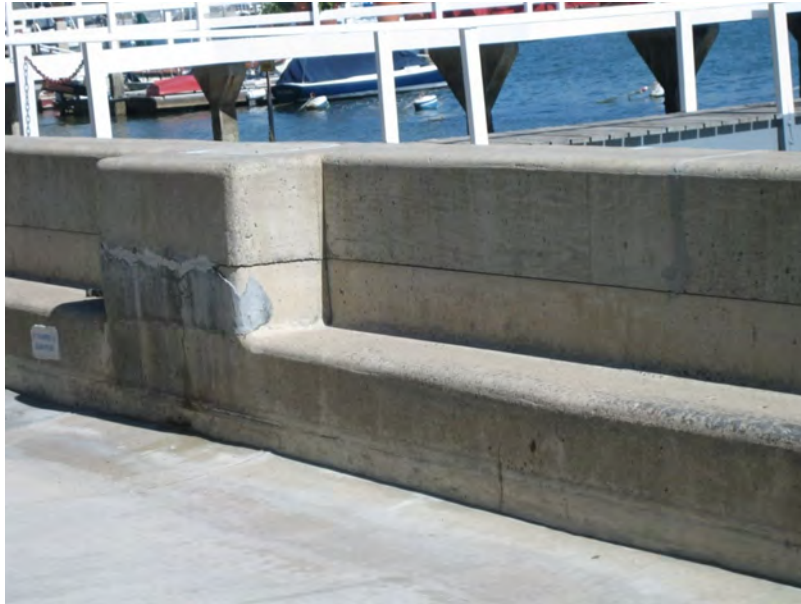
Photo 9: Little Balboa seawall cap extension

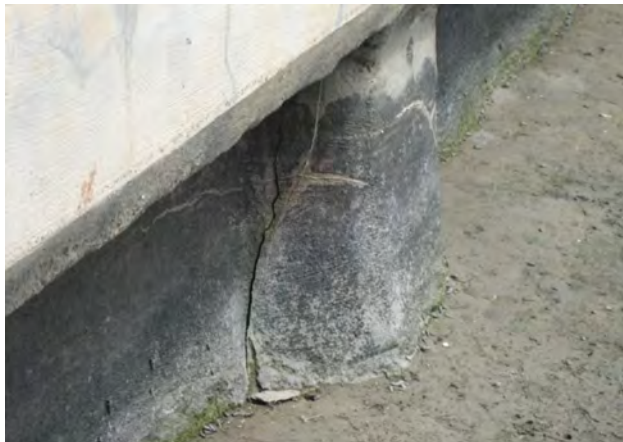
The visual survey also found universal distress in the cap, specifically multiple cracks, coinciding with the locations of the soldier piles. The development of these cracks at the specific locations of the soldier piles is likely due to a reduced structural cross-section and a concentration of load ultimately relating to concrete stress. Despite a concentration of cracks at the soldier piles, cracking also can be found at many locations along the concrete cap including the structural cap along the Grand Canal. Coupled with similar cracks found on the exposed portions of the soldier piles and panels, the evidence portends to universal distress throughout the seawall. The shot-creted piles and panels along the Grand Canal walls (see Photo 10) are of particular concern because the condition of the original concrete is hidden by the shot-crete repairs. As noted in Section 2.2 – Reports and Studies, other cracks in the cap have been repaired over the years. As shown in Photos 11 through 13, the quality of the repair and the degree of distress have varied.

Photo 10: Shot-crete on Grand Canal seawall

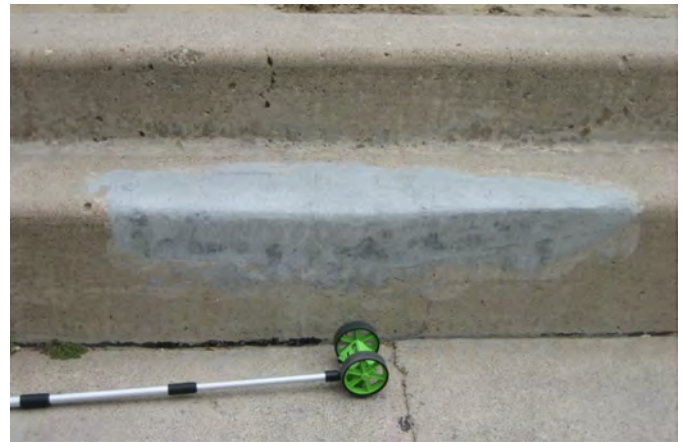
Photo 12: Successful spall repairs

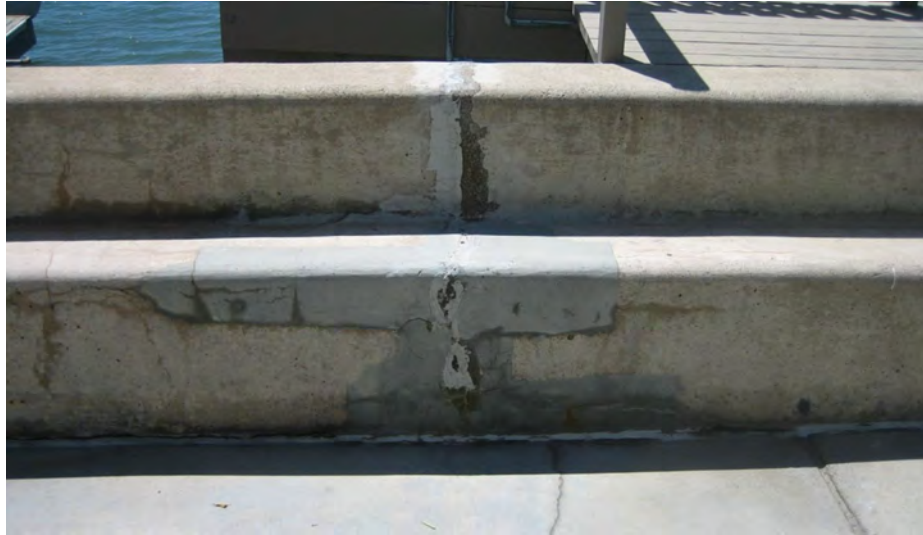
Photo 11: Typical spall and crack repairs

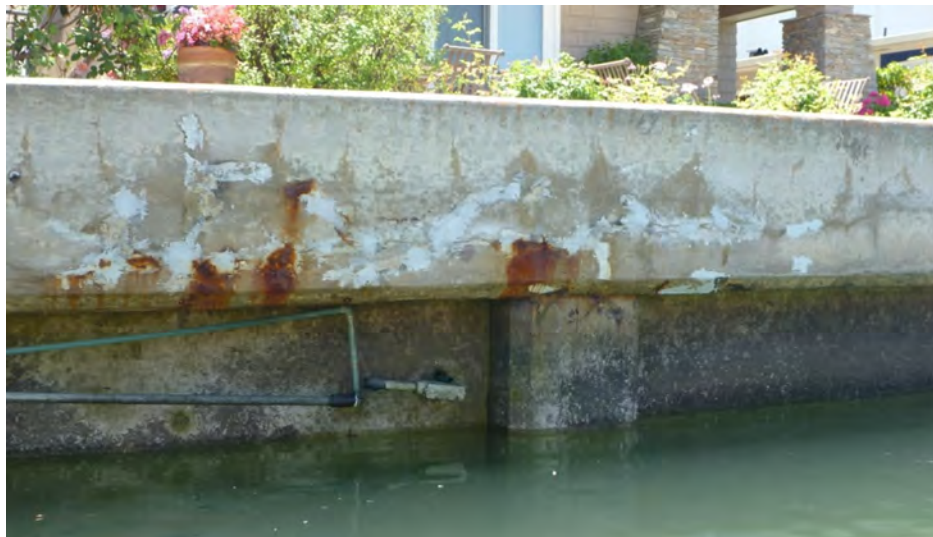
Photo 13: Crack repairs with corroding rebar

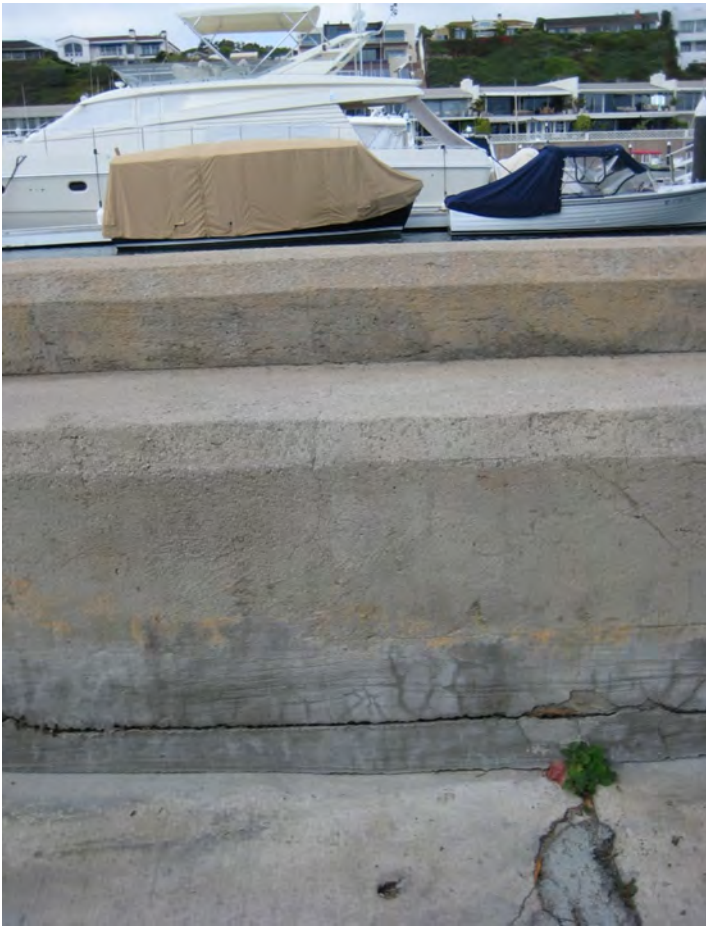
Photo 14: Crack along sidewalk separation from seawall

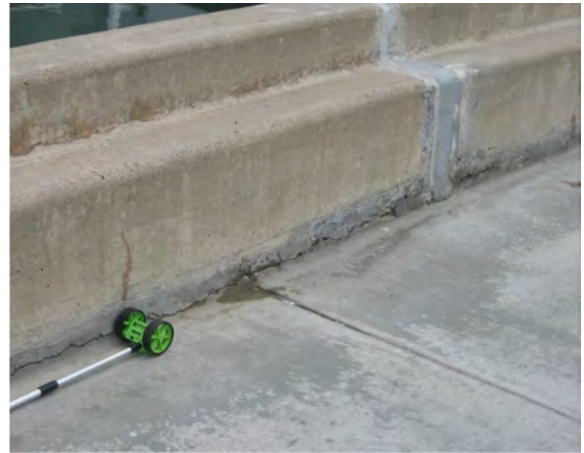
Photo 15: Sidewalk separation from seawall

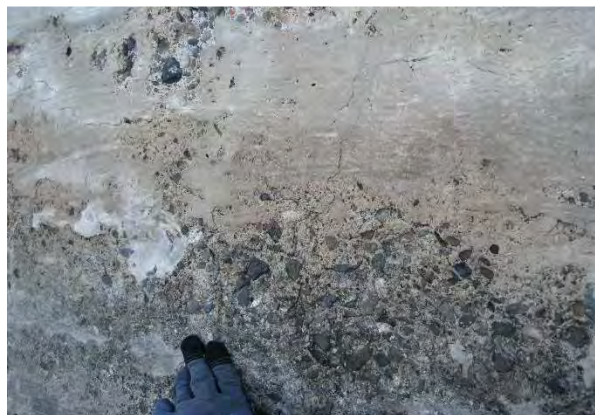
*Photo 1 – Example of hairline cracks, not individually called out in defect tables*

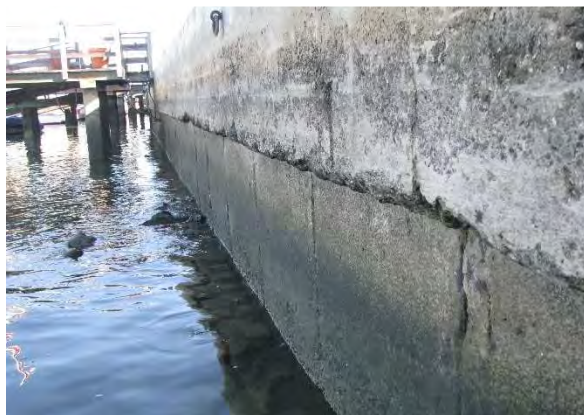
*Photo 2 – Erosion of wall and coping from station S0+09 to S0+31*

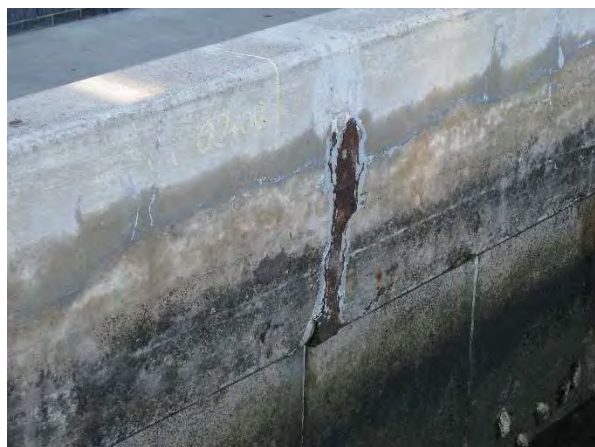
*Photo 3 – Previous cementitious repair exhibiting rust stains at bent S2+92*

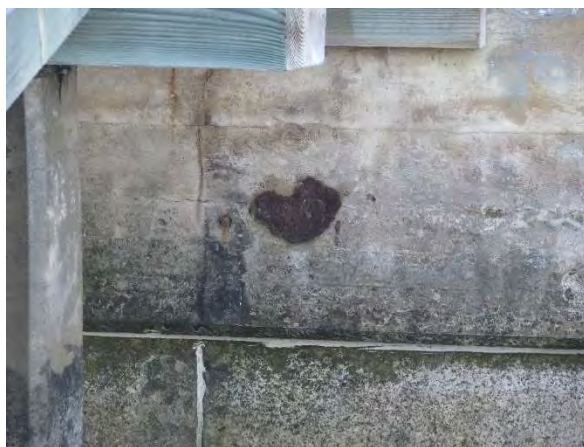
*Photo 4 – Rusted plug at wall, with flexible sealant at joints, at station S3+08*

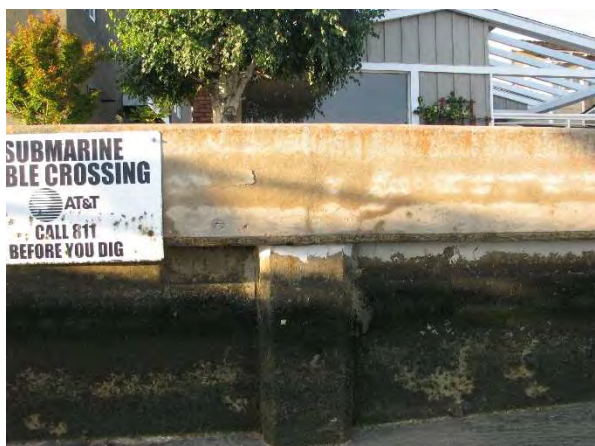
Photo 9 – Photo showing flexible sealant present in some locations, but not all.

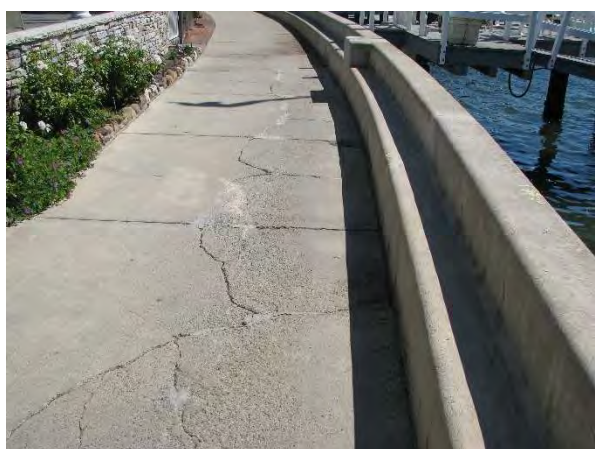
Photo 10 – Major cracks in sidewalk. Station S4+21

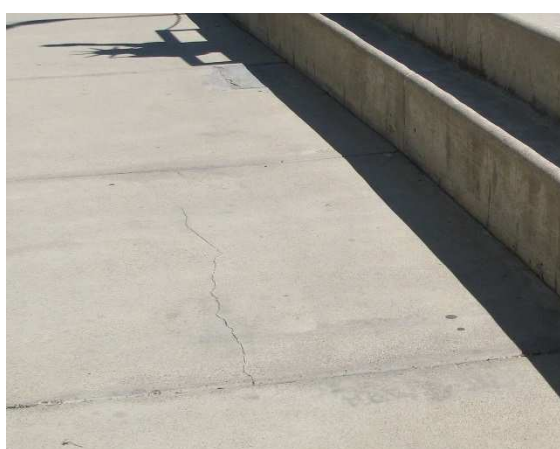
Photo 11 – Moderate crack in sidewalk. Station S2+16

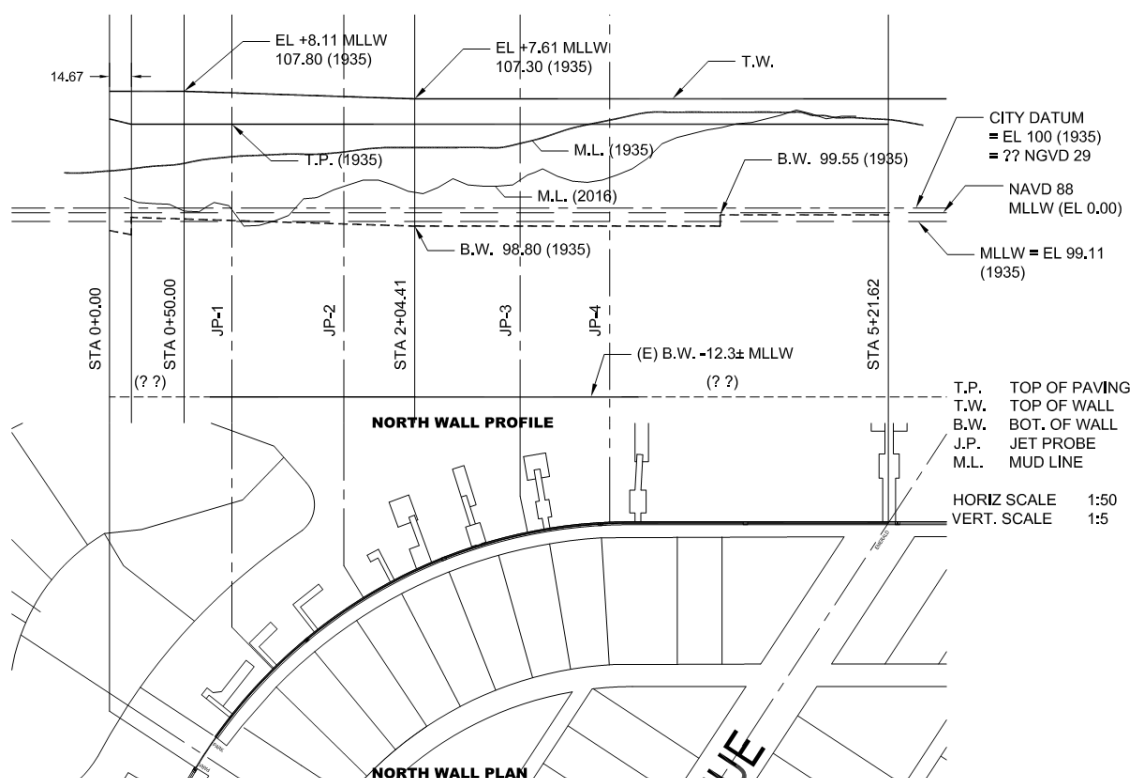
*Figure 2 - Plan and Profile of Existing Wall North of Collins Island*

location. Per details on sheet 9, these piles are only 12'-3" long. To be effective, they would also need to be increased in length.
