**ASBESTOS AND LIMITED  
LEAD-BASED PAINT  
SURVEY**

Proposed Christian Science First Church  
3303 Via Lido  
Newport Beach, CA 92663

PSI Project # 0588483-1

September 27, 2012

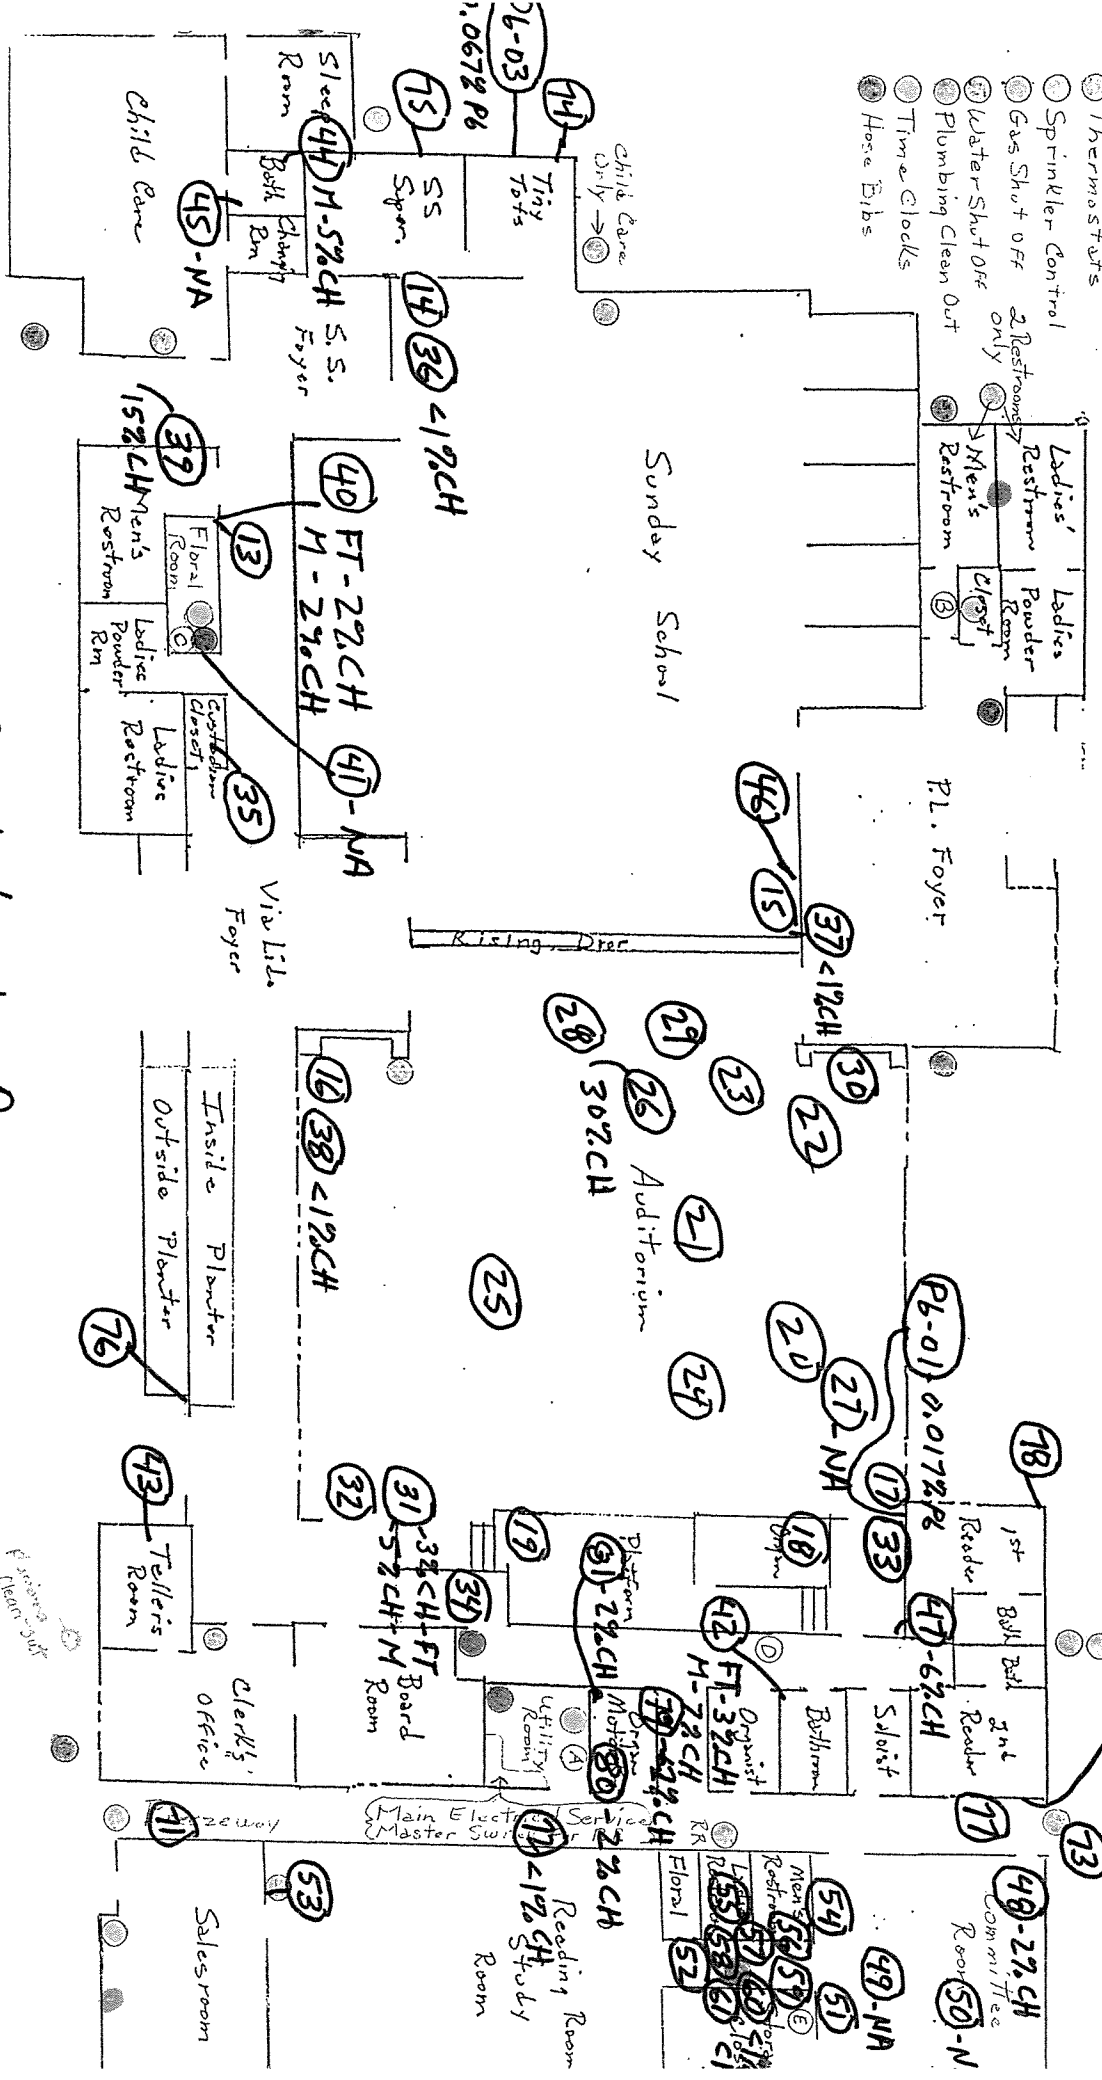
Sample Location Diagram

All Samples are negatived unless otherwise noted.
