November 22, 2013

***Subject: Results of Post-Construction Site Evaluation at the Los Trancos Creek Maintenance Project, Crystal Cove State Park, Orange County, California***

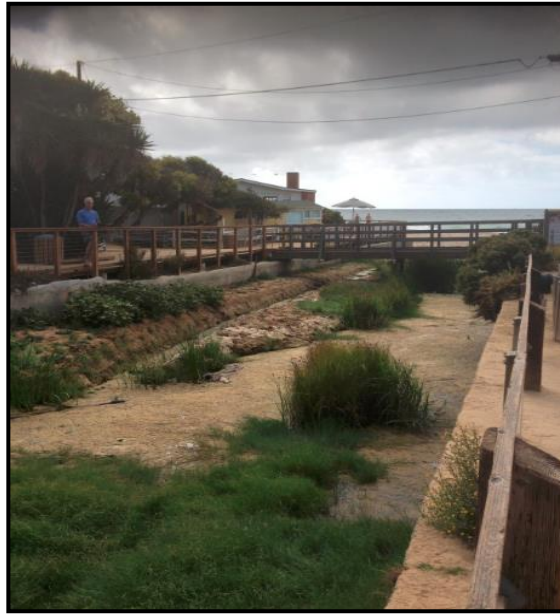
During the September 2013 biological resources assessment, moderate quantities of kikuyu grass were still noted in the upper reaches of Los Trancos Creek, in addition to the non-native/invasive species castor bean (*Ricinus communis*). The establishment of native species within the creek is evident and is progressing satisfactorily, however, plant establishment has been slowed by the lack of consistent watering and some disturbances from un-seasonal creek flows. The natural vegetation and revegetation effort in Los Trancos Creek is relying on either natural precipitation or channel flows and subsurface moisture, as no irrigation was feasible. Because the project was constructed in May 2013, rain events were sparse and minimal at best and moisture in the creek has been minimal. However, there were reports of an un-seasonal rain event in late May/early June 2013 that appears to have washed away some of the hydroseed materials and impacted the revegetation efforts.

Additionally, some supplemental sand accumulation on the beach has resulted in the creation of a berm at the mouth of Los Trancos Creek that is blocking flow from the creek and as of the September visit, was yet to be breached by creek flow or high tide events. This has resulted in water body stagnation with notable quantities of algae on the water surface. Once this berm is breached and/or the area receives precipitation and flow from expected fall and winter rain events, we are certain that native plant recruitment and recovery will progress at a more vigorous rate. It is evident that areas that once supported predominantly kikuyu grass and garden nasturtium are now slowly recovering with native salt grass, pickleweed, salty-susan (*Jaumea carnosa*), and various sedges (*Cyperus* spp.). Please see Photo 1 for a visual illustration of the site conditions as of our September site visit.

Photo 1: South-facing view of Los Trancos Creek.

The pilot channel that was hand excavated using hand tools has helped to re-establish and stabilize a more natural channel cross-section with a central low flow flanked by artificially constructed primary floodplain terraces. These terraces were initially targeted for native plant revegetation as part of the initial Project efforts; however, as mentioned above, an un-seasonal rain event in late spring/early Summer 2013 washed-out some of the revegetation materials in these areas, leaving behind some unvegetated areas. However, these areas are already beginning to show signs of natural native plant recolonization and, as previously mentioned, they are expected to naturally re-establish with native species over time. As seen in Photo 1, non-native kikuyu grass continues to establish in the Project area, in the more upper reaches of the creek near the far north pedestrian bridge. Dudek recommends targeting this exotic grass, along with newly recruited seedlings of salt cedar (*Tamarix ramosissima*) and castor bean (*Ricinus communis*), for removal in 2013/2014 to help ensure these species remain controlled and do not pose a continued threat to project success. All weed material should be removed and disposed of appropriately off site. Mechanical weed whips are not recommended for use in the creek, as they could impact native seedlings. Hand pulling and/or target spot spraying of weeds and exotics are recommended to reduce collateral damage to surrounding establishing native plants. Dudek also recommends re-hydroseeding to the island and south channel banks in early 2014 to further assist in plant establishment, native plant recruitment and overall site recovery.
