BIG CANYON CREEK

Historic Tidal Wetlands Conceptual Restoration Plan

Upper Newport Bay
Orange County, California
April 2004

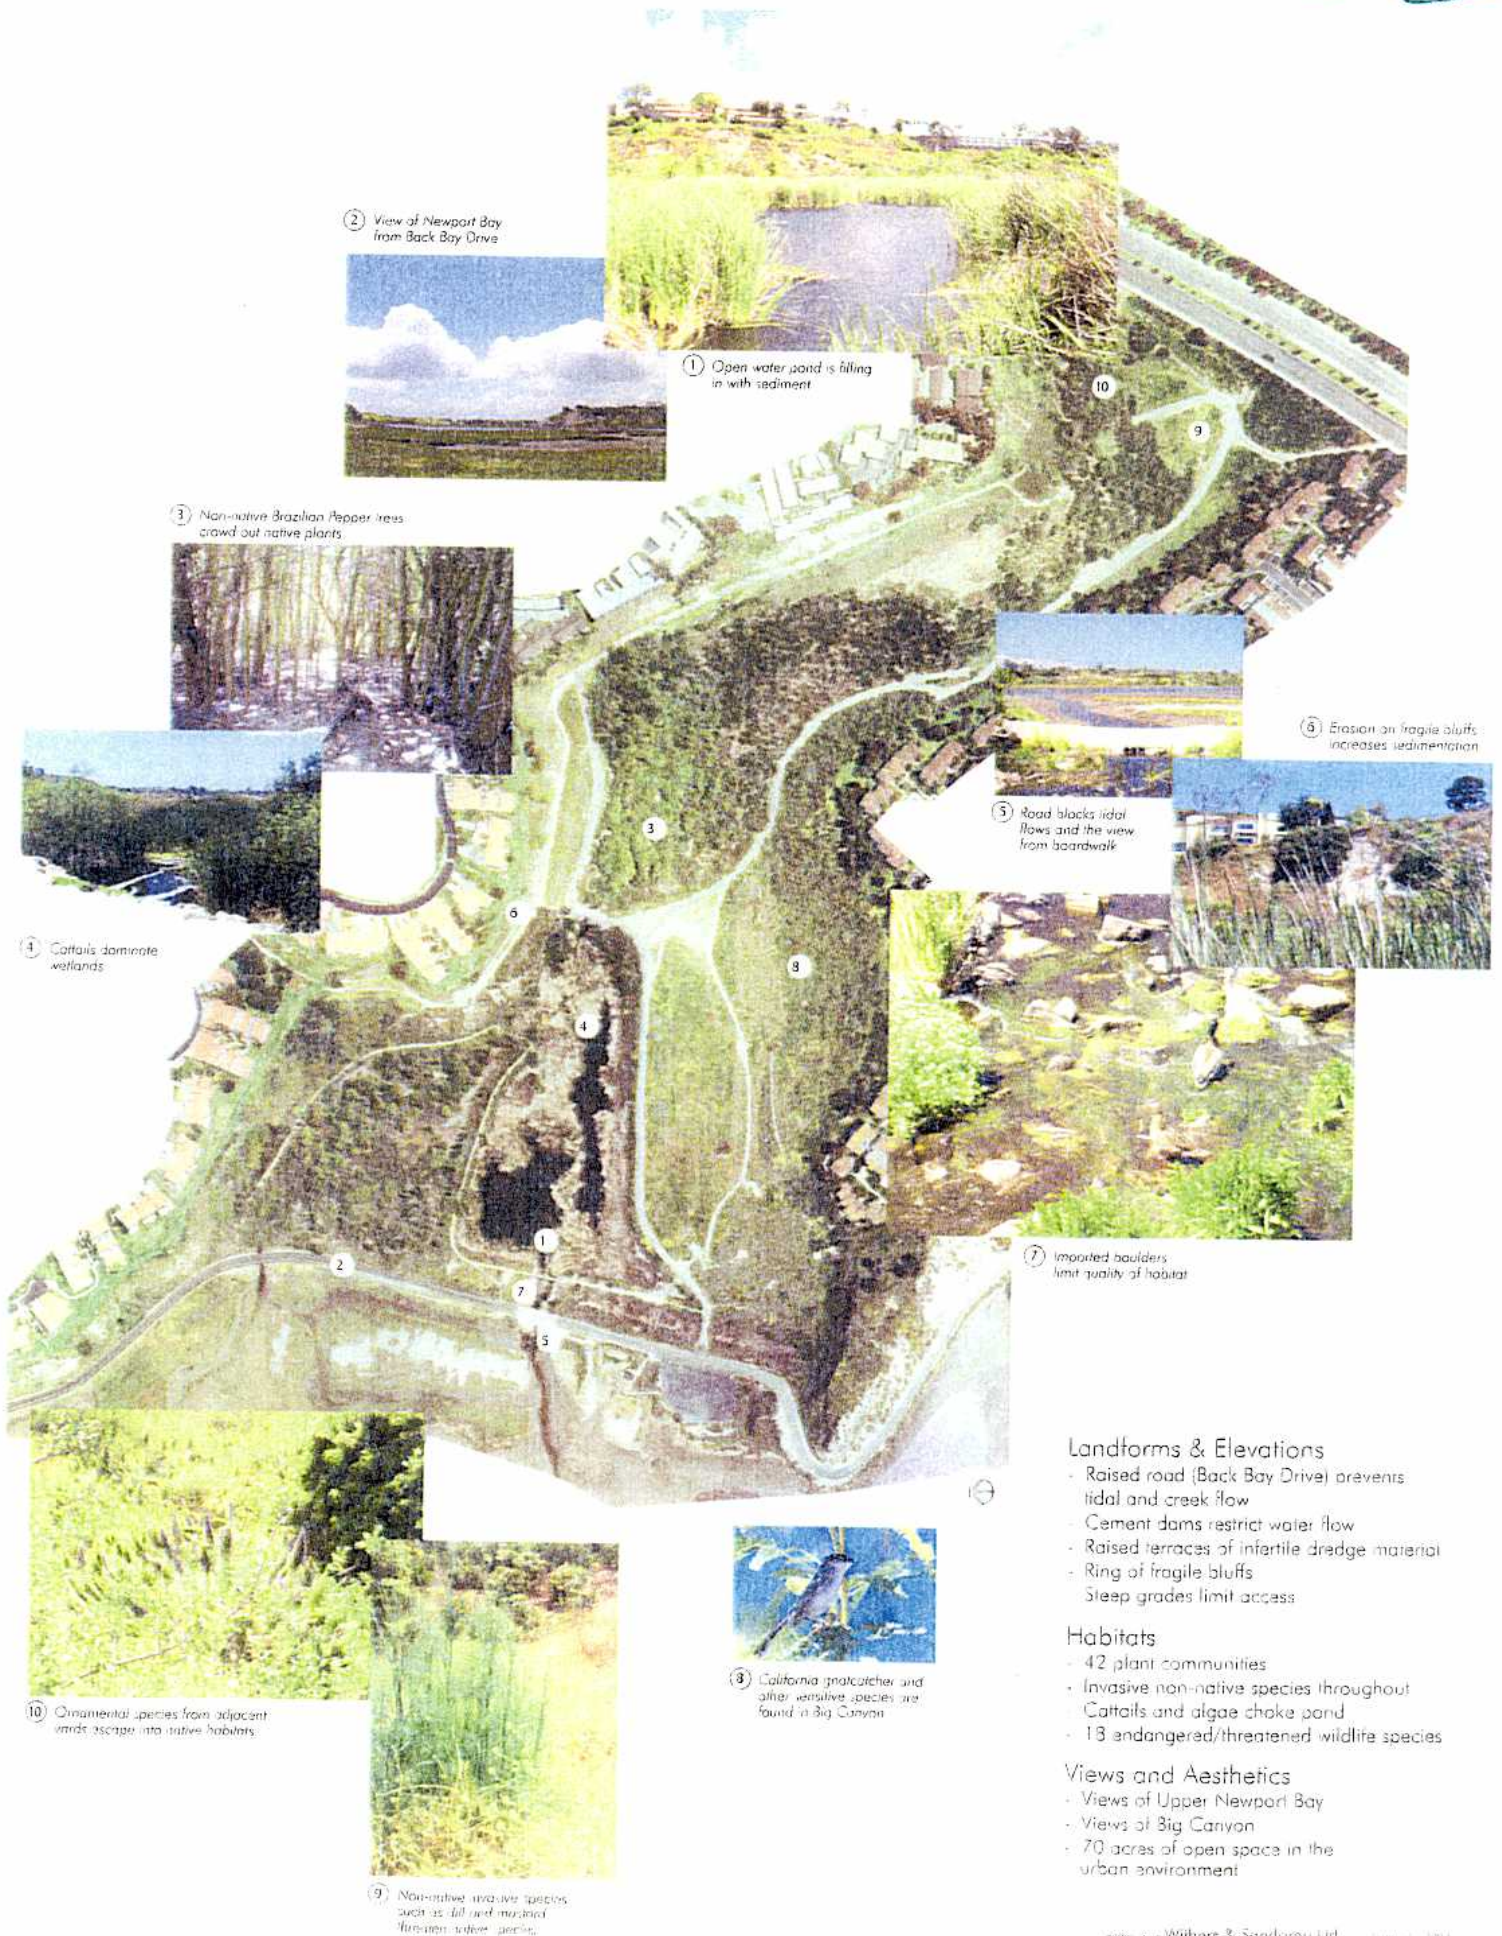
BIG CANYON TODAY: ISSUES OF CONCERN

- Raised road (Back Bay Drive) prevents tidal and creek flow
- Cement dams restrict water flow
- Raised terraces of infertile dredge material
- Ring of fragile bluffs
- Steep grades limit access

- Back Bay Drive provides primary access
- Wide gravel and dirt sewer access roads
- Damaged bridges and boardwalks
- Limited official trails
- Unauthorized trails and access

- Big Canyon is key public access to Upper Newport Bay
- One-way car access on Back Bay Drive
- Parking lot in sensitive wetlands area (35 cars, 2 buses)
- Limited bicycle access on Back Bay Drive
- No disabled access
- Deteriorating and isolated interpretive signage

- Constricted drainage at creek mouth
- Sewer lines and manholes
- Storm drains
- Cement "dams"
- Riprap edges (concrete stream banks)

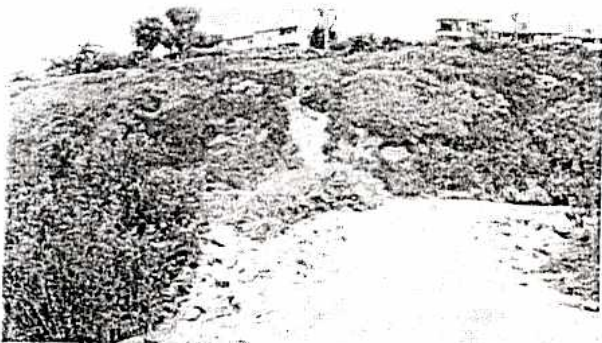
Concrete embankment and maintenance road crossing over creek

The maintenance road crosses the stream course in the middle of the canyon. Culverts under a concrete embankment constrict the winter flows, creating a riparian woodland and wet meadow upstream.
