**Delineation of Jurisdictional Waters and Wetlands
12.5-Acre Newport Village Park
City of Newport Beach, Orange County, California
(Laguna Beach 7.5 Minute USGS Topographic Map Section 93, T-6S, R-10W)**

August 2004

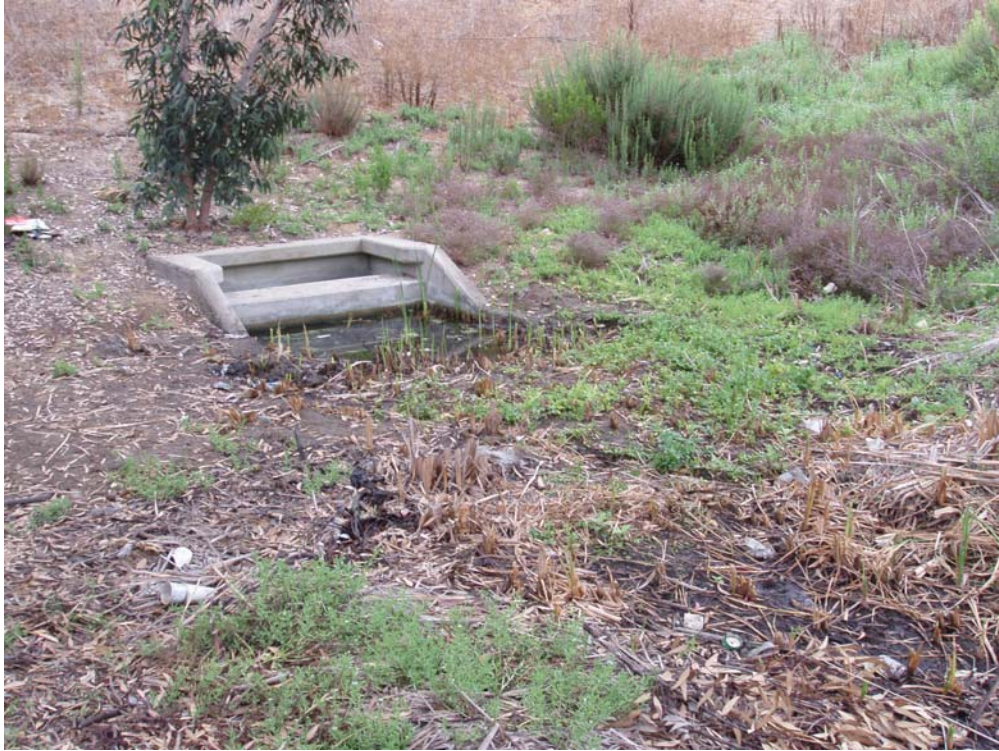
Facing north; cache basin at origination of drainage

The northern drainage originates from an underground culvert and a concrete flood control facility at the northern property boundary. The flowing water likely originates from urban runoff, and flows southwesterly to converge with the southern drainage. The portion of this drainage within the project site is approximately 432 feet in length and the OHWM ranges from 4 feet to 30 feet in width with an average of approximately 25 feet. The dominant plant species associated with the bed of this drainage feature include slender cattail (*Typha angustifolia*), sweet alyssum (*Lobularia maritima*), western yellow cress (*Rorippa curvisiliqua* var. *occidentalis*), and marsh fleabane (*Pluchea odorata*). Upland species on the banks of the drainage include California sagebrush (*Artemisia californica*), black sage (*Salvia mellifera*), and California bush sunflower (*Encelia californica*).

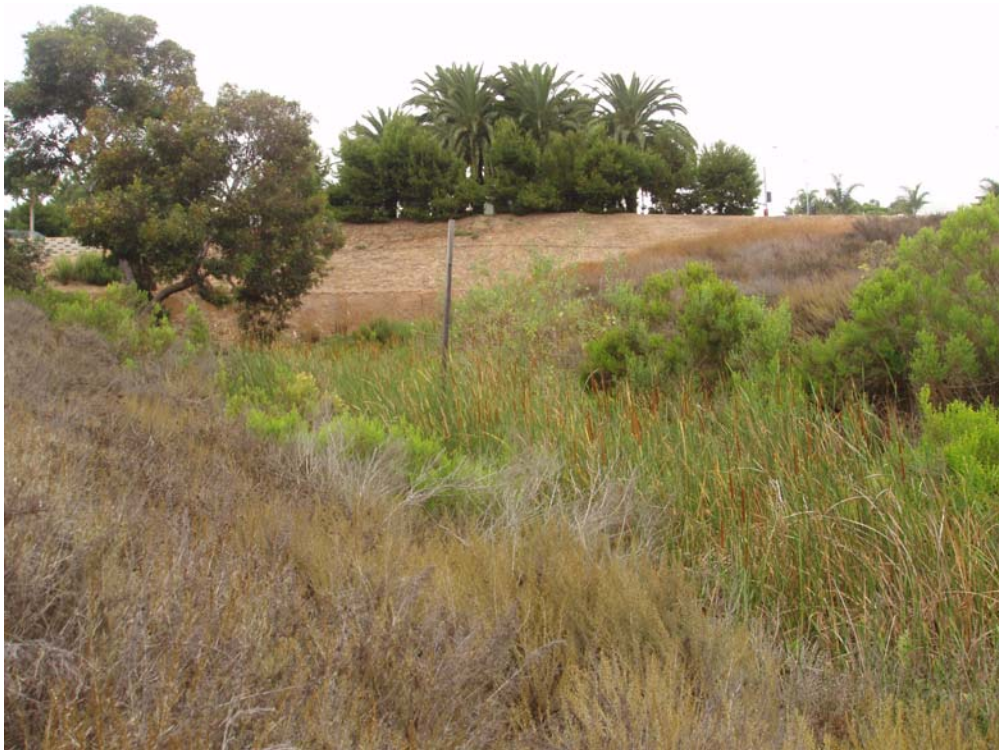
At midway of drainage, facing north at wetlands

The northern drainage can be divided into two distinct areas (north and south). The portion of the drainage north of data point 3 is considered to be a perennial drainage with riparian vegetation. It is approximately 288 linear feet and averages 30 feet in width. South of data point 3, the riparian vegetation ends and the drainage becomes ephemeral. At this point, the channel is approximately 4 feet in width and is covered by a canopy of coastal sage scrub species including sugar bush (*Rhus ovata*) and California sagebrush, as well as African daisy (*Osteospermum ecklonis*). The channel is concrete lined for approximately 50 linear feet before it joins the southern drainage.

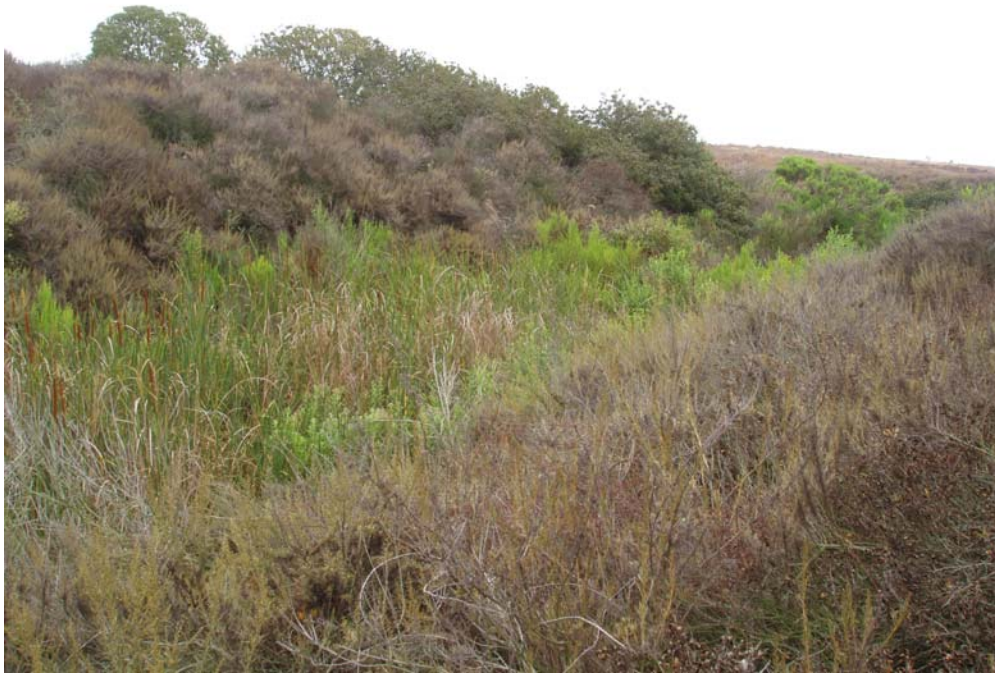
At midway of drainage, facing south at wetlands

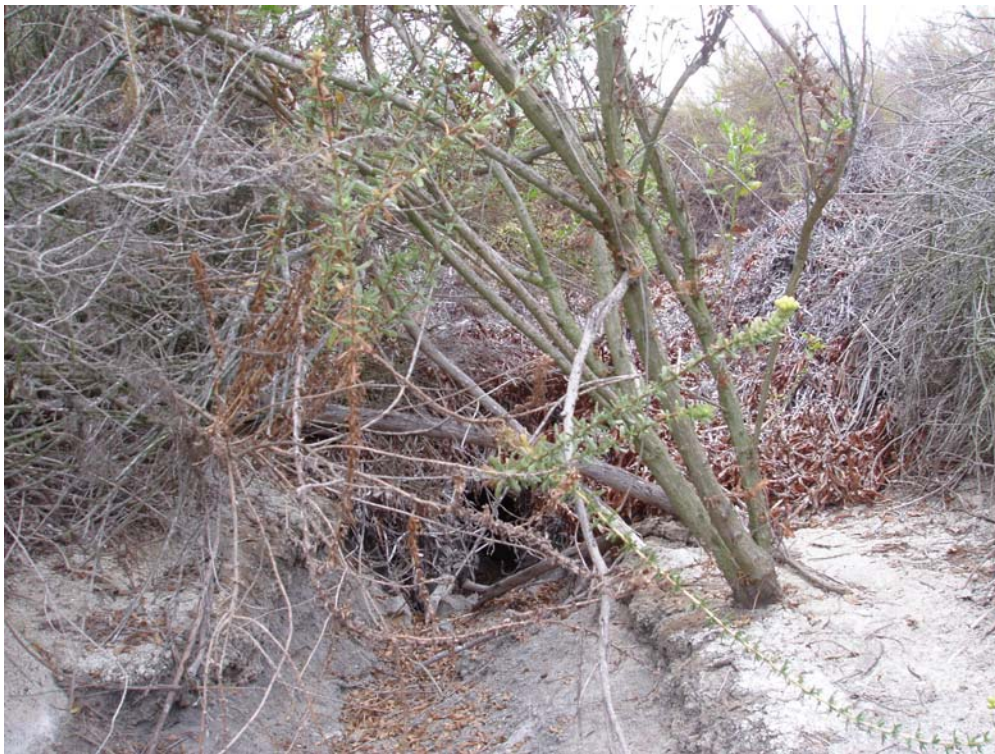
End of wetlands; facing south, drainage is covered by upland vegetation

For the northern drainage, the segment south of data point 3 is covered by a canopy of coastal sage scrub species including sugar bush (*Rhus ovata*) and California sagebrush, as well as African daisy (*Osteospermum ecklonis*). All three of these species are considered upland and therefore, this segment of the drainage feature does not meet the criteria for hydrophytic vegetation

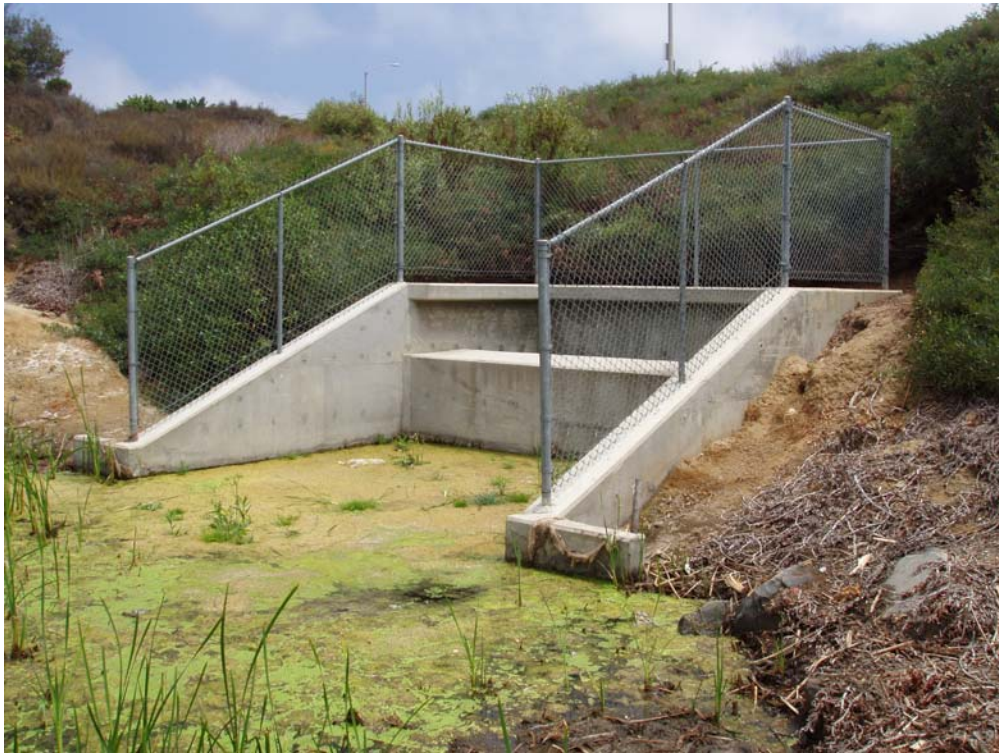
Facing east; cache basin at origination of drainage

The southern drainage originates at the eastern property boundary with from an concrete culvert that also contains urban runoff. It flows westerly through the proposed project site to an underground

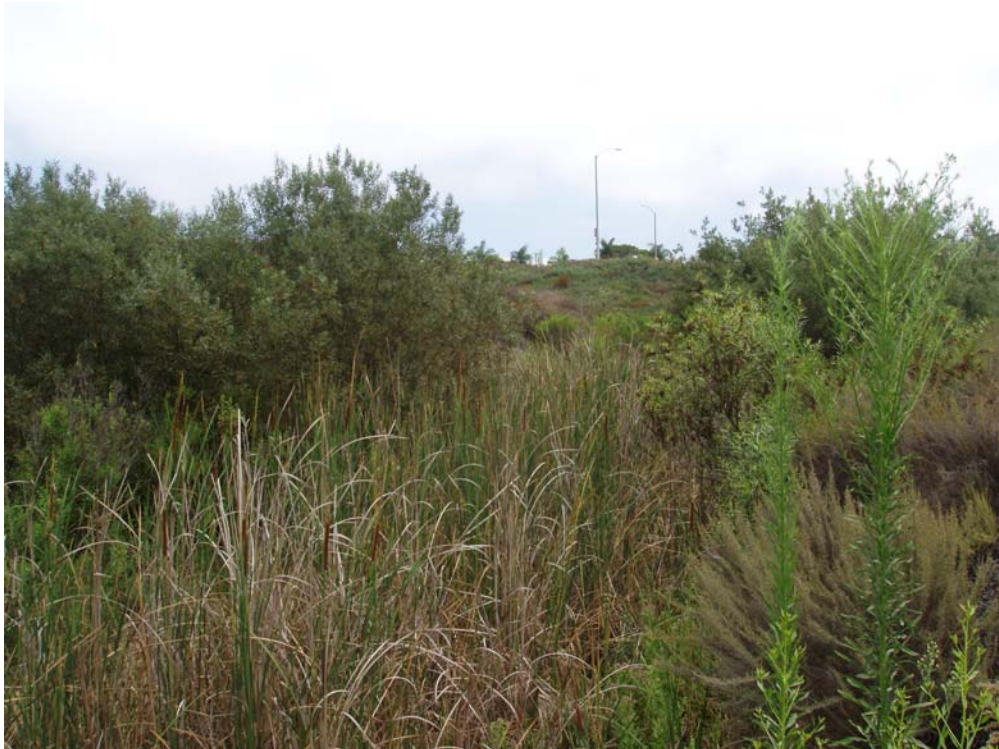
Facing east at wetlands

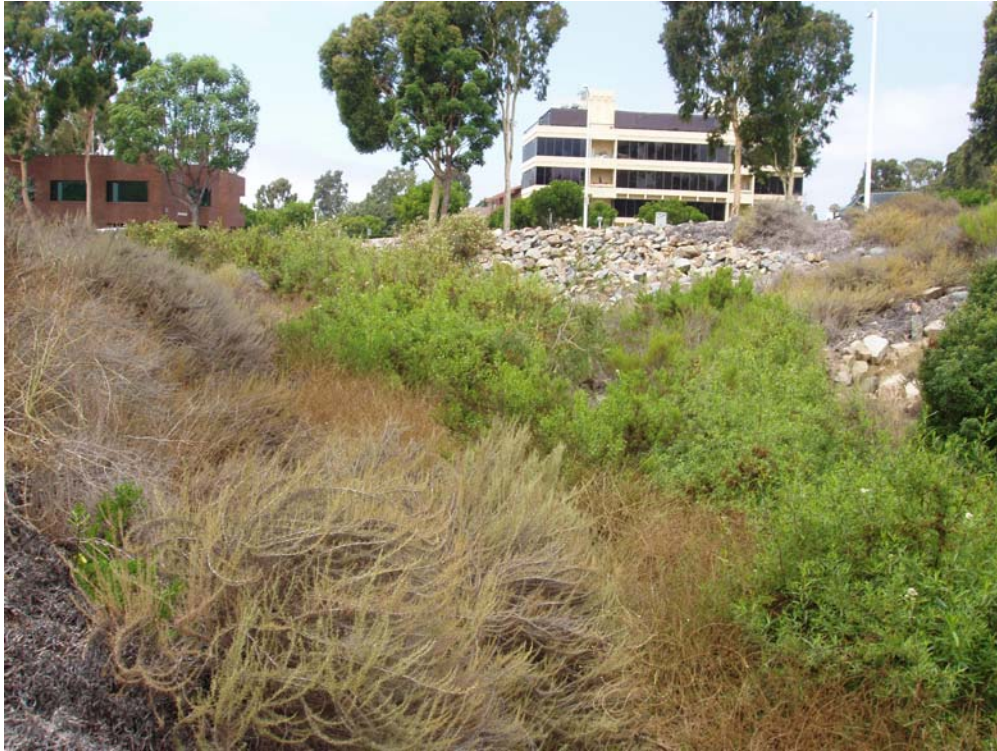
Facing west; end of wetlands, associated riparian vegetation continues

drainage structure at the western property boundary beneath Avocado Avenue. The onsite portion of the drainage is approximately 366 linear feet and the OHWM ranges from 2 feet to 50 feet with an average of about 20 feet. This drainage can also be divided into two segments, east and west of data point 8. West of data point 8, the water flows into an underground concrete channel that is stabilized with riprap. The vegetation communities of the eastern segment of the southern drainage are similar to the northern segment of the northern drainage. The vegetation in the bed of the channel consists of slender cat-tail, western yellow cress, sweet alyssum, marsh fleabane, and duck weed (*Lemna* sp.). This drainage also contains black willows (*Salix gooddingii*) and arroyo willows (*Salix lasiolepis*), extending the jurisdiction of CDFG beyond the bed and bank of the stream.
