UPPER NEWPORT BAY ECOSYSTEM RESTORATION PROJECT
 April 2006 to July 2009
 PHASE 1

UPPER NEWPORT BAY ECOSYSTEM RESTORATION PROJECT
 September 2009 to March 2010
 PHASE 2

Recovery - Upper Newport Bay
Ecosystem Restoration Phase 2
Status of Project Features March 2010

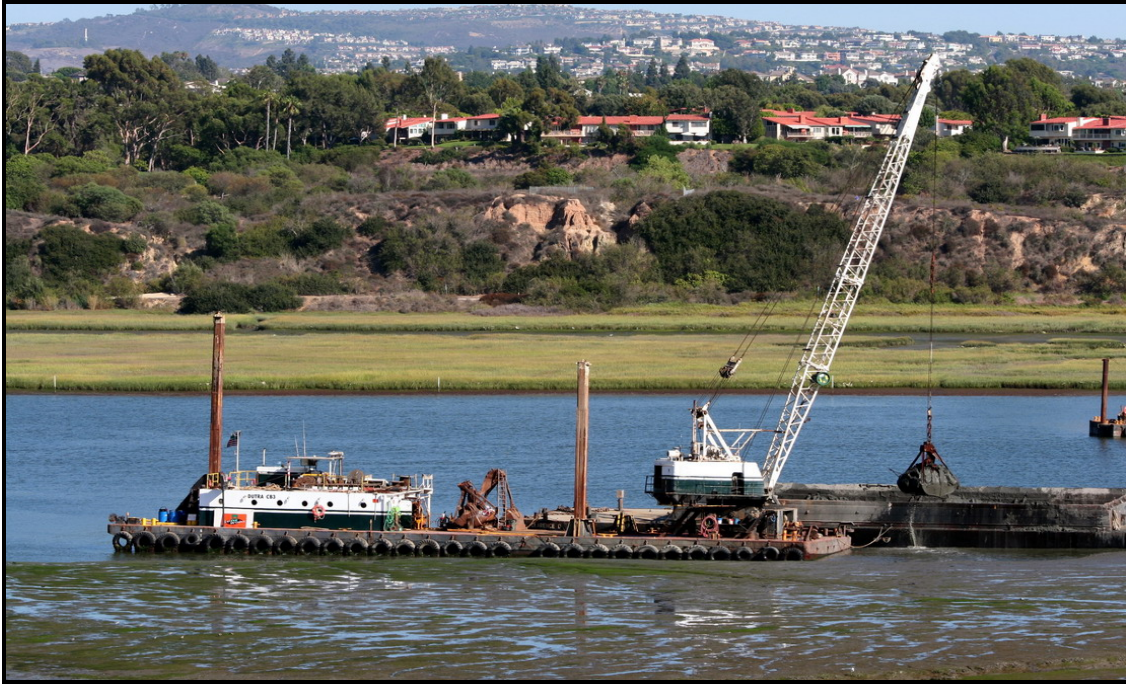
DB-3 dredging Unit II Sediment Control Basin, 29 August 2007

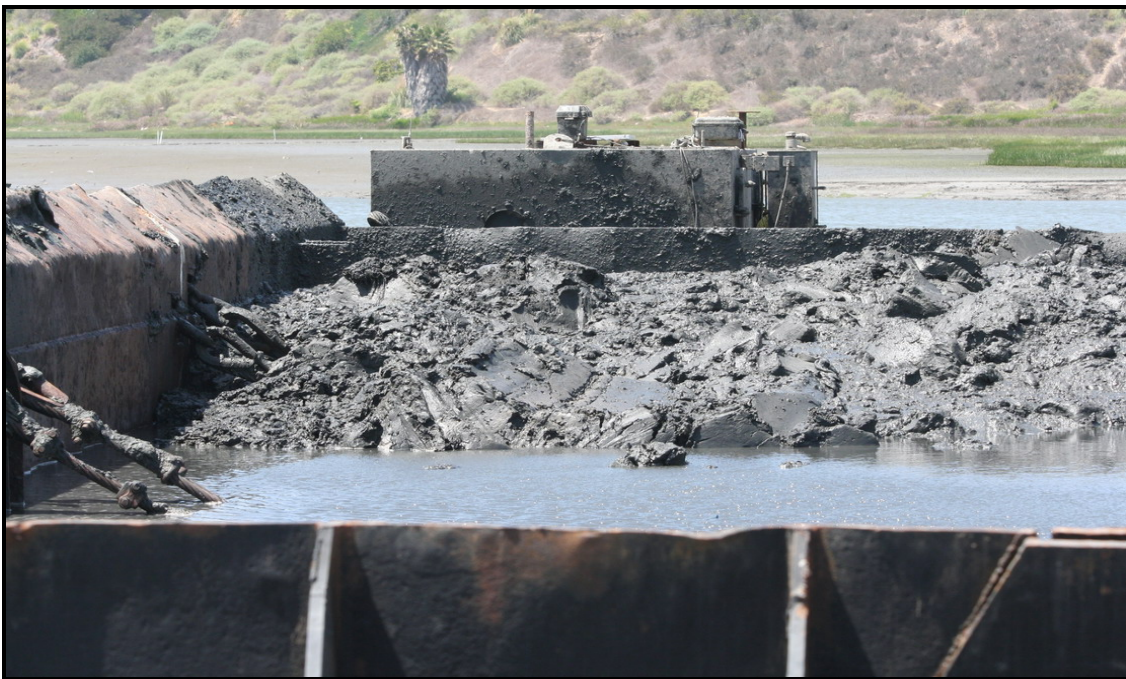
View inside scow being loaded with sediment for disposal at LA-3, 8 June 2007

Material disposal. The majority of dredged sediments are being disposed offshore at LA-3, with the use of towed dump scows. The predominate scows utilized for disposal operations are the 2,228 cubic yard scows, the 260 and 261. These scows are 197 feet long and 45 feet wide. The molded deck from the deck to the bottom of the hull is 16 feet. The overall hopper length is 136.7 feet. The width of the hopper is 35 feet. Alternate scows utilized occasionally are the 1500 cy scows Clarence and the Harold. Scows of different sizes may be utilized throughout the project duration. The disposal barge moorage area previously located immediately south of Harbor Island has been relocated to deeper water west of Harbor Island. The Lower Bay moorage area will continue to be used, as infrequently as possible, to accommodate the disposal barges as they await appropriate tide levels to transit upstream to the Upper Bay work area. Under the Phase 1 project, about 1,580,000 cubic yards of material have been removed from the Upper Bay by the dredging of the access and side channels, sediment basins, and wetland restoration areas. The dredged material removed from the bay has been placed either at the LA-3 ocean disposal site, located 5-miles southwest of the entrance to Newport Harbor, or nearshore. Nearshore disposal operations are complete and any additional placement outside the bay will be at LA-3. Additional material has been moved from wetland restoration sites and placed in bay for island construction and improvement. Material from Shellmaker Island and 23rd Street Wetland Restoration areas were used to construct the New Least Tern Island.

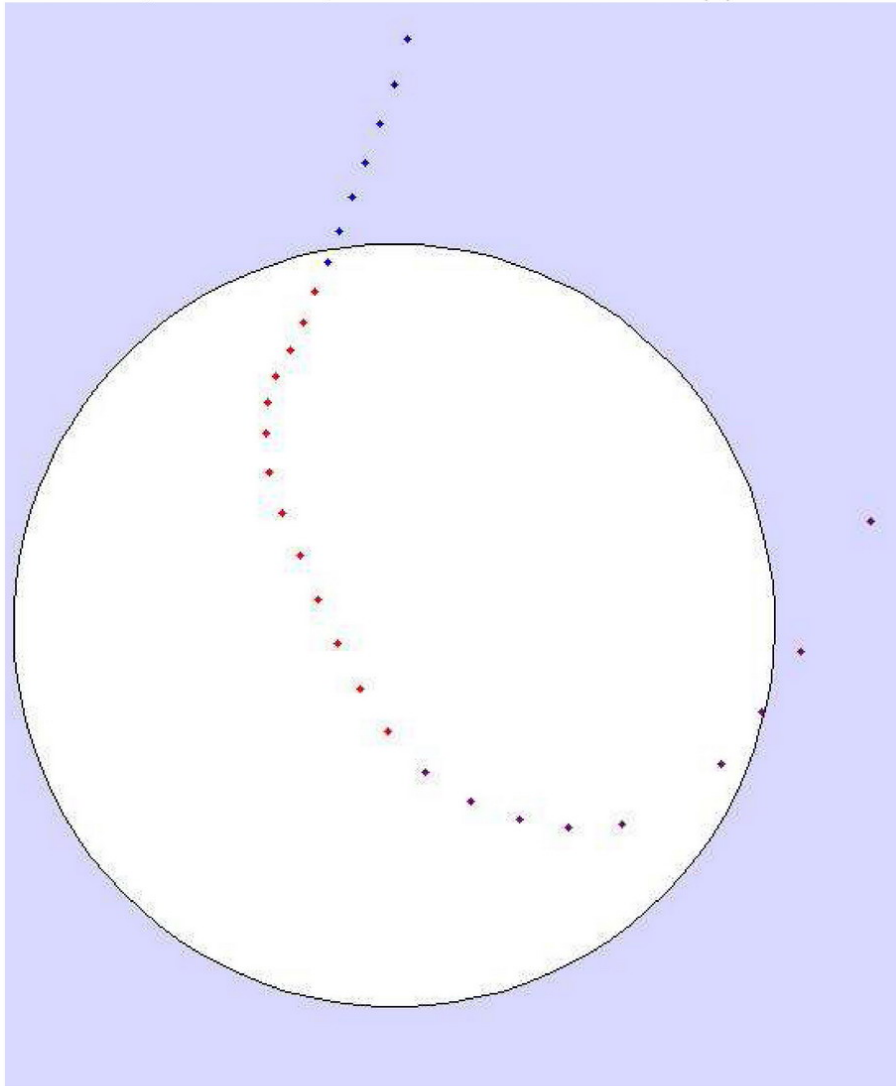
Trip:	73		
Scow:	DS6		
Transit Start:	16-Sep-2006 11:18:19	AFT DRAFT (ft) =	11.4
Begin Disposal:	16-Sep-2006 13:20:10	AFT DRAFT (ft) =	11.4
Post Disposal:	16-Sep-2006 13:23:22	AFT DRAFT (ft) =	3.7

Three figures follow, showing plots of the tracking system from one scow trip, the 3000 Cubic Yard DS6 on the date of September 16, 2006. The first plot shows the track from the bay to the LA-3 disposal site (note that there are two circles, the larger circle depicts the location of LA-3 that is no longer used, and the smaller circle is the current target). The second plot shows a detail of the LA-3 target disposal zone (the circle) and the dots indicate where the scow was located when materials were being bottom dumped out of the scow. The third plot shows the draft of the scow as it transits out of the bay to the disposal zone. The measurement fluctuates due to motion upon the water, but shows the same draft at the beginning of disposal as at the beginning of transit. This implies that the scow is not leaking material. When disposal occurs, the graph documents the 7 to 8 feet of change in scow draft.

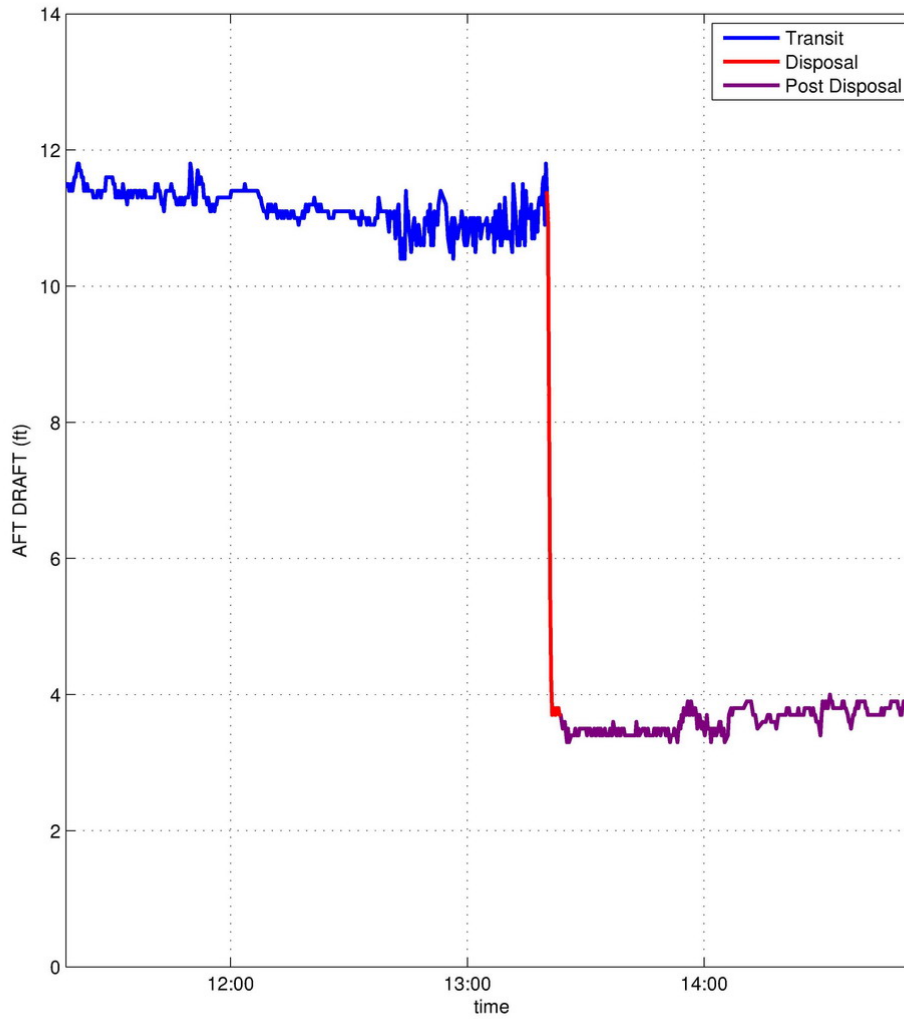
Trip:	73		
Scow:	DS6		
Transit Start:	16-Sep-2006 11:18:19	AFT DRAFT (ft) =	11.4
Begin Disposal:	16-Sep-2006 13:20:10	AFT DRAFT (ft) =	11.4
Post Disposal:	16-Sep-2006 13:23:22	AFT DRAFT (ft) =	3.7

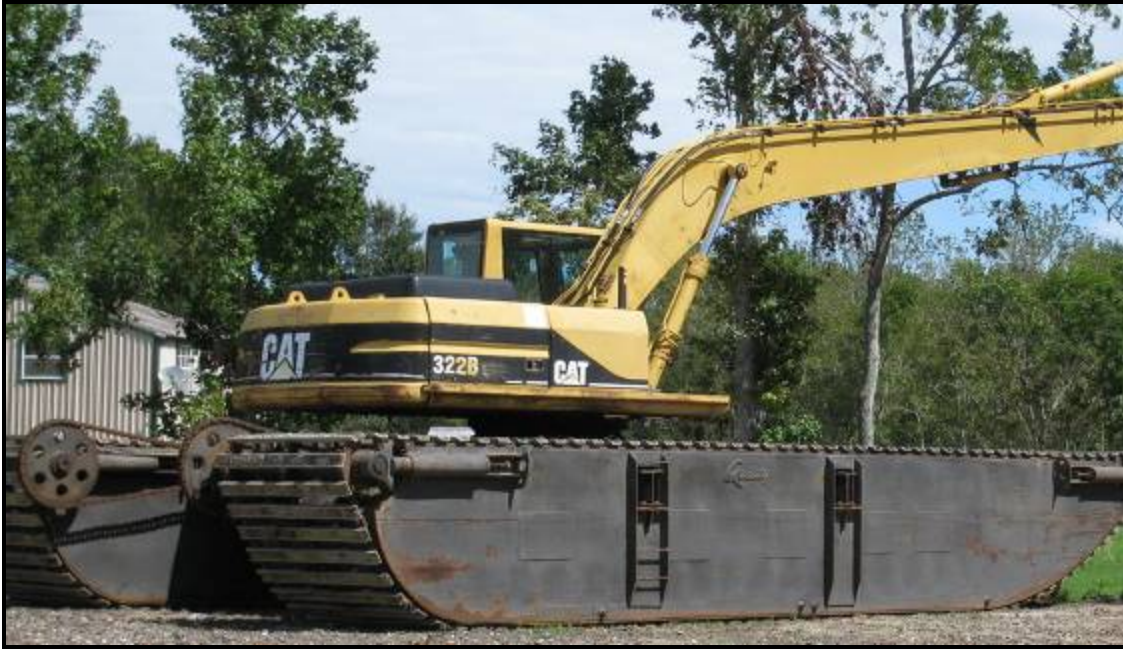
Amphibious Excavator, photo courtesy of DD-M and Cooper's Crane.
Amphibious Cat 322BL Long Reach Excavator with: The machine is 34' long, 18' wide, 13' tall and the ground pressure is 2 psi; 60' of reach; 3/4 cubic yard bucket; 5'x5'x31' pontoons

Answer #5: This piece of equipment is an amphibious excavator, an excavator mounted on two pontoons with tracks. The equipment is useful for working in areas subject to tide. It will float; however, operation is expected to be when the tide is no higher than 3 or 4 feet, when the pontoons will still have some contact with the existing surface.

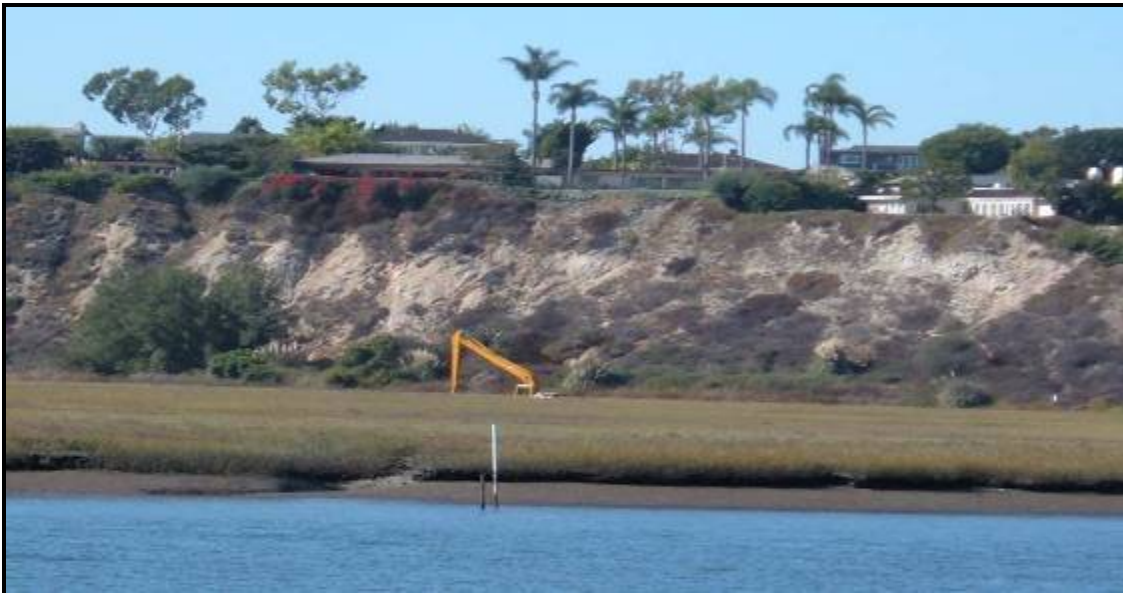
Amphibious Excavator working in Middle Island Channel, photo by Jay Grandon, October 2008

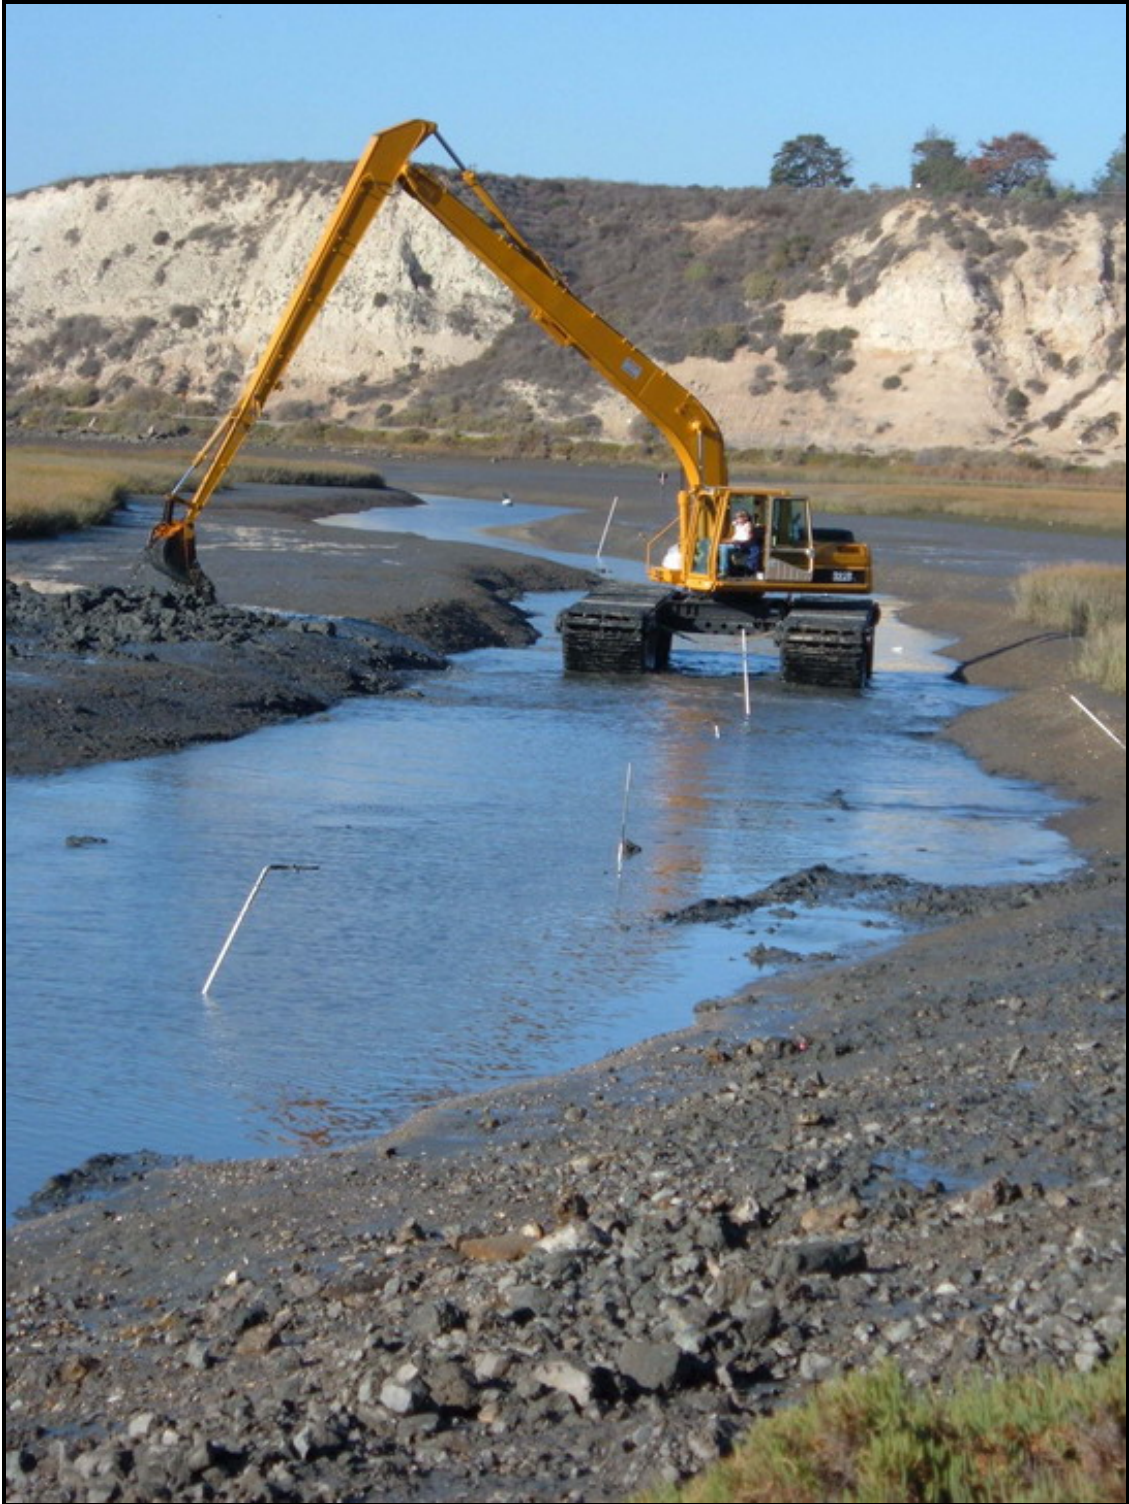
Amphibious Excavator working in Shellmaker Island, October 2008

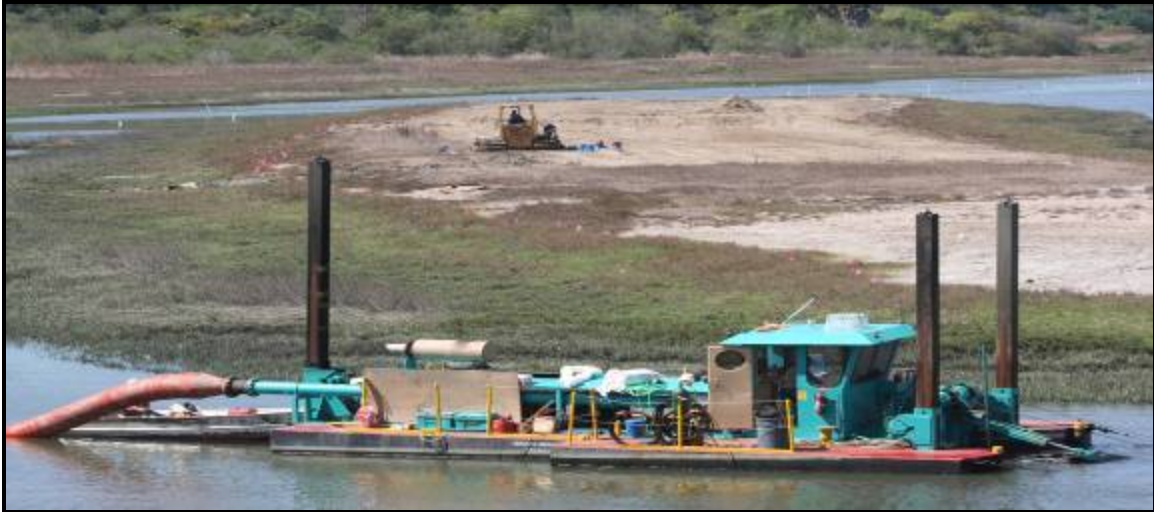
Dredging Hotdog Tern Island Restoration Channel and resurfacing Hotdog Island, Photo by Keane Biological, March 2007

Least Tern Island Creation/Improvement. Hotdog Tern Island required resurfacing in order to become a more viable habitat for the California Least Tern, an endangered species. Clearing the vegetation, grading of on site materials, and placement and grading of coarser-grained sand cap was performed and completed in April 2007. Construction of the New Least Tern Island was completed April 2008, using materials from the wetland restoration sites. The New Least Tern Island is located adjacent to the main dike next to Basin II.

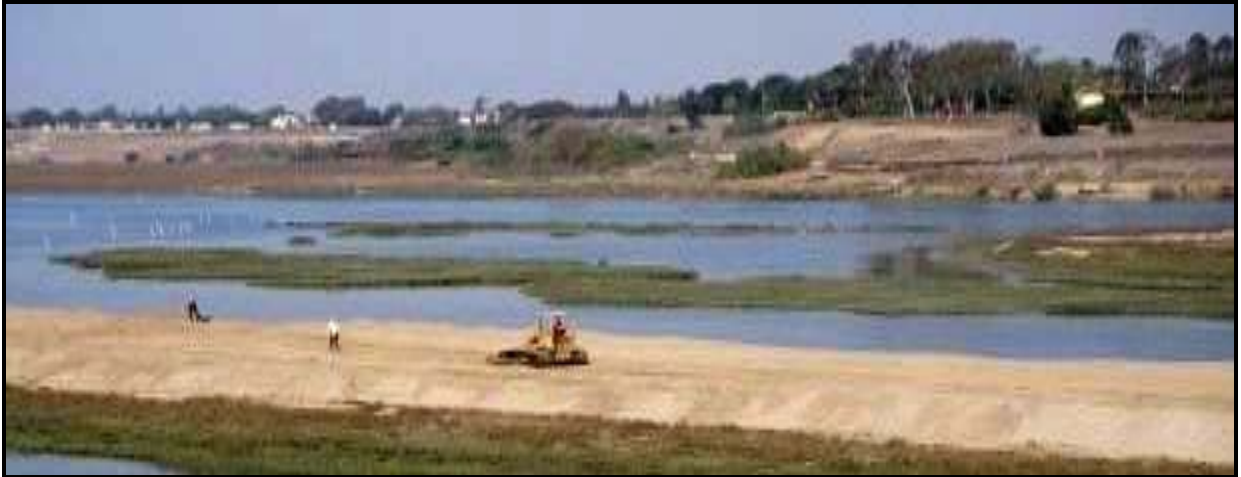
Hotdog Island with beginning of sand capping, Photo by Keane Biological, 3 April 2007

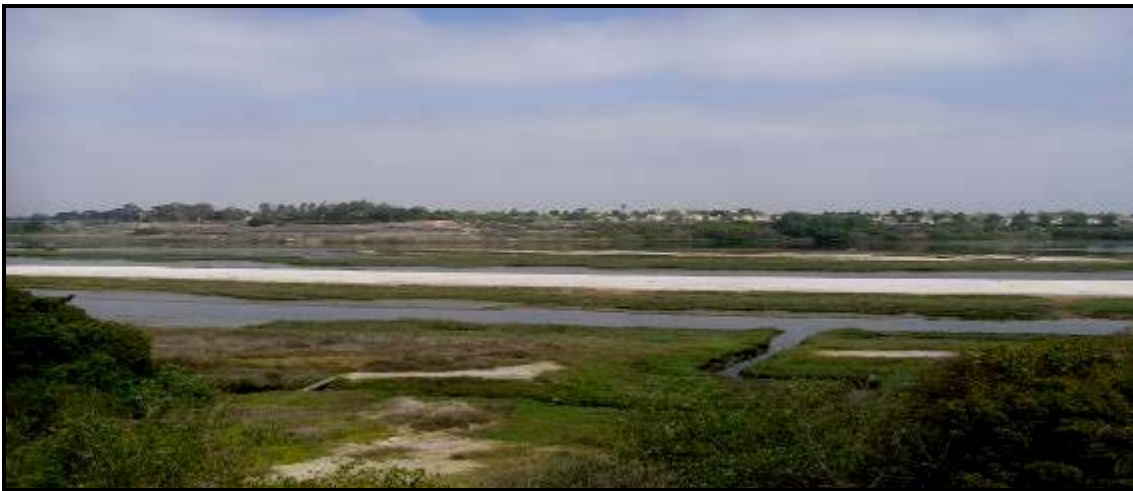
Hotdog Island with sand capping completed, Photo by Keane Biological, 28 April 2007

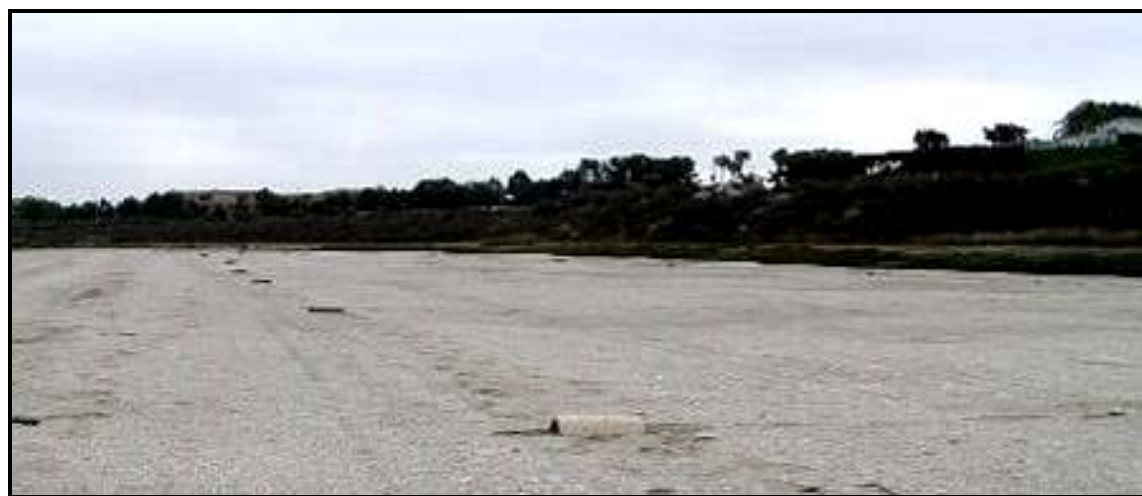
Hotdog Island chick shelter tiles placed, Photo by Keane Biological, 28 April 2007

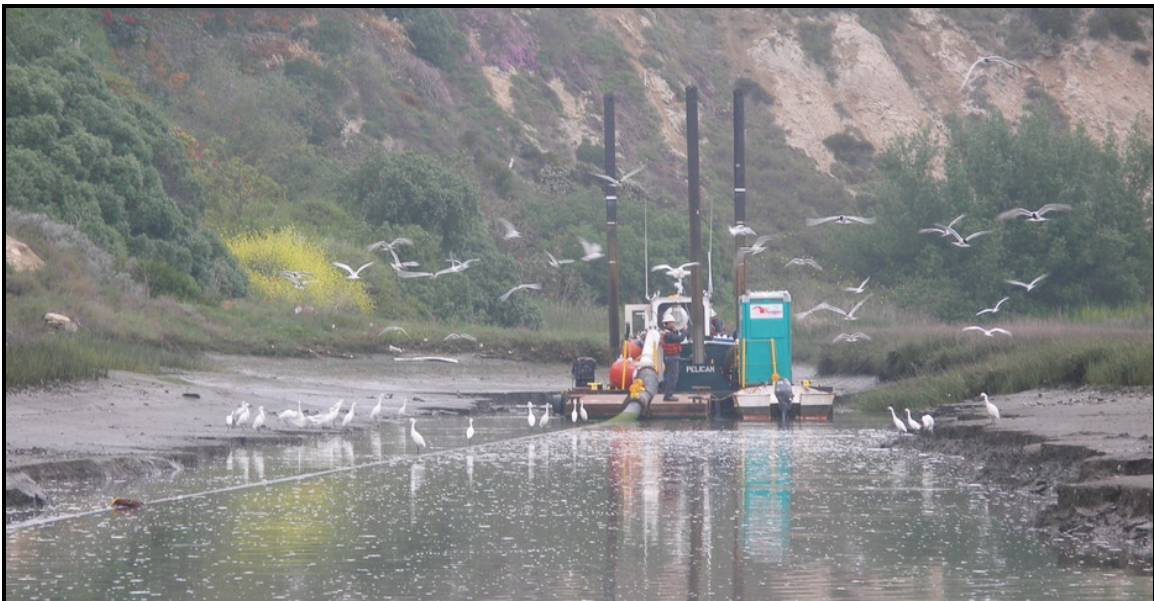
Hydraulic Dredge "Pelican" dredging Middle Island Restoration Channel, May 2006
