# Phase I Environmental Site Assessment 1.8-Acres of Land Currently Developed with Retail Shops 320 to 600 West Coast Highway, Newport Beach, California

AutoNation, Inc. 200 Southwest 1<sup>st</sup> Avenue, 14<sup>th</sup> Floor Fort Lauderdale, Florida 33301

JHA Environmental, Inc. 2646 Palma Drive, Suite 450 Ventura, California 93003

March 30, 2015

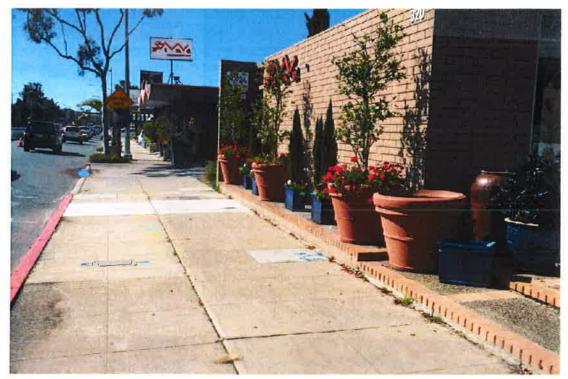
**PHOTOGRAPH 1** – View looking west along the north side of West Coast Highway from the east end of the Site. 320 West Coast Highway is the brick building on the right with the sign for The FIND Etc. on the front of the building, and across the driveway is 400 West Coast Highway with the roof sign for The FIND Etc. a consignment store that occupied both addresses.

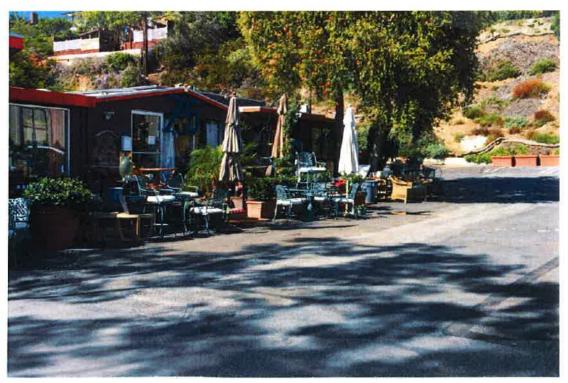
**PHOTOGRAPH 2** – View looking northwest at the connected buildings at 400 West Coast Highway with some of the outdoor and patio consignment items on display.

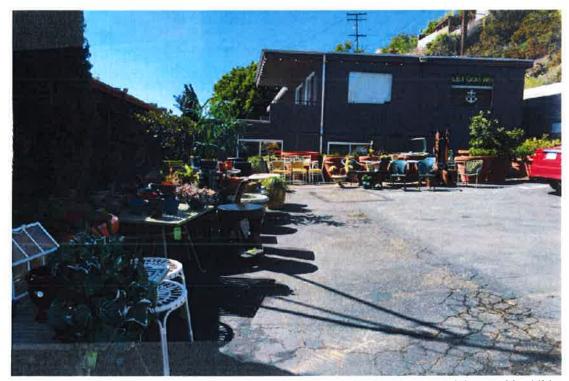
**PHOTOGRAPH 3** – View looking west at the parking lot at the rear of 400 West Coast Highway with additional item on display. The gray building beyond the parking lot is the rear two-story wing of the Shops at the Cove at 410 West Coast Highway. Residential dwellings are along the top of the mesa to the north of the Site.

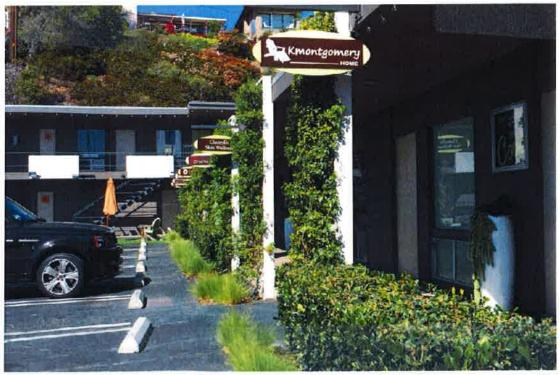
**PHOTOGRAPH 4** – View looking north at the east wing of the Shops at the Cove at 410 West Coast Highway. The two-story wing is at the rear of the parking lot. A residence is seen at the top of the slope north of the Site.

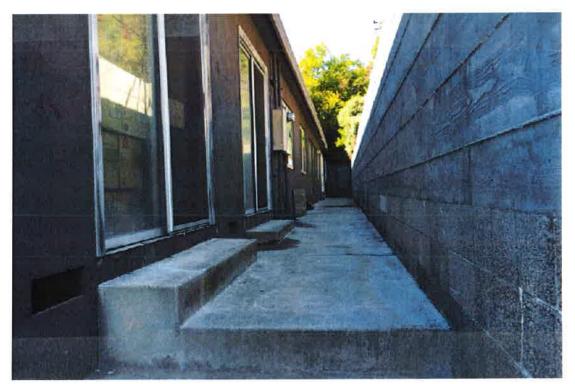
**PHOTOGRAPH 5** – View looking west at the second-story walkway and retaining wall behind 410 West Coast Highway. A portion of the wall collapsed into the building in 2005 and was repaired in 2010.

410 West Coast Highway: The first permit was dated April 30, 1959, for construction of an office building on Lots 10 and 11. The owner was listed as Water & Tarnutzen. In 1985, the building was re-roofed. In March 2005, the rear portion of the building was red-tagged due to a failure of the retaining wall behind the building. The building apparently remained partially unoccupied until June 2010, when a permit was issued to add 40-linear-feet and repair 55 feet of the damaged retaining wall. The owner is listed as Mr. Russ Fluter. There are no permits after 2010.

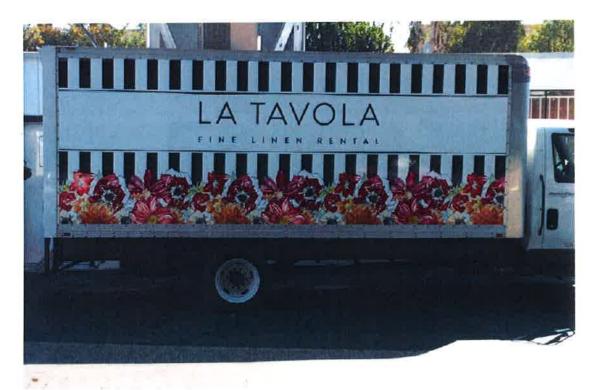
**PHOTOGRAPH 6** – View looking south at the delivery truck parked behind 430 West Coast Highway. La Tavola Fine Linen Rental occupies the building that is used to display and store the rental linen and other rental items. The truck is used to transport rented linens to the renter's location.

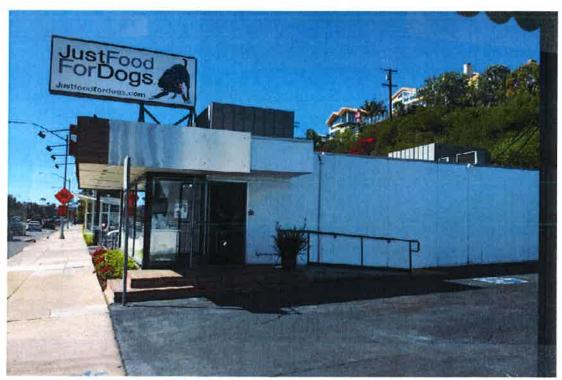
**PHOTOGRAPH** 7 – View looking west at 500 West Coast Highway was occupied by Just Food For Dogs. Dog food is cooked on stoves and in ovens inside the building and either delivered or picked up by the dog owners.

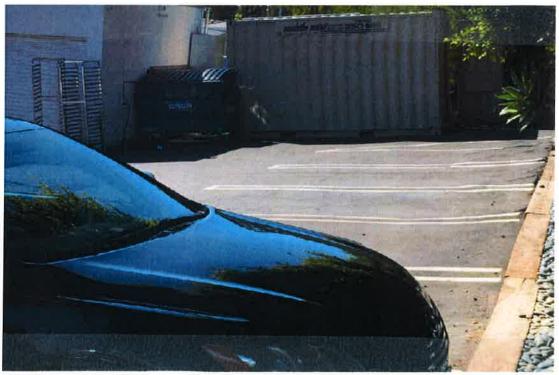
**PHOTOGRAPH 8** – View looking west at the rear of 500 West Coast Highway. The metal storage container has freezers and storage for dry goods and vegetables used to make the dog food.

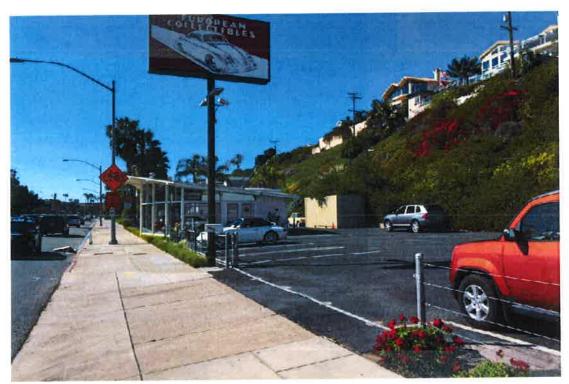
**PHOTOGRAPH 9** – View looking west at 600 West Coast Highway. The north boundary of the Site is part way up the slope. The residential dwellings are on the Newport Mesa.

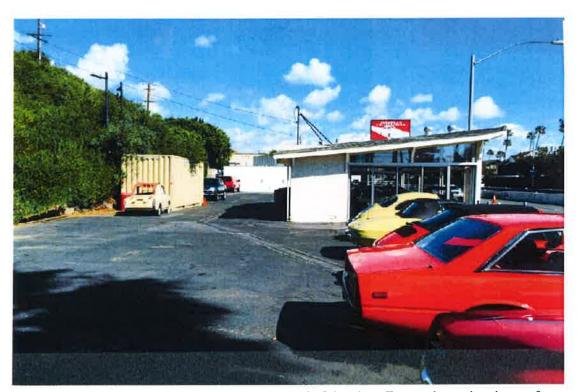
**PHOTOGRAPH 10** – View looking east from the west end of the Site. The metal container is uses for storage of vintage auto parts. The white building is the west side of 500 West Coast Highway.

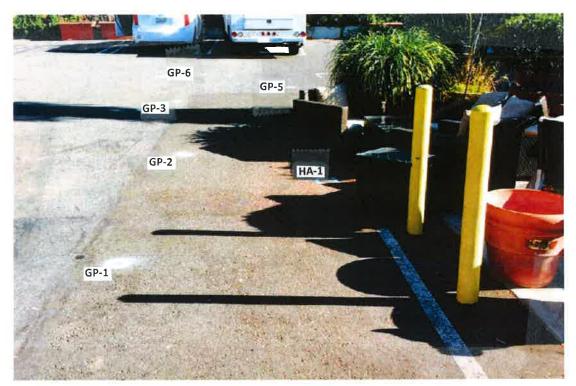
**PHOTOGRAPH 1** – View looking north along the driveway on the west side of 320 West Coast Highway, the Site. The locations of Borings HA-1, GP-1 through GP-3, GP-5 and GP-6 are shown in the photograph. The location of the underground storage tank (UST) shown on the permit was generally between GP-3 and GP-2. The concrete pad is seen to the right of the crash posts. Patio furniture and decorative items are displayed on the concrete pad. The current building is to the right and the rear of the view.

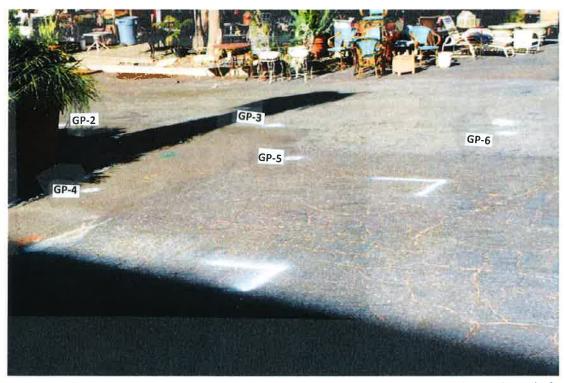
**PHOTOGRAPH 2** – View looking west at the location of Boring GP-4 and the other Borings. The patio furniture on display across the parking lot is on the adjacent property at 400 West Coast Highway. The geophysical survey covered all the asphalt parking lot seen in the view and continued south along the driveway seen in Photograph 1.
