BIOLOGICAL RESOURCES TECHNICAL REPORT Big Canyon Habitat Restoration and Water Quality Improvement Project

January 2016

Prepared for City of Newport Beach Public Works Department

Prepared by Environmental Science Associates San Diego, California

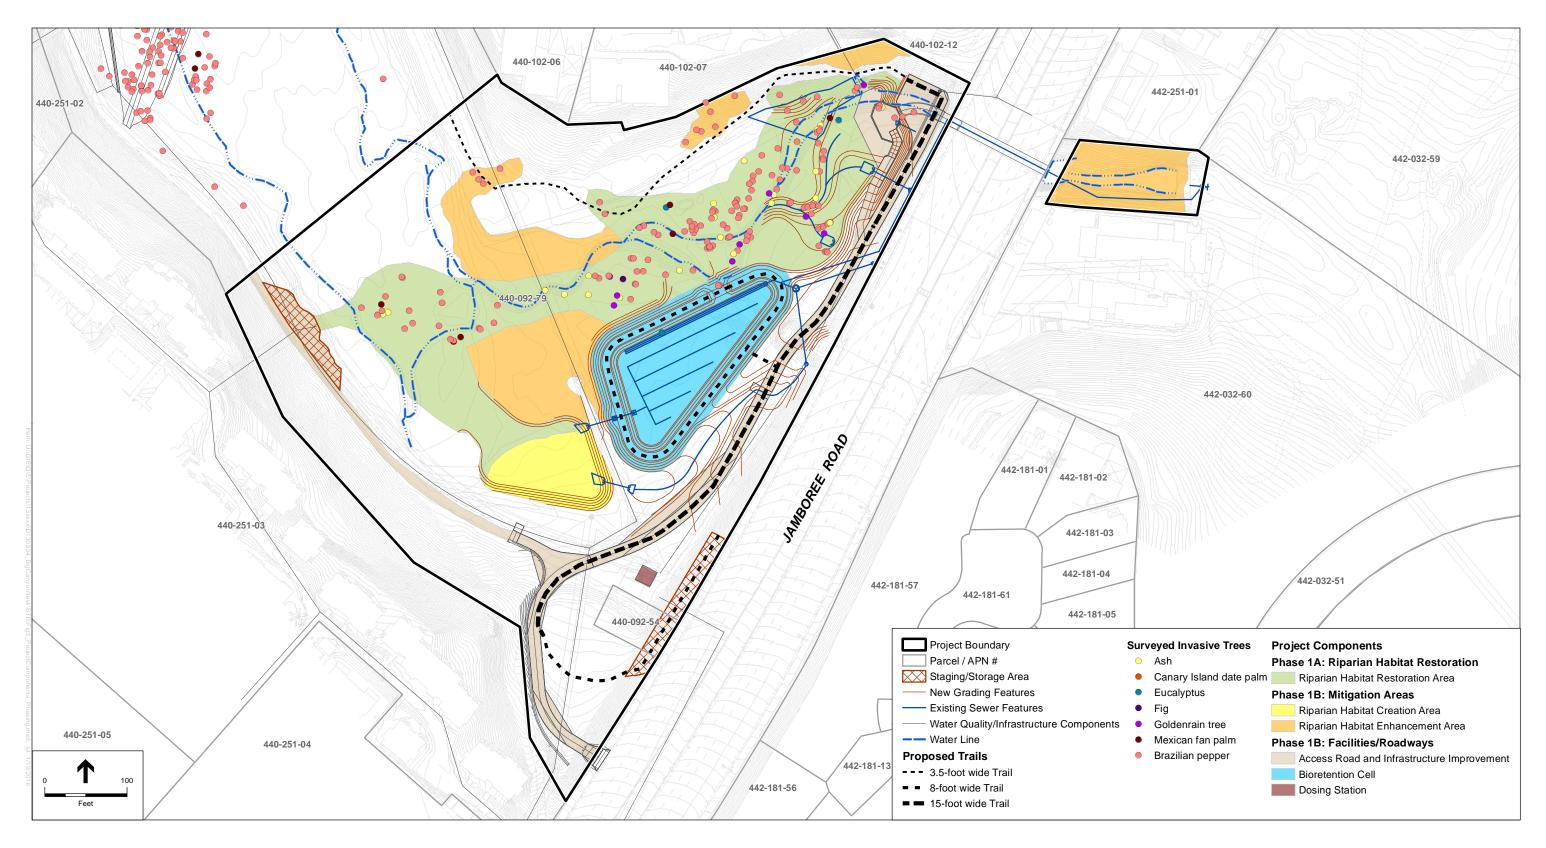
1. Creek Restoration. The project proposes to conduct creek restoration activities, which will include floodplain restoration, streambank stabilization, and habitat restoration. The main channel is currently incised and is confined to the incised narrow creek bed. The channel will be realigned away from the eroding and undercut north bank into the center of the floodplain, and a new floodplain will be created on both banks. The north creek bank at the inlet will be stabilized using natural bioengineering techniques by adding encapsulated vegetated soil lifts, which will be planted with willows and other native vegetation to construct and protect the banks, and to provide erosion control. The existing area to the south of the creek would be lowered by approximately 6 feet to create a floodplain 2 to 3 feet above the low-flow channel to allow for frequent inundation during high-flow events. Willow brush mats will be placed over the cut bank and secured with biodegradable coir fabric, then secured with biodegradable rope and wooden stakes. Floodplain restoration and streambank stabilization activities will result in increased flood flow attenuation, stabilization of the north bank of the main channel, and creation of an active braided riparian floodplain.

Riparian habitat will be restored directly downstream of the restored floodplain through the removal of invasive trees, soil modification to reduce plant-limiting sodium levels, and replacement with native riparian species. Under current conditions, invasive trees (mostly Brazilian peppertree) and an extensive understory of non-native forbs and grasses have been documented in the project area. In addition, soil testing results have indicated extremely high levels of sodium, boron, and sulfur in the soils, which inhibit growth of native plant species. The invasive plants are better able to compete under the poor soil conditions that are found within Big Canyon. The trees, forbs, and grasses will be aggressively removed as part of this project. Mature trees will be removed during mass grading and isolated individuals will be killed in place without soil disturbance. Following invasive plant removal, the soil will be amended to levels where native

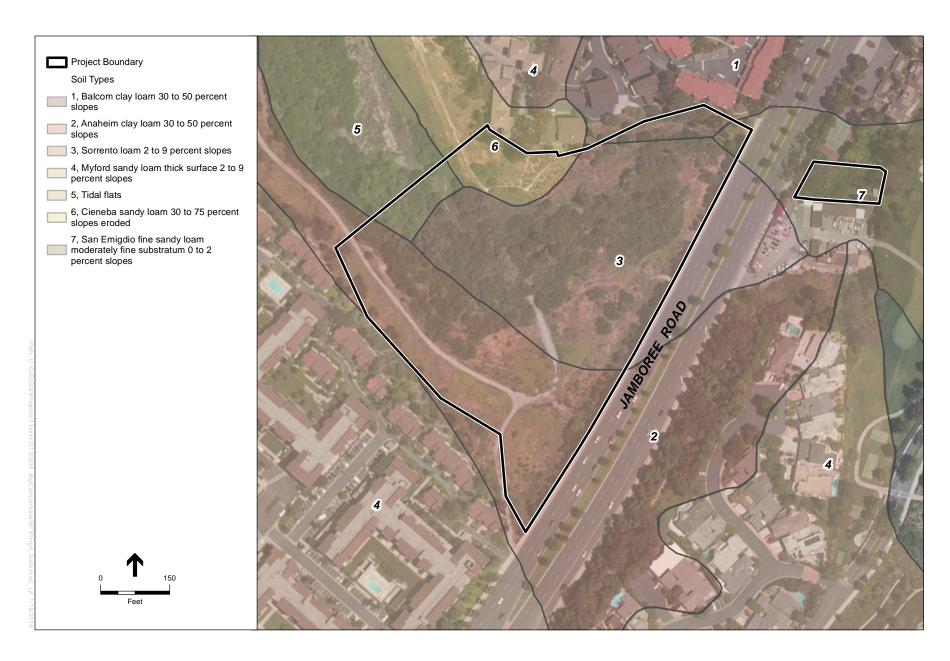
The project area is generally quite disturbed. The area has been degraded as the result of decades of dredging spoils from the bay and dumping onsite; the quality of soils throughout the site is generally very poor as a result. There are six soils classes within the project area according to the Natural Resources Conservation Service (NRCS) (2015). Each soil type in the project vicinity is described below and shown in Figure 4.

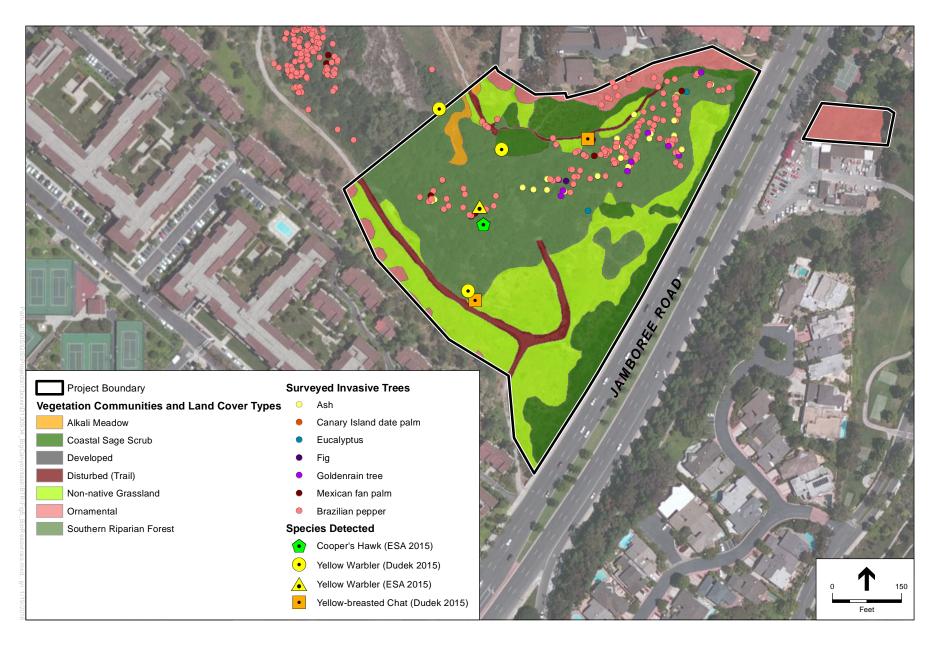
well-defined habitat types. Vegetation communities are mapped in **Figure 5**. The vegetation communities are described below according to the Orange County Habitat Classification System (Jones and Stokes 1993, Gray and Bramlet 1992). Each description includes a list of the California vegetation alliances (Sawyer et al. 2009) that are found within that vegetation type. Acreages of each vegetation community in the project area are summarized in **Table 1**.

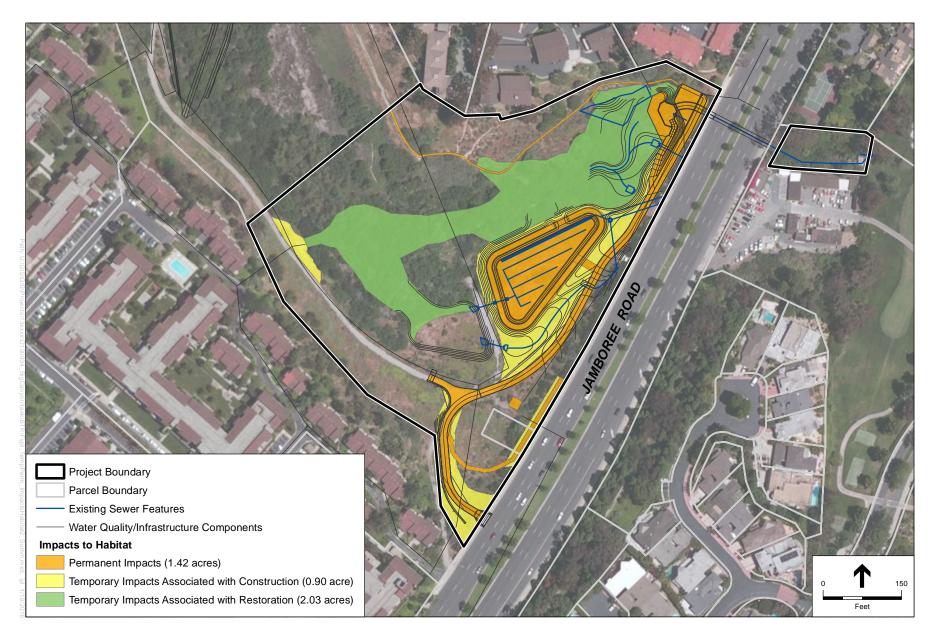
Figure 9
Temporary and Permanent Impacts Summary

The proposed project will permanently impact a total of 1.42 acres from water quality and infrastructure components and proposed trails. A total of 2.03 acres will be temporarily impacted from the riparian habitat restoration component of the project. An additional 0.90 acres will be temporarily impacted from construction-related activities (**Figure 9**).

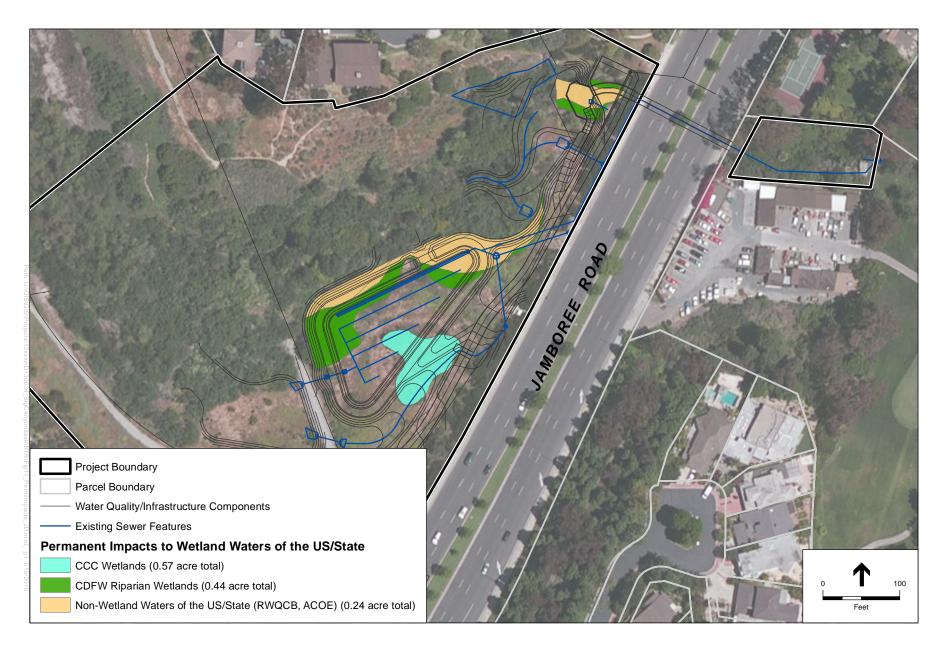
Figure 11

As a result of the water quality improvement and infrastructure components, the project would permanently impact Waters of the United States/State which are characterized as southern riparian forest habitat. Impacts to Waters of the Waters of the United States/State would result from the extension of the culvert into Big Canyon, installation of the stilling basin and rip-rap energy dissipater, the maintenance road and turnaround, and construction of the bioretention cell. **Table 7** and **Figure 11**, Permanent Impacts to Jurisdictional Areas, defines impact acreages per the regulating resource area. Note, CDFW riparian includes Corps/RWQCB acreage, and CCC wetlands include CDFW and Corps/RWQCB jurisdiction. Thus, maximum permanent jurisdictional impacts do not exceed 0.57 acre.

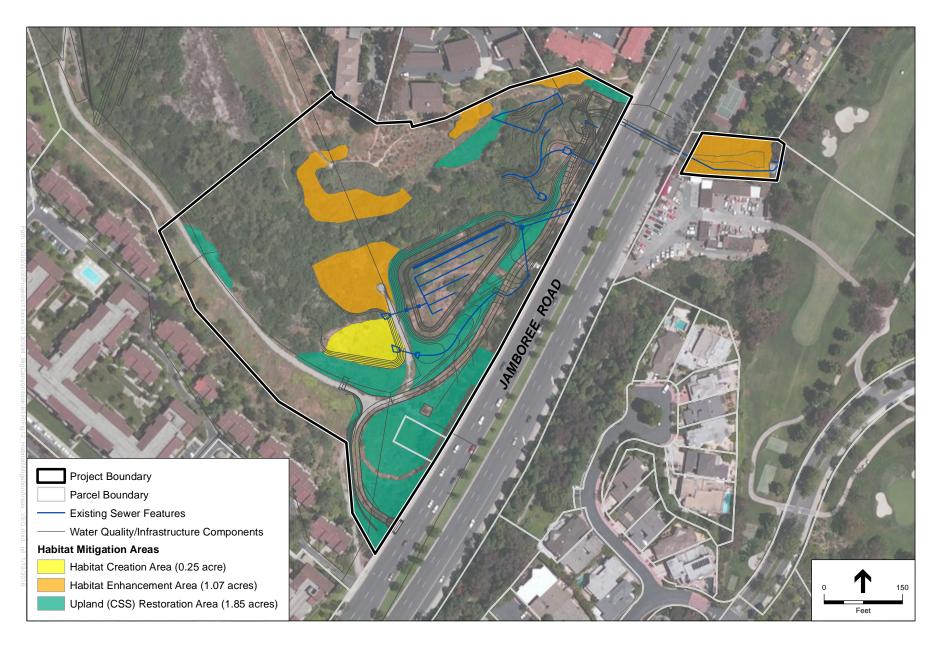
Figure 12
Habitat Mitigation Areas for Impacts to Vegetation Communities

As described in Section 5, the project will impact a total of 2.46 acres of southern riparian forest, and 0.50 acre of coastal sage scrub. These vegetation communities are both highly disturbed from a heavy infestation of non-native plants and compacted, saline soils. These low-quality habitats will be restored to provide habitats with much greater ecological function than the current conditions. A total of 2.46 acres of southern riparian forest will be mitigated onsite through substantial habitat restoration (2.03 acres), willow riparian forest habitat creation (0.25 acre), and riparian habitat enhancement (0.64 acre), as shown in **Figure 12**. Impacts to coastal sage scrub will be mitigated onsite through restoration of 1.85 acres, which is 1.35 acres in excess of the required 1:1 ratio. Impacts to non-native grassland, disturbed areas, and ornamental vegetation do not require mitigation (**Table 8**).

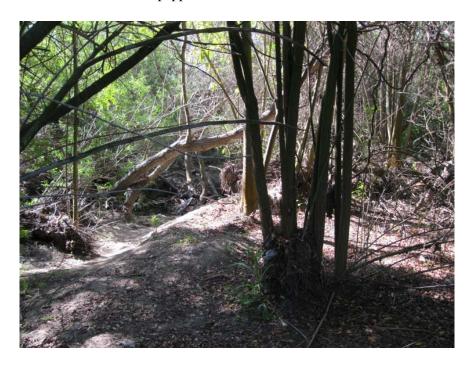
Photo 6. Typical interior shot of riparian habitat, with low-flow channel and frequent inundation over bank.

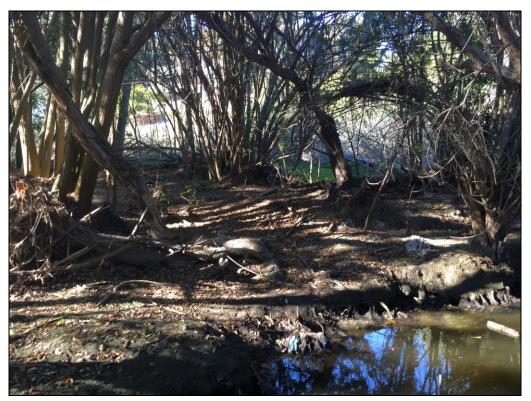
Photo 4. Photo shows the lack of understory along the creek bank.
