# ASSESSMENT OF SEAWALL STRUCTURAL INTEGRITY AND POTENTIAL FOR SEAWALL OVER-TOPPING

## *for Balboa Island and Little Balboa Island*

Prepared for  
**City of Newport Beach**

Prepared by  
**Everest International Consultants, Inc.**

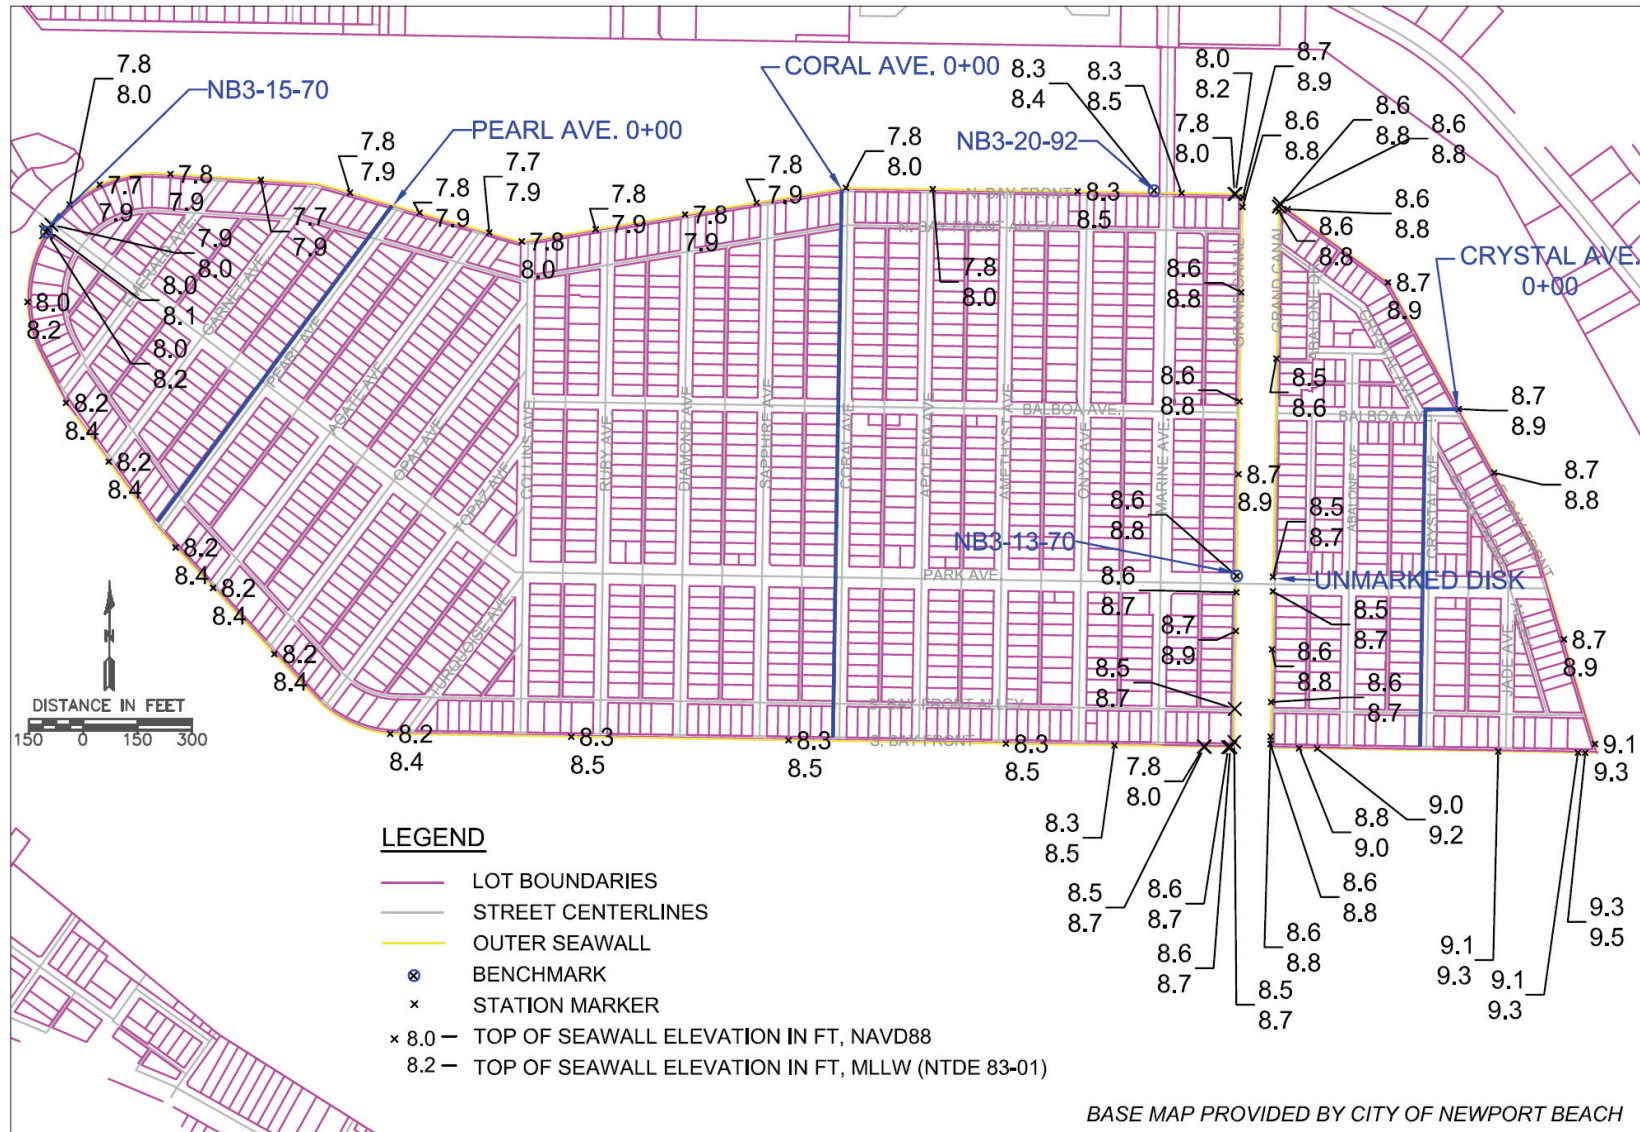
Figure 2.2 Top of Seawall Survey Results

The top of seawall elevations were found to vary between 7.6 and 8.7 feet NAVD88 (7.8 and 8.9 feet MLLW) on Balboa Island and between 8.5 and 9.3 feet NAVD88 (8.7 and 9.5 feet MLLW) on Little Balboa Island. Mudline elevations vary between approximately 1 foot below the top of seawall elevation in locations where the beach sand has been replenished and/or managed, to approximately 7 feet below the seawall elevation, where beach sands have eroded over time.

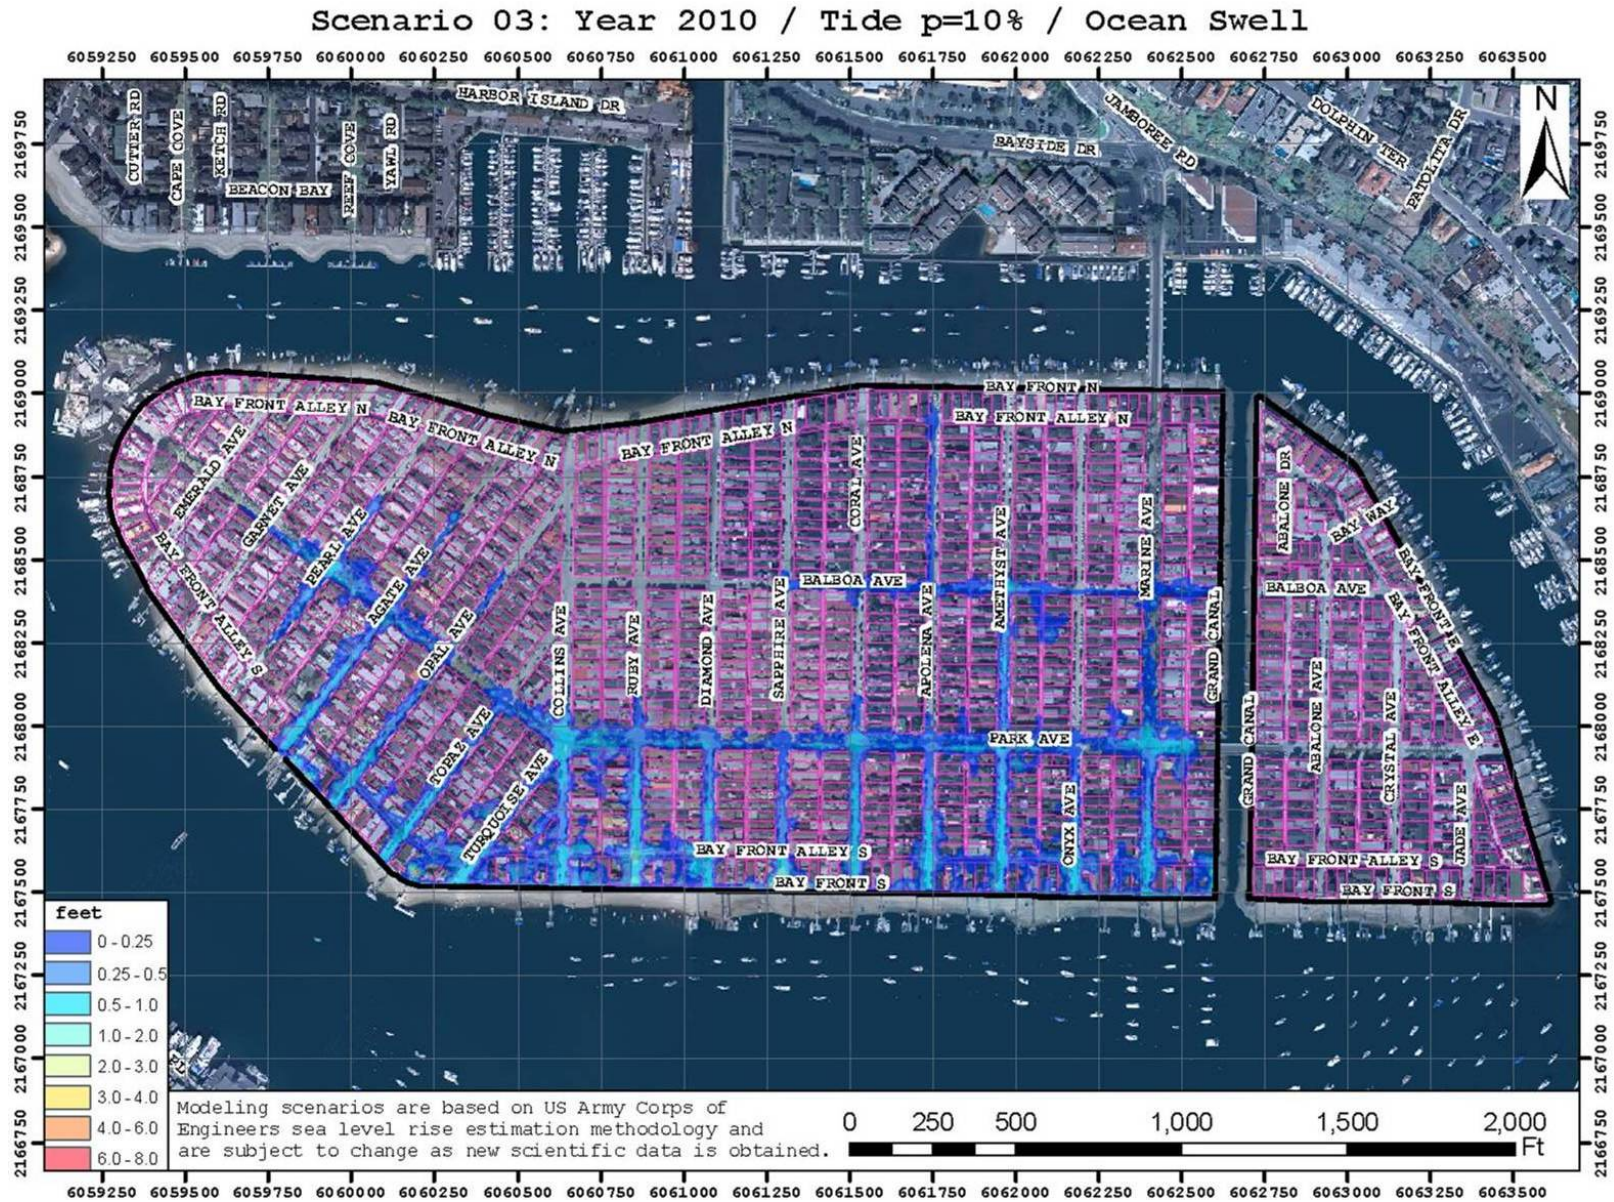
**Figure 3.7 Model Prediction of Flood Extent and Flood Depth for Scenario 3**

Ocean swell (Scenario 3, see Figure 3.7) is predicted to have a stronger effect on flooding than wind waves (Scenario 4, see Figure 8), mainly because swell-induced overtopping is initiated at lower tide heights than wind-wave overtopping. Additionally, flood modeling indicates that Little Balboa Island is presently well protected from tide and wave-driven flooding. This is attributed to a higher seawall compared to Balboa Island.

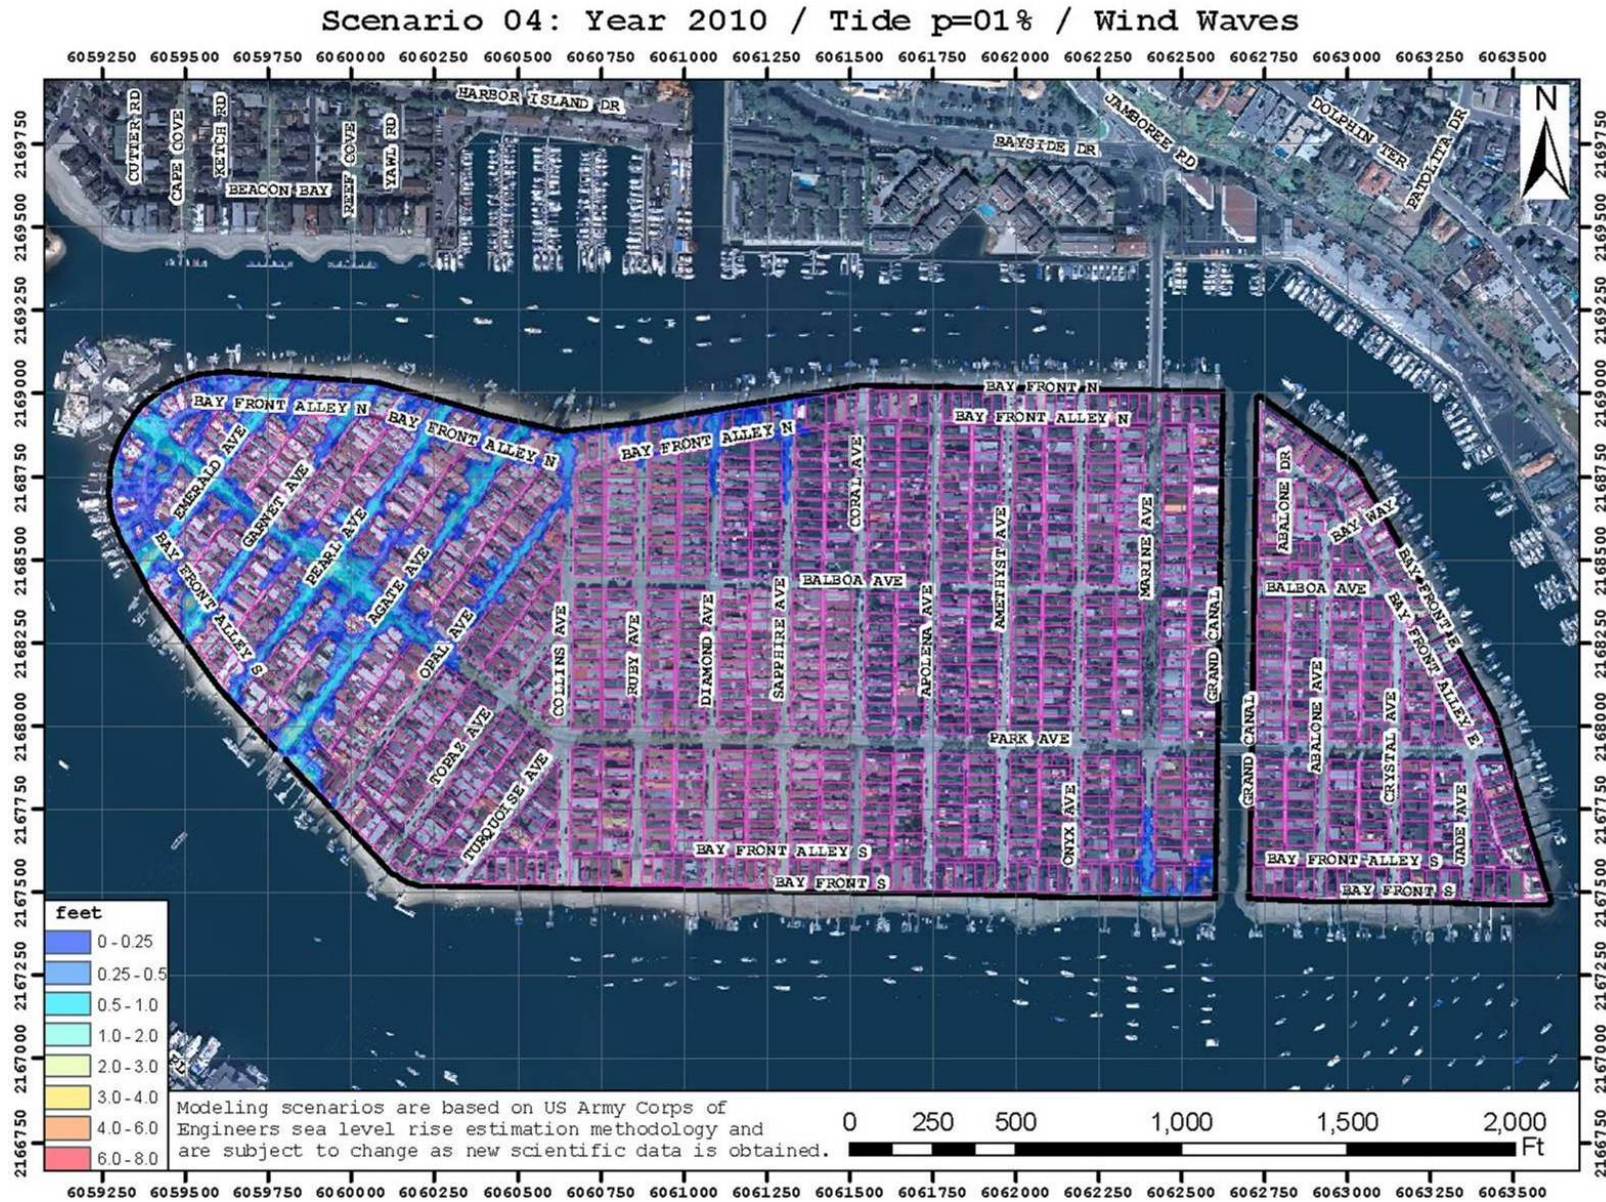
**Figure 3.8 Model Prediction of Flood Extent and Flood Depth for Scenario 4**

Scenario 4 shows that flooding may commence on the southwest and northwest edges of Balboa Island from a 1% exceedance probability tide and wind waves. The number of impacted parcels is smaller compared to Scenario 3, but the estimated impact to buildings is roughly equal. This is attributed to lower elevations on the west end of the island. This scenario causes water to pond more and spread less compared to Scenario 3.

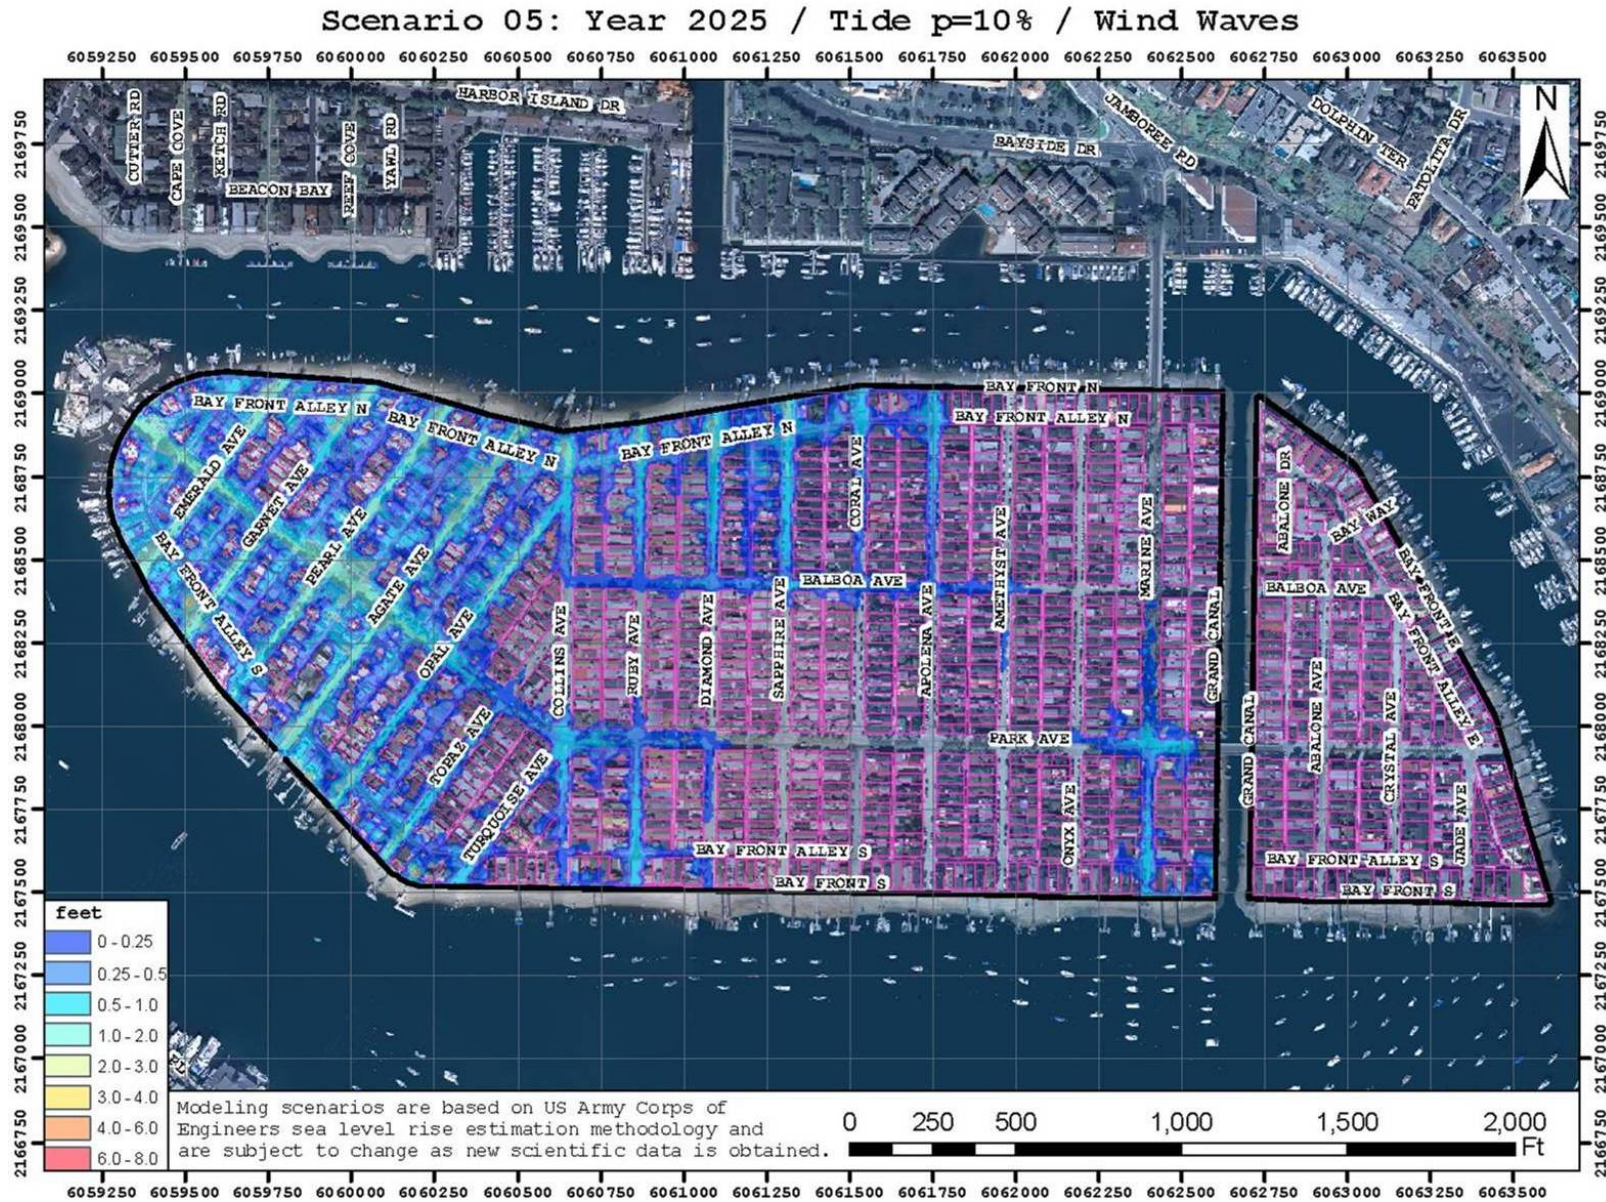
**Figure 3.9 Model Prediction of Flood Extent and Flood Depth for Scenario 5**

Scenarios 5 through 7 (see Figures 3.9 through 3.11) results indicate that by 2025, a majority of the parcels on Balboa Island will be at risk of flooding and impact to over 400 buildings is possible. Scenario 5 (Figure 3.9) shows overtopping of the southwest and northwest seawalls, and ponding west of Collins Avenue. Flood water depths exceeding 2 feet are predicted for Park Avenue near Pearl Avenue. Scenario 5 also shows overtopping along the southern seawall at Marine Avenue, and the spread of water north to Balboa Avenue with depths exceeding 0.5 feet.

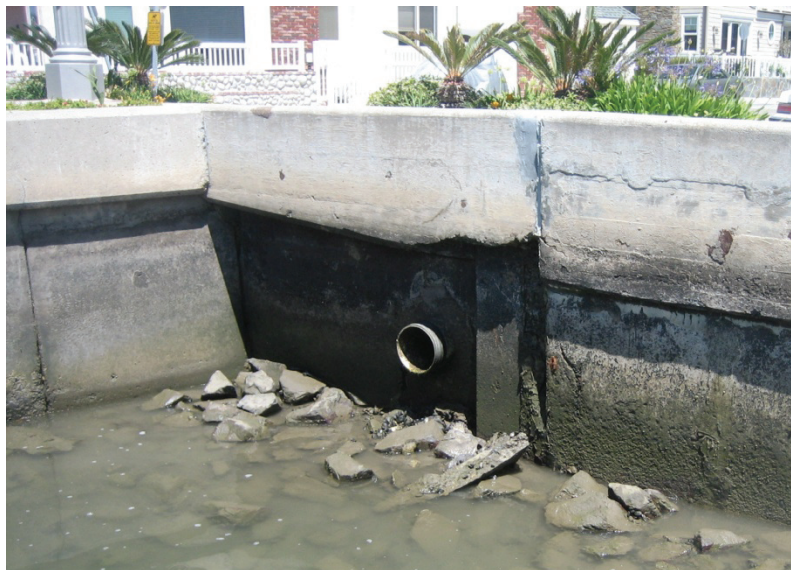
**Figure 4.9 Storm Drain Outlet Through Seawall**

Storm drain outlets that drain through the seawall and into the Bay (see Figure 4.9) have existed for decades at the street ends of Balboa Island, based on the 1935 record drawings and the recent visual survey. In the 1980's as part of the boardwalk reconstruction, a storm water drainage system with 4- to 6-inch diameter drains was constructed landward of and parallel to the seawall. These drains connect to the City's storm drain system outlets at the street ends and were designed to keep water from ponding along the seawall and from spilling onto private property.

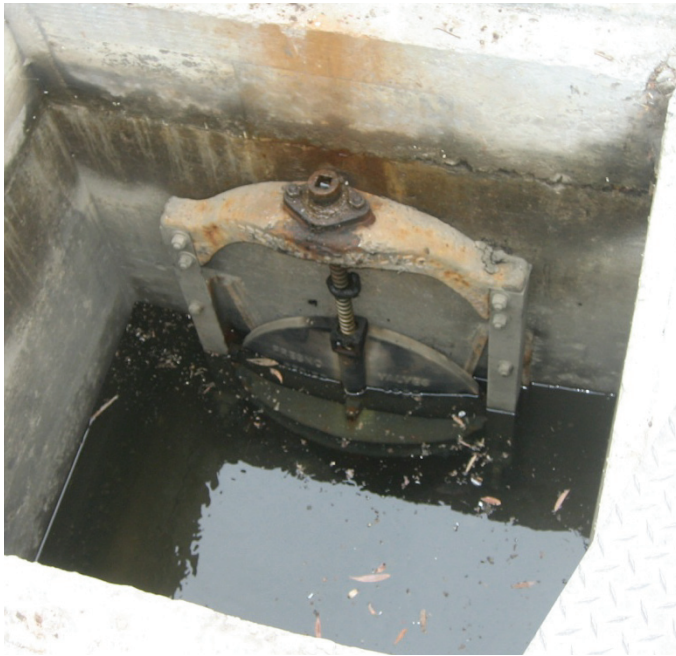
**Figure 4.10 Hand-Operated Gate Valve in Storm Drain Manhole**

This drainage system would not have functioned without the installation of gate valves at all storm water outlets on Balboa Island, as shown in Figures 4.10 and 4.11. These valves are closed during high water events to prevent seawater from flooding low lying spots on the Island. Prior to the valve installation, the storm drain outlets were a major source of flooding during high water events.
