Technical Memorandum

Subject: Aircraft Hazard and Land Use Risk Assessment & Wildlife Hazard Management Analysis – Snug Harbor Project

This technical memorandum is prepared for the Snug Harbor Project located at 3100 Irvine Avenue in the City of Newport Beach (Project). John Wayne Airport (SNA or Airport) property is located approximately 2,700 feet to the north of the Project site. This technical memorandum compiles the publicly available and relevant information related to the Aircraft Hazard and Land Use Risk Assessment and Wildlife Hazard Management Analysis for the Project. Information presented in the Airport Environs Land Use Plan (AELUP) for SNA is also reviewed, specifically as it relates to aviation safety and aircraft overflight. Additionally, a solar photovoltaic (PV) glare analysis was completed and is provided in a separate Technical Memorandum.

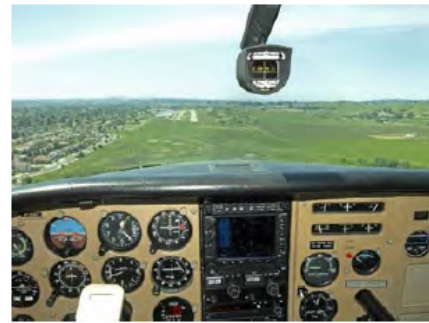
Figure 7 – Zone 4 Risk and Compatibility

Nature of Risk

- Normal Maneuvers
 - Approaching aircraft usually at less than traffic pattern altitude. Particularly applicable for busy general aviation runways (because of elongated traffic pattern), runways with straight-in instrument approach procedures, and other runways where straight-in or straight-out flight paths are common
- Altitude
 - Less than 1,000 feet above runway
- Common Accident Types
 - Arrival: Pilot undershoots runway during an instrument approach, aircraft loses engine on approach, forced landing
 - Departure: Mechanical failure on takeoff
- Risk Level
 - Moderate
 - Percentage of near-runway accidents in this zone: 2% - 6%

LONG FINAL

Basic Compatibility Policies

- Normally Allow
 - Uses allowed in Zone 3
 - Restaurants, retail, industrial
- Limit
 - Residential uses to low density
- Avoid
 - High-intensity retail or office buildings
- Prohibit
 - Children's schools, large daycare centers, hospitals, nursing homes
 - Stadiums, group recreational uses
- Other Factors
 - Most low to moderate intensity uses are acceptable. Restrict assemblages of people
 - Consider potential airspace protection hazards of certain energy/industrial projects

Refer to Chapter 3 for dimensions.

The Project site is located within the AELUP Safety Zones 2, 4, and 6 as shown in Figure 5. The AELUP uses further descriptions from the 2002 Handbook to define safety risk and basic land use compatibility in these zones. For the purpose of this analysis, descriptions from the most current 2011 Handbook are used. As shown in Figure 6, Zone 2, the Inner Approach/Departure Zone, poses a higher risk to persons in the area for aircraft accidents. Aircraft are typically overflying this zone at lower altitudes and emergency landings from straight out departures can be more prevalent in this zone than in other zones. Figure 7 shows a summary of accident risk and land use compatibility for Zone 4, the Outer Approach/Departure Zone. This zone has moderate aircraft accident risk; aircraft emergencies can occur over this area approximately two to six percent of the time. Zone 6, the Traffic Pattern Zone, is shown in Figure 8. This zone has the lowest risk for aircraft accidents and no land use is prohibited.
