# Balboa Islands Seawall Rehabilitation Project

## Rehabilitation Options

City Council Study Session  
July 14, 2015

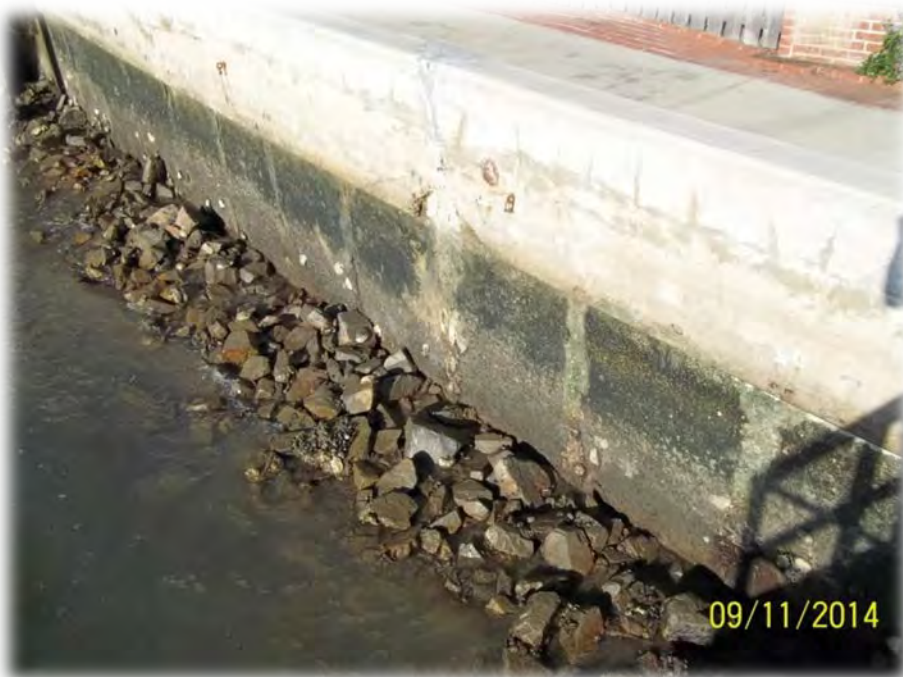
Rock Ballast Placed at West End for Support (1985)

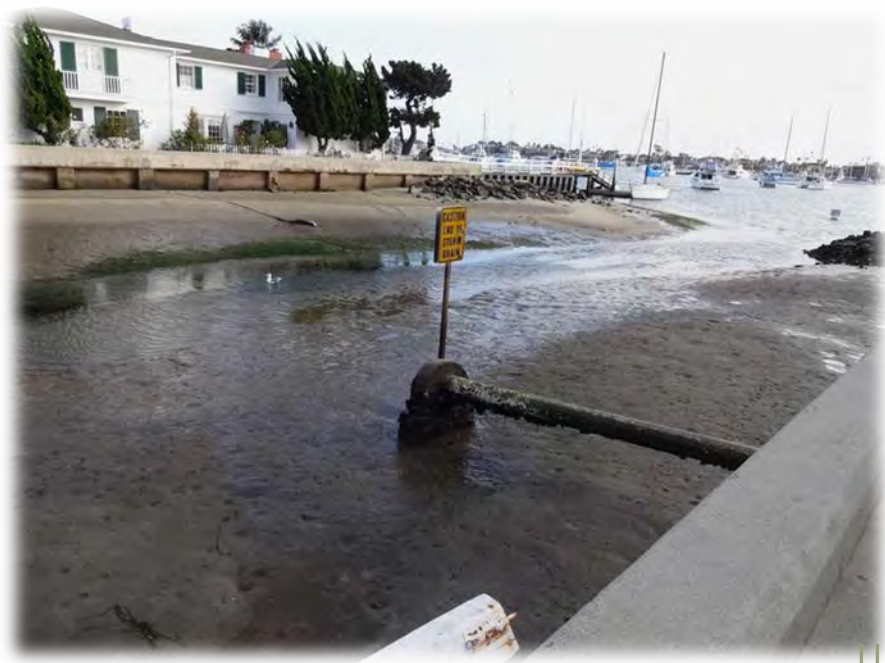
# Earth Anchors installed E/o Balboa Island Ferry Landing - South Bay Front (1987)

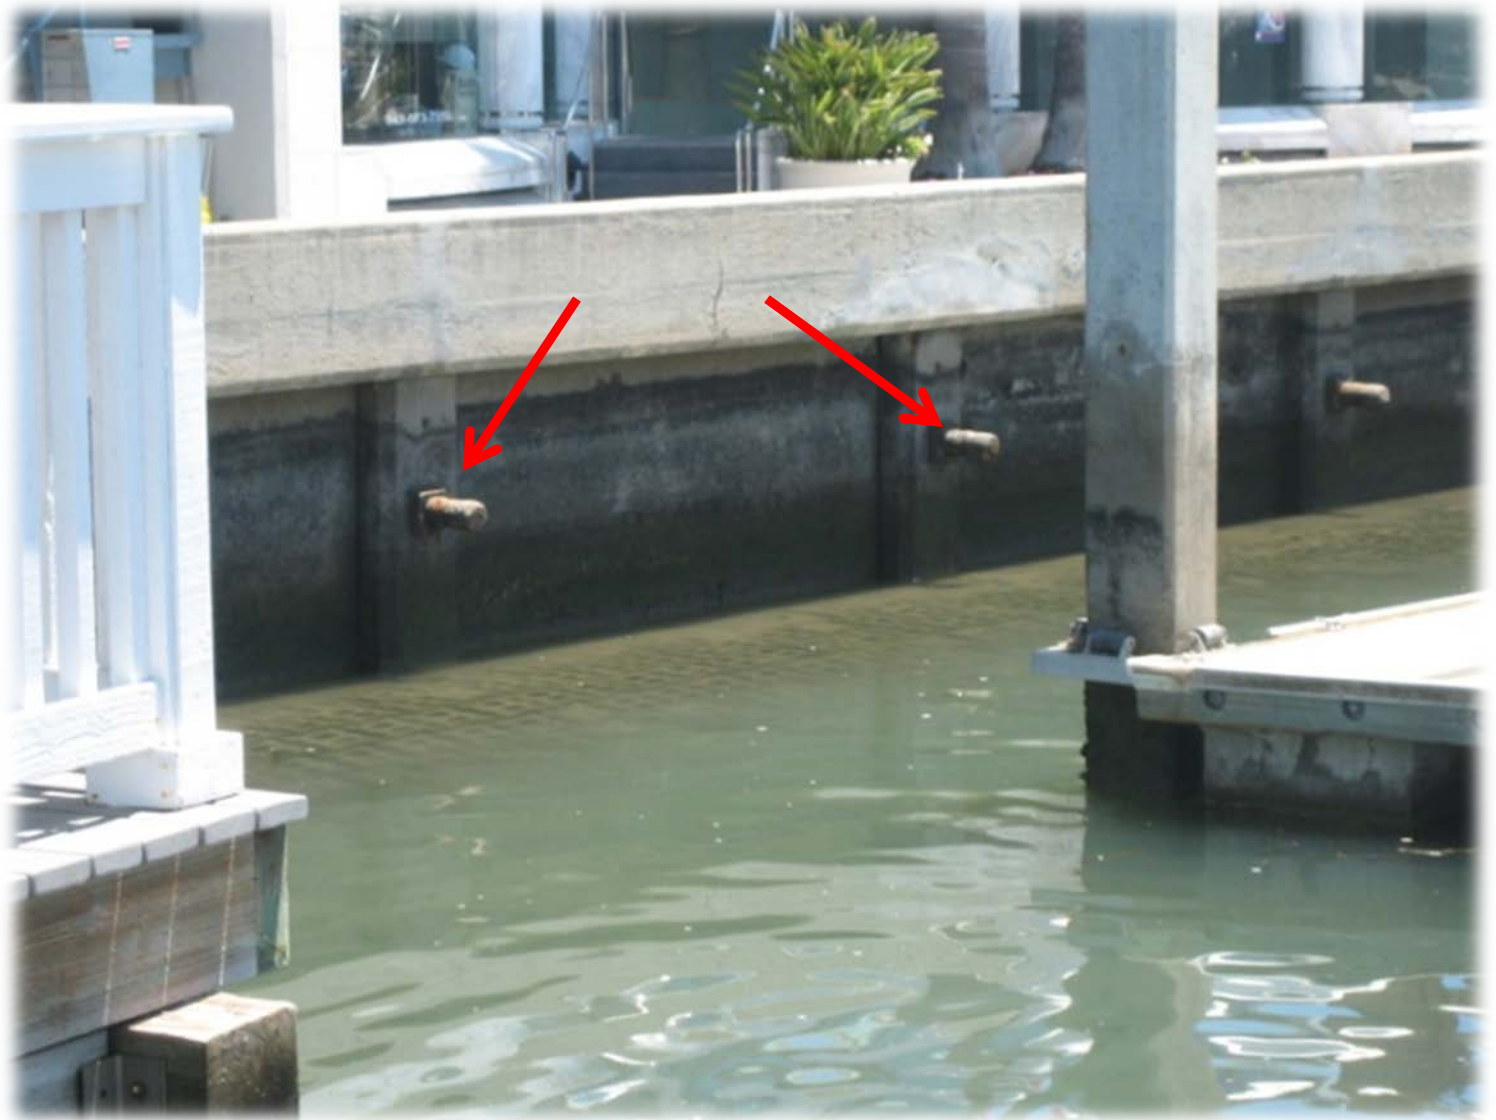
Pile Cracks (West End)

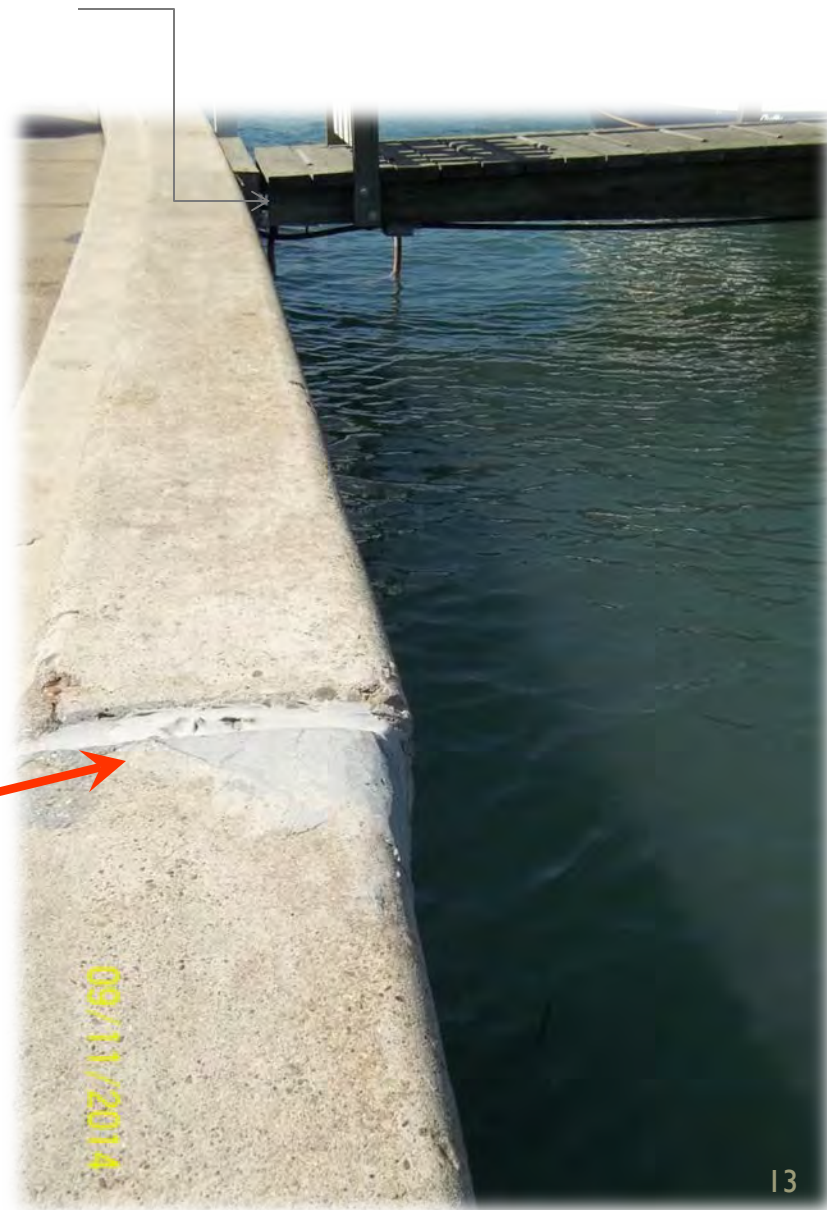
Wall Movement  
(West End)

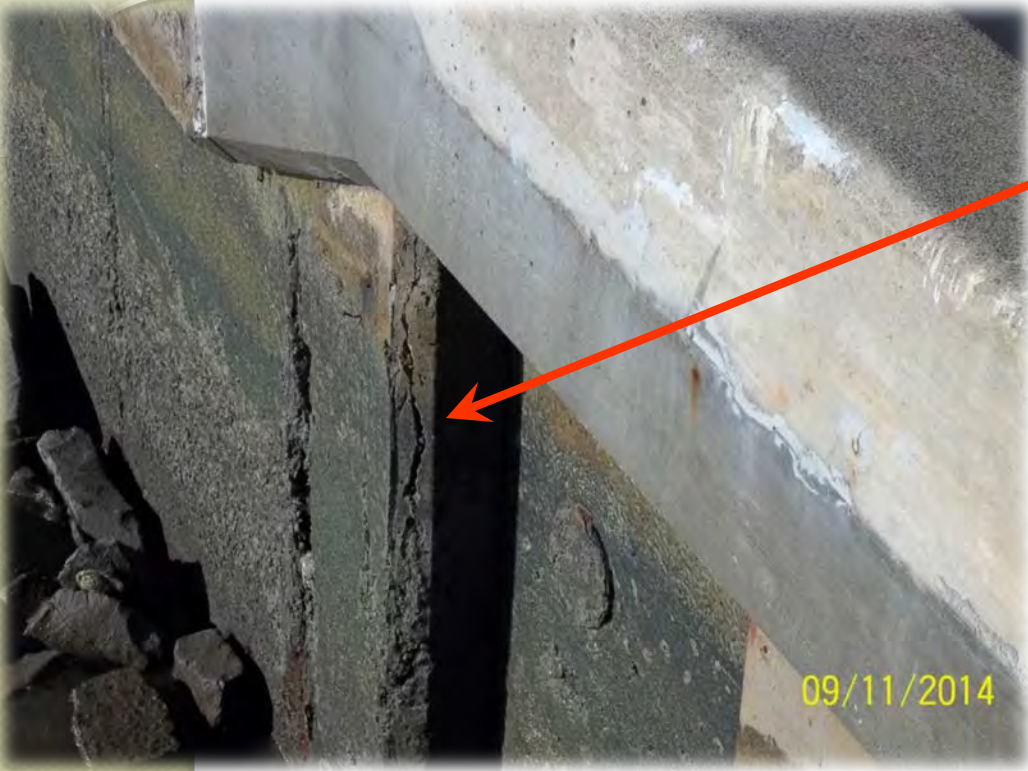
# Grand Canal: Spalling Veneer

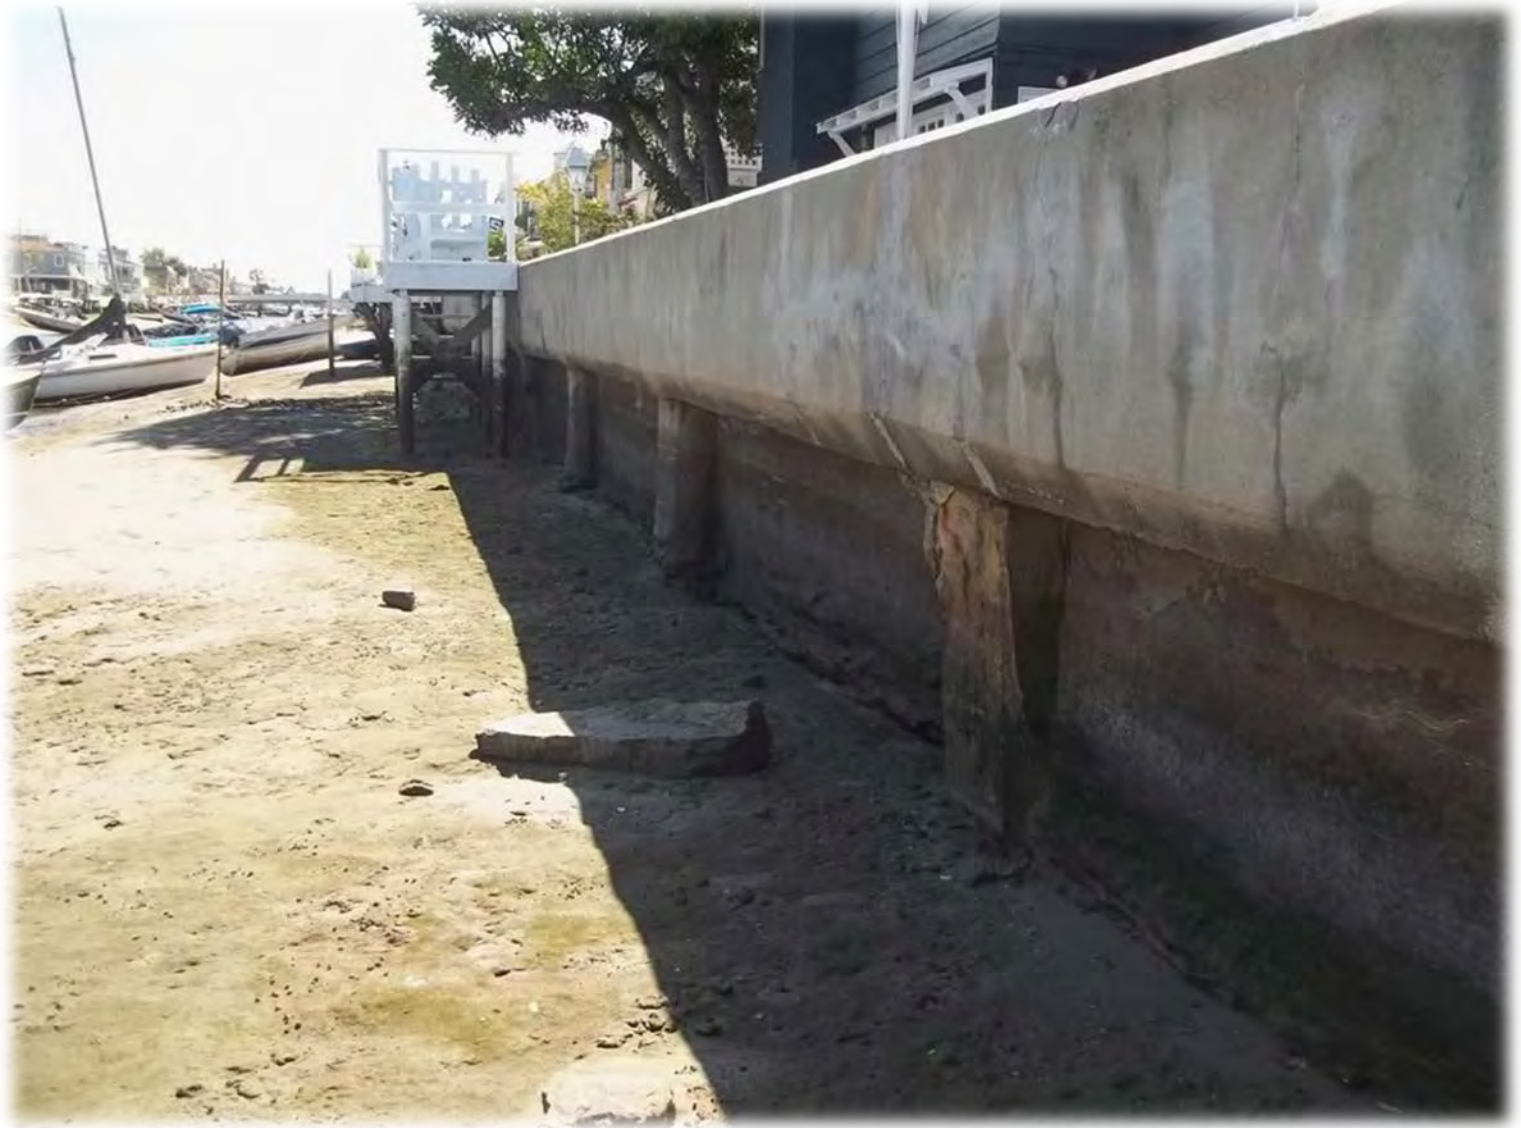
# Grand Canal: Spalled Veneer

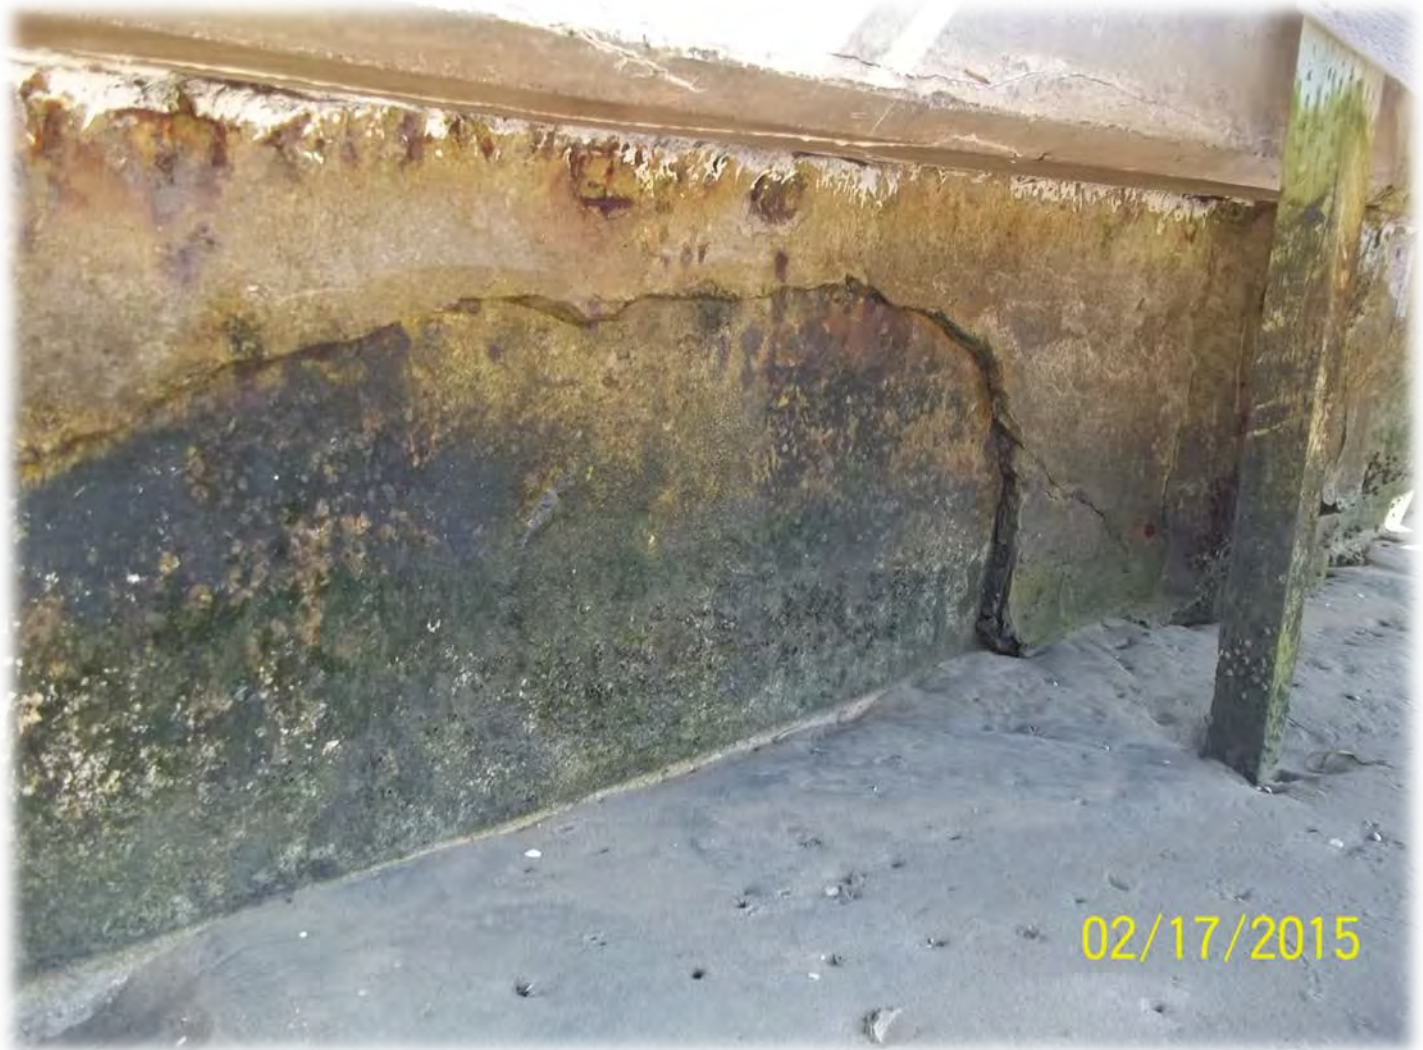
# Grand Canal: Spalled Veneer on Soldier Pile

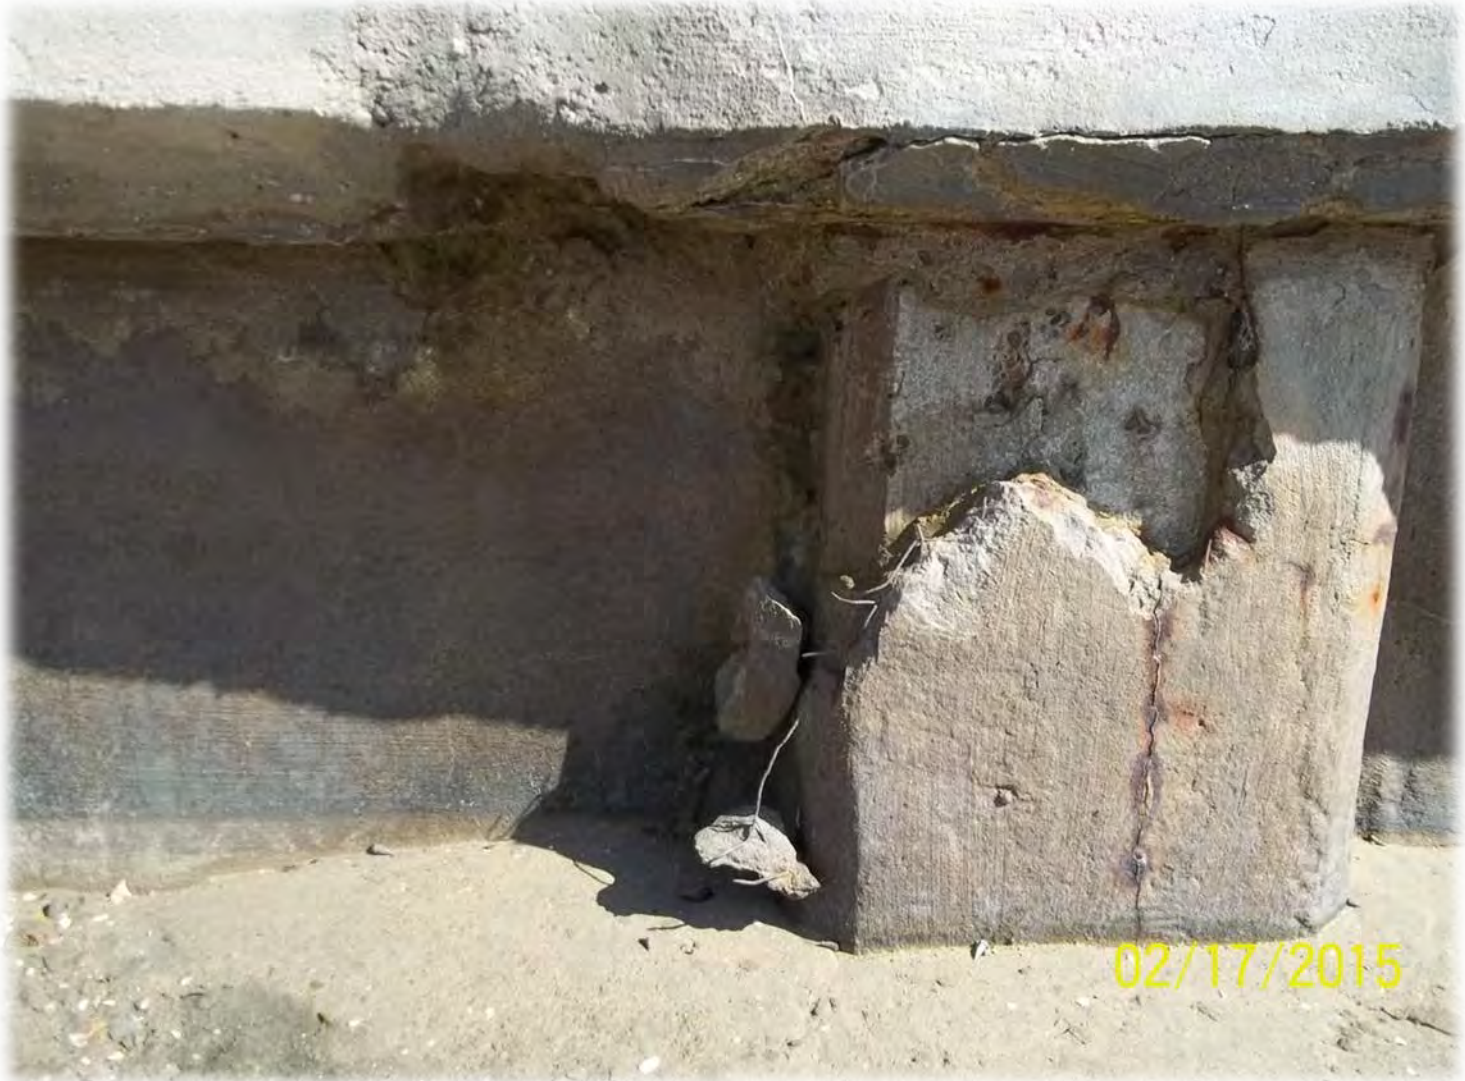
# Grand Canal: Cap Veneer Spalled

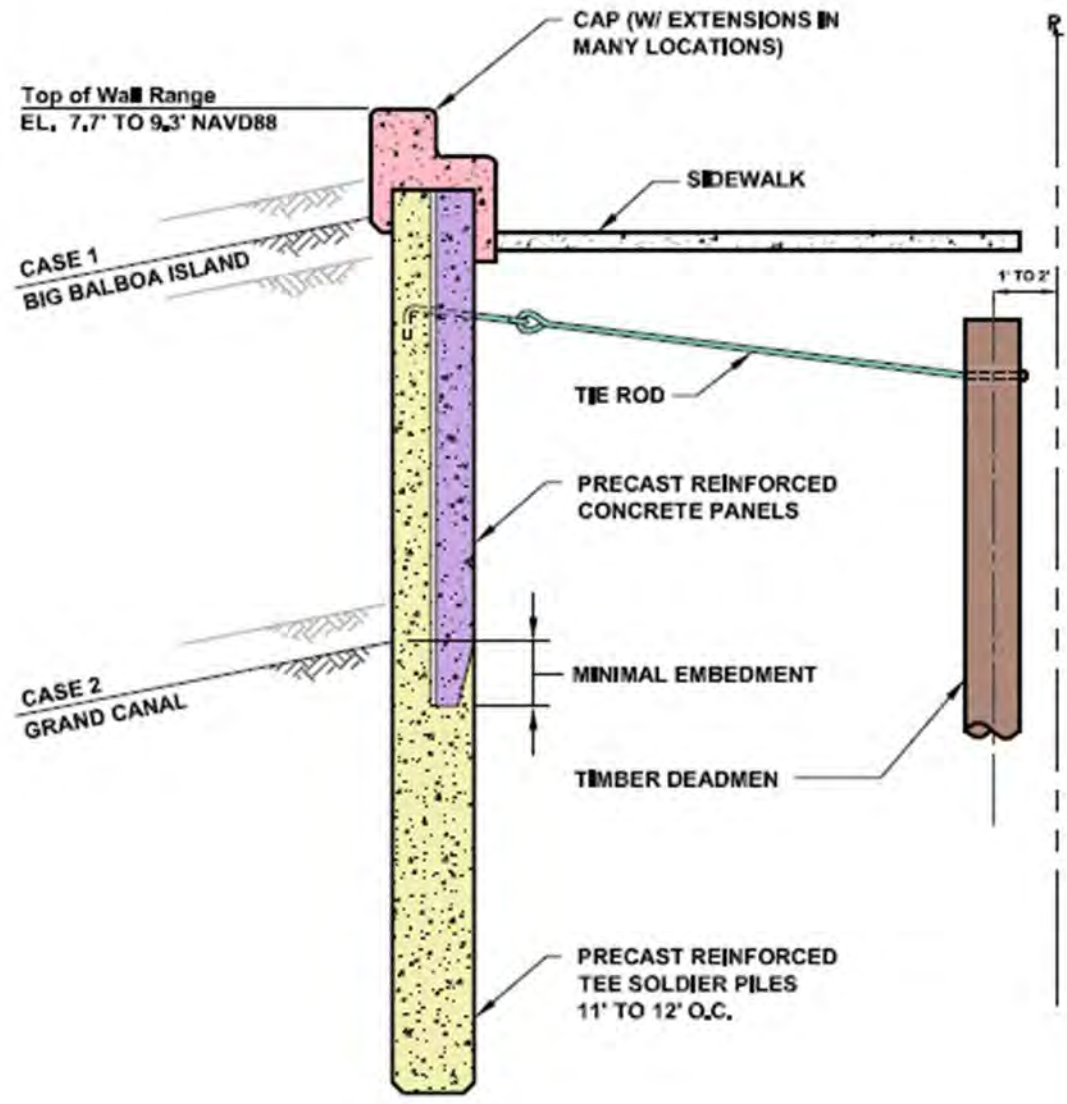
# Grand Canal As-Built Condition

**TYPICAL WALL CASES<sup>(1)</sup>**

<sup>(1)</sup> OTHER NON-TYPICAL CONDITIONS EXIST

## 1. Grand Canal Walls:

- a. Wall veneer is failing.
- b. Very shallow embedment (~2 to 3 feet).

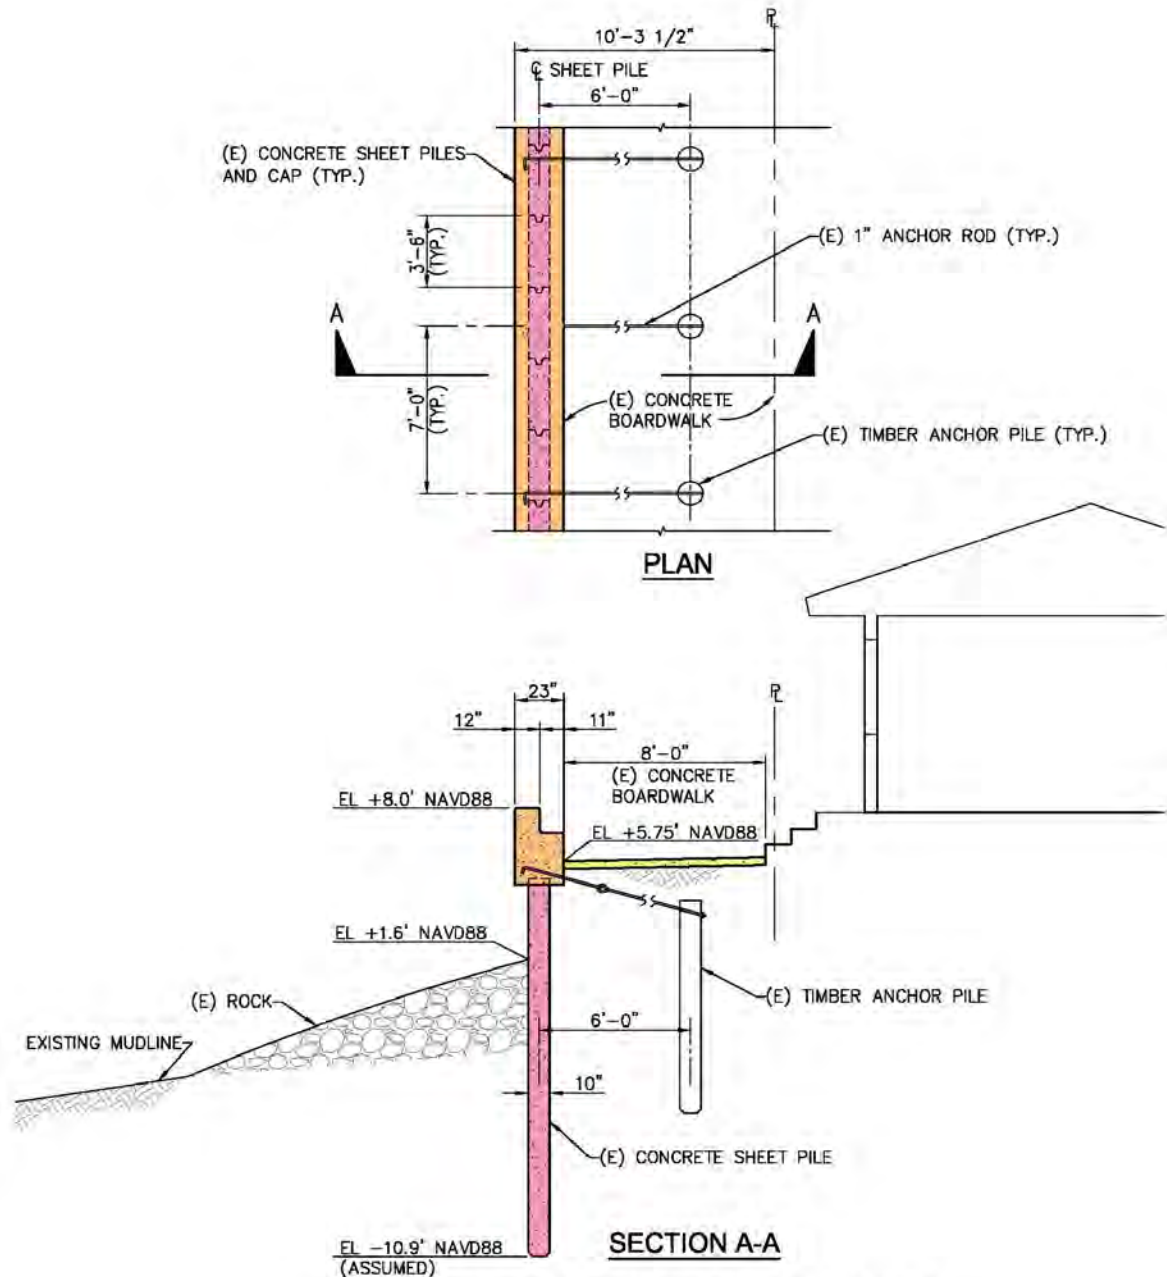
# West End As-Built Condition

Constructed  
~1925-1935

Rock  
reinforcement  
installed 1985

CASE 2 - EXISTING CONDITION at WEST END

## 2. West End:

- a. Floating sidewalks at high tide indicating leaks in the wall.
- b. Surficial signs of distress caused by current-induced shear stress and wave impacts.

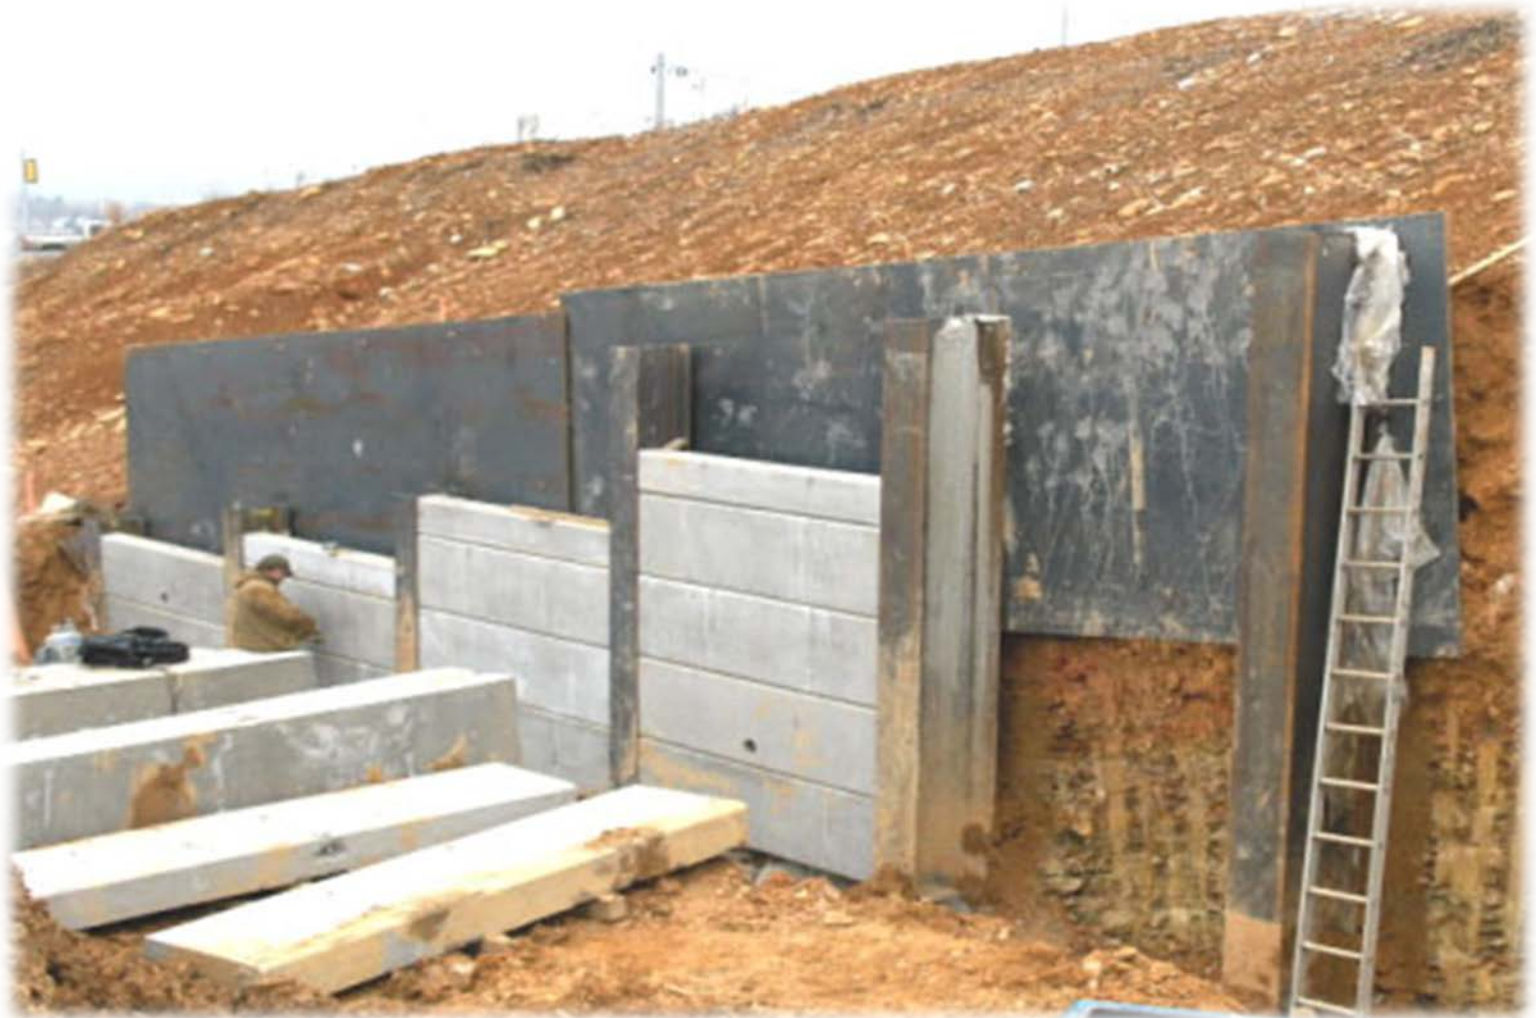
# New Seawall Construction – Option 1

## H-Piles and Concrete Wall (Lag) Panels

(No tiebacks)

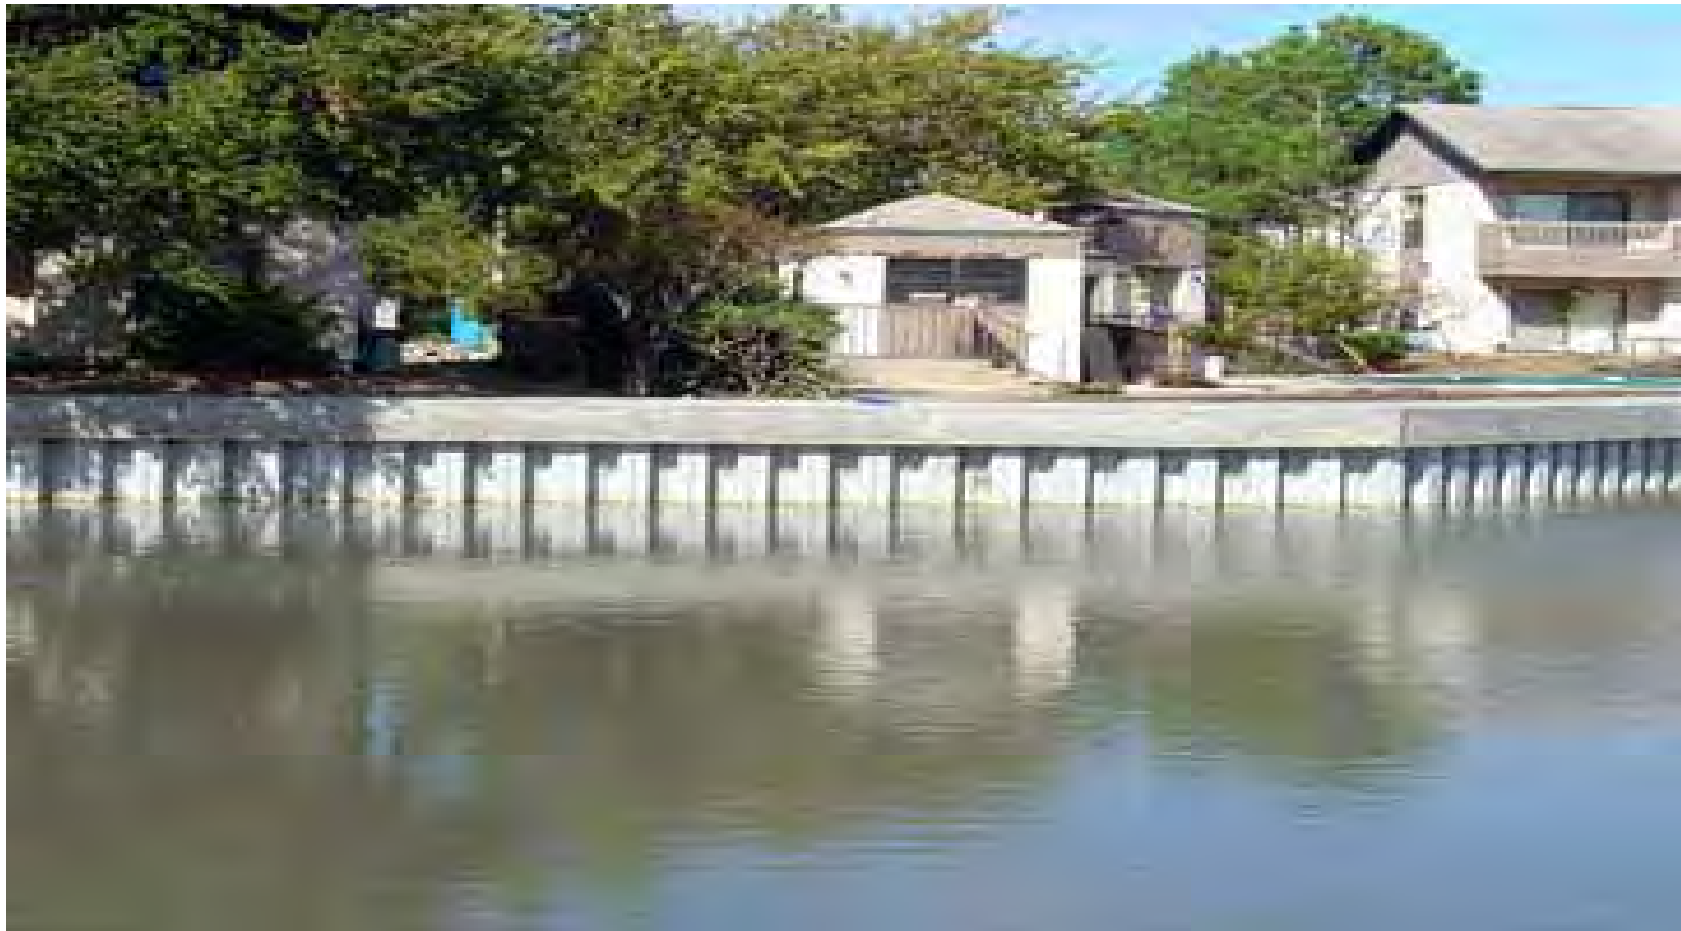
# New Seawall Construction – Option 2

## Steel Sheet Pile Bulkhead

(No tiebacks)

Staff & TMC recommend the steel sheet pile walls.

- Slightly Lower Construction Cost
- Much Less Disruption to Install

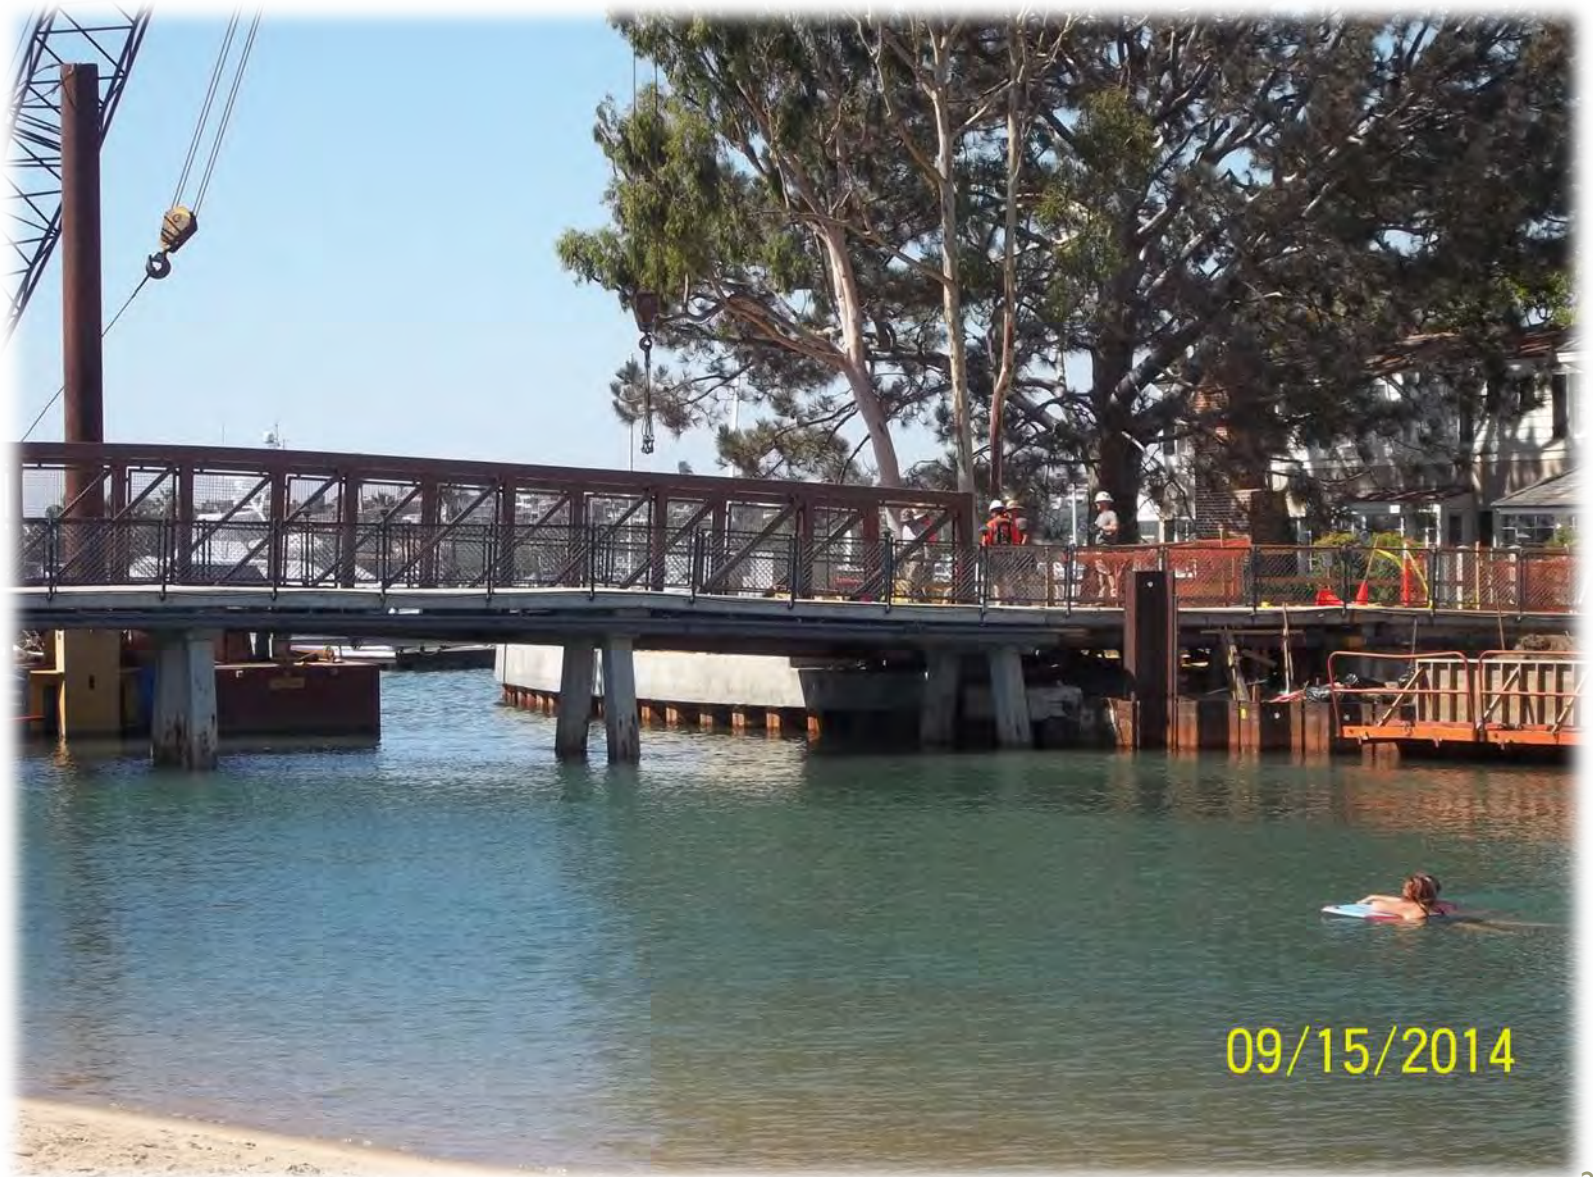
# Bay Island: Steel Sheet Piles and Cap

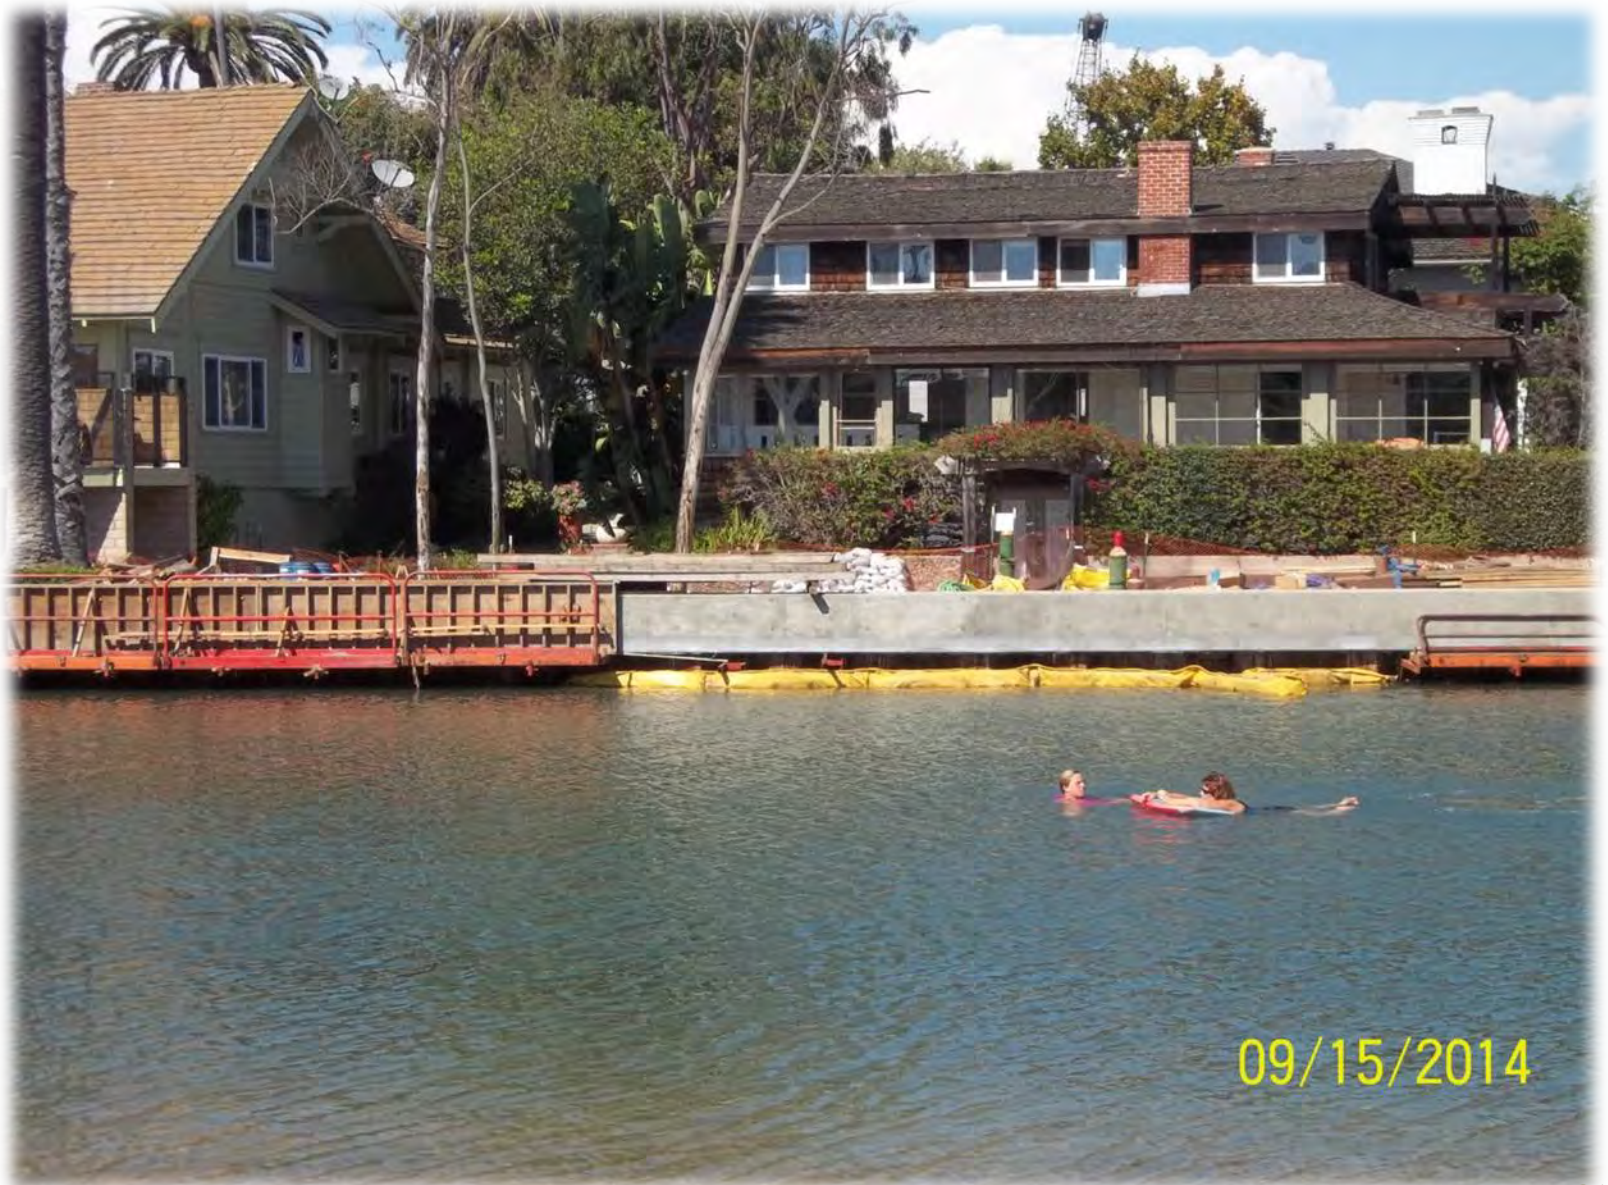
# Bay Island Sheet Piles and Cap

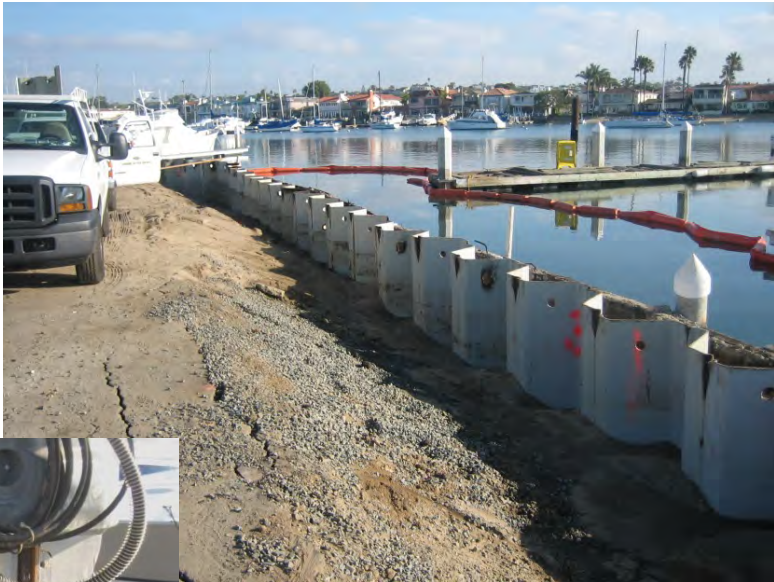
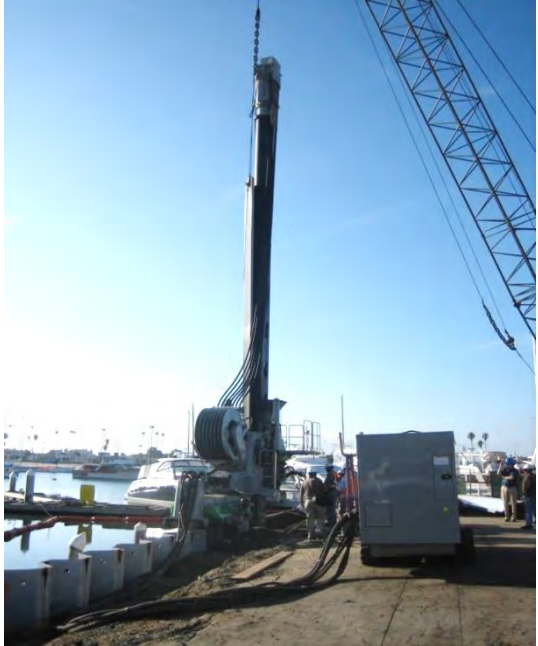
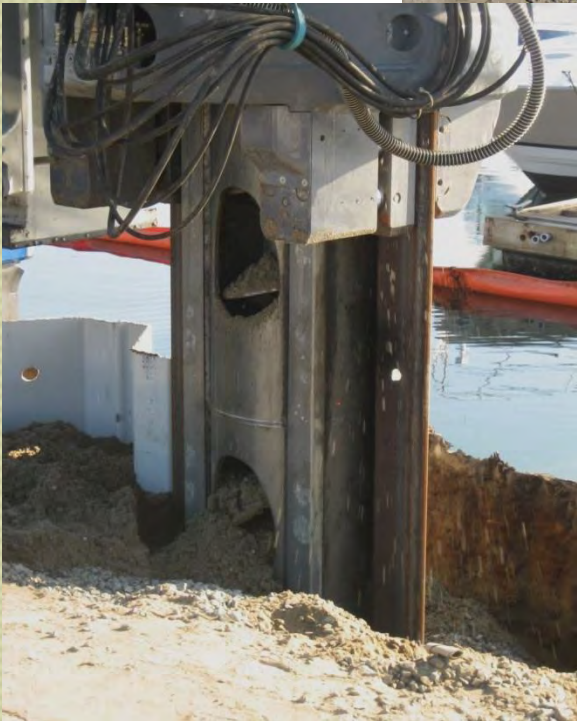
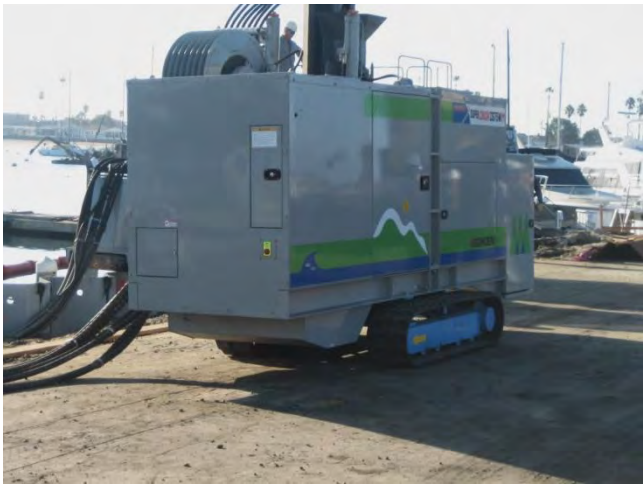
# Steel Sheet Piles Installation (Silent Pile Driver)

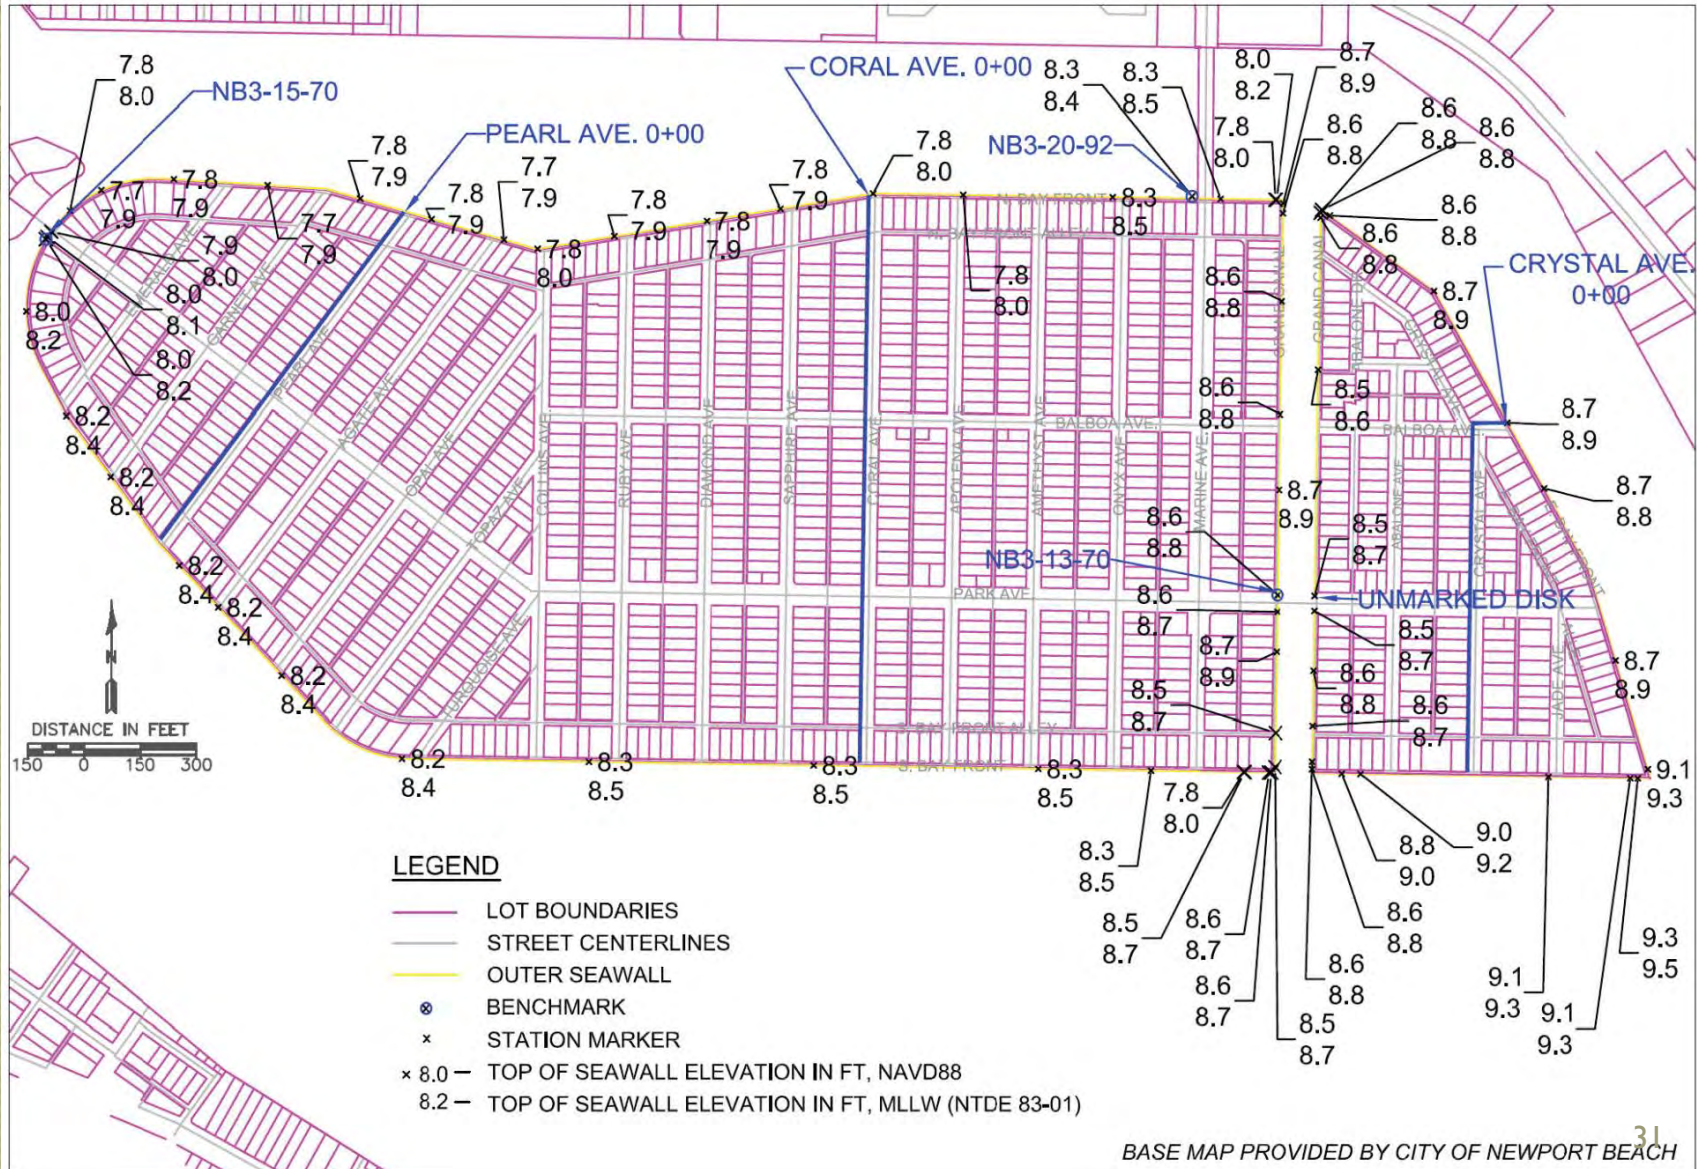
# Existing Top of Wall Elevations
