# Balboa Islands Seawall Rehabilitation Project

## Rehabilitation Options

City Council Study Session  
July 14, 2015

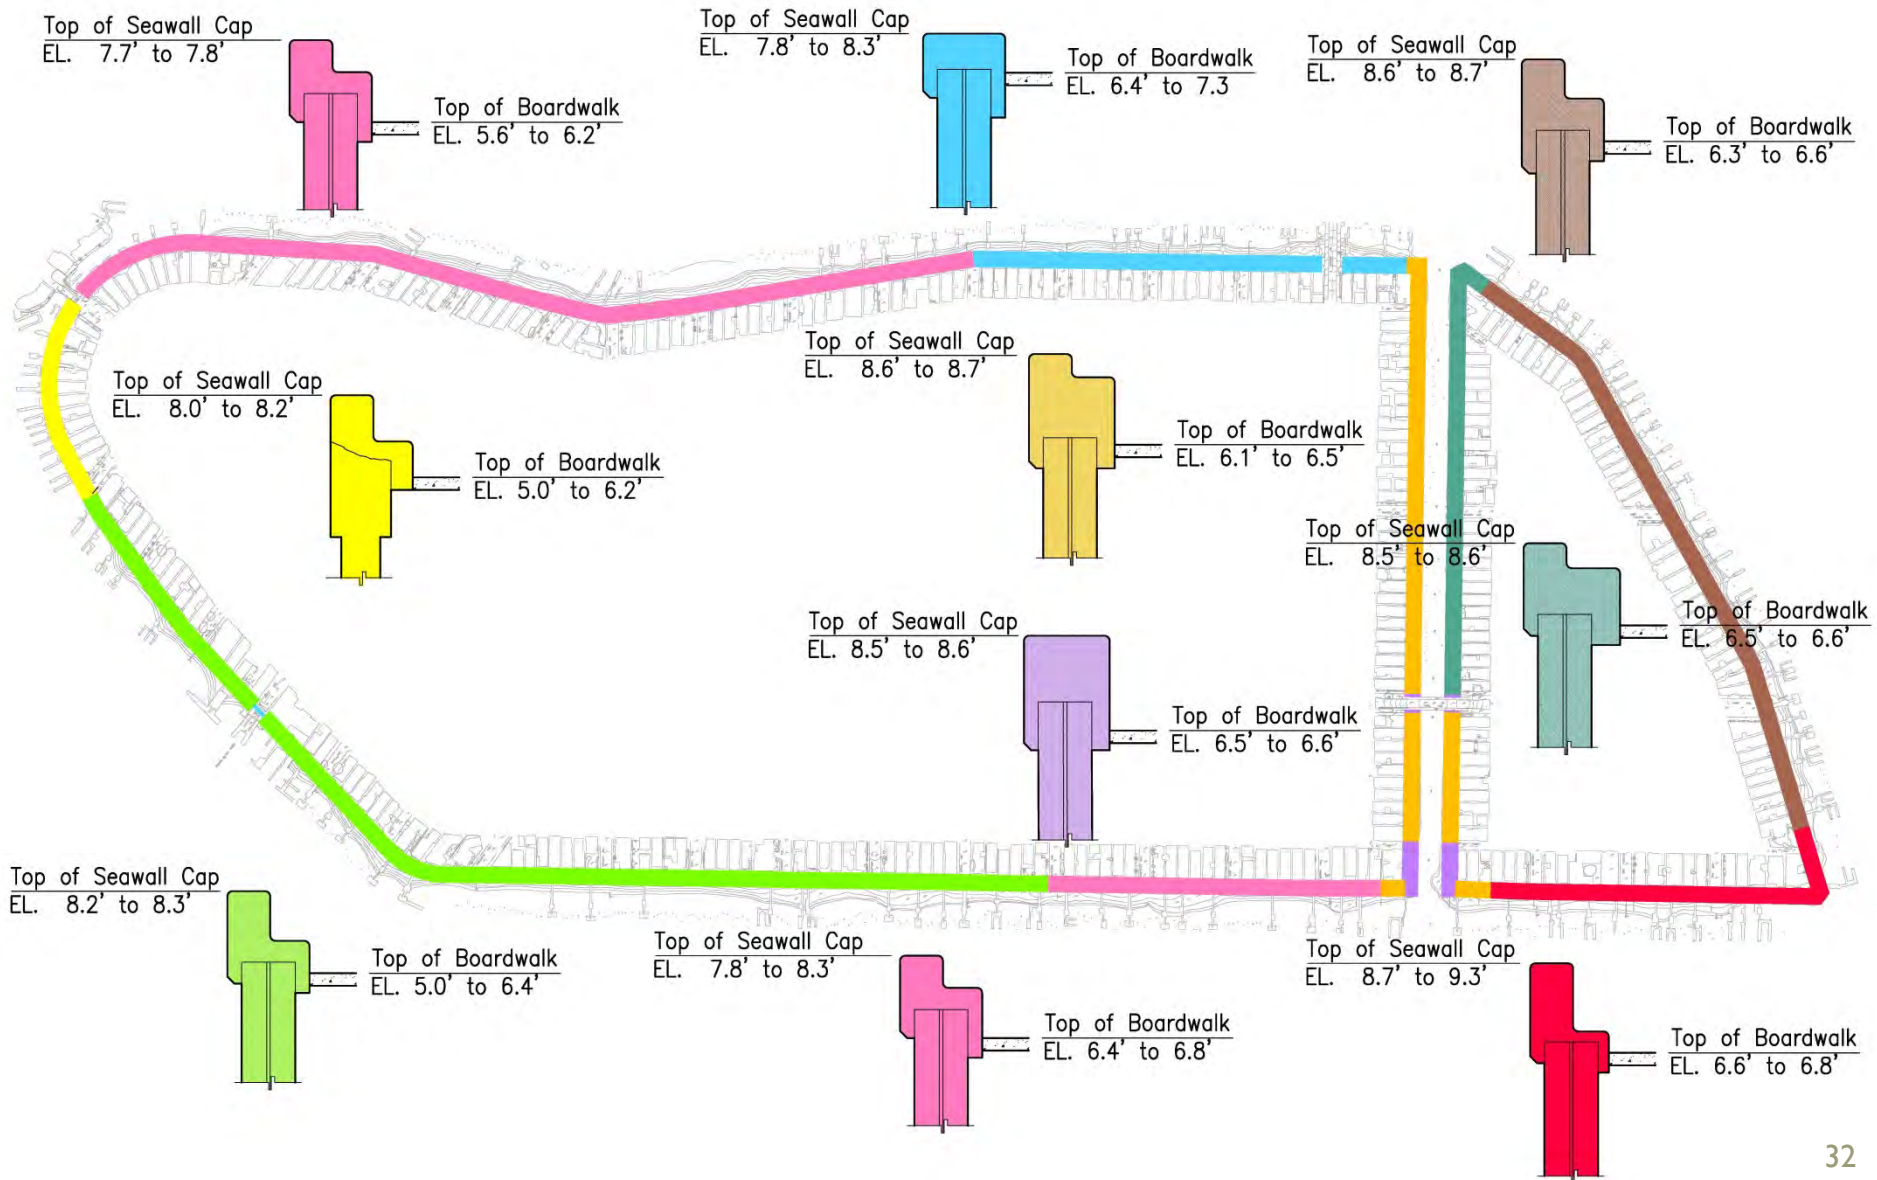
# Wall Elevation Study – Various Existing Conditions

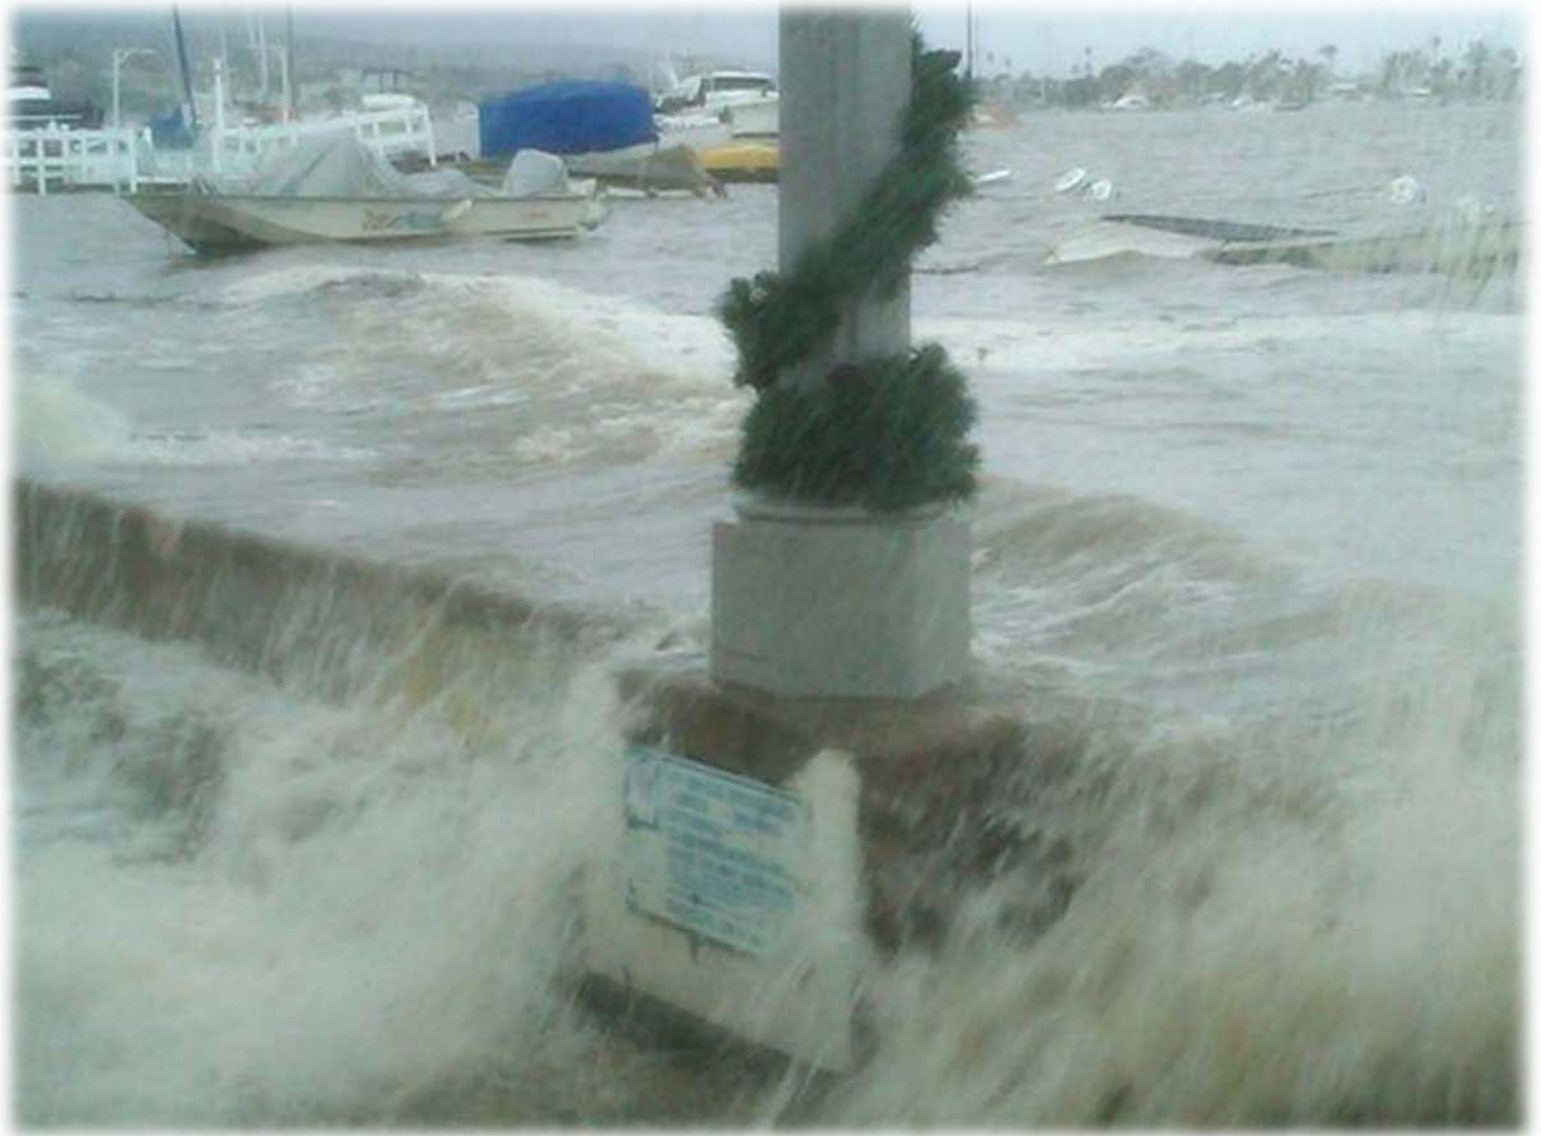
# Overtopping Due To Storm Surge

South Bay Front

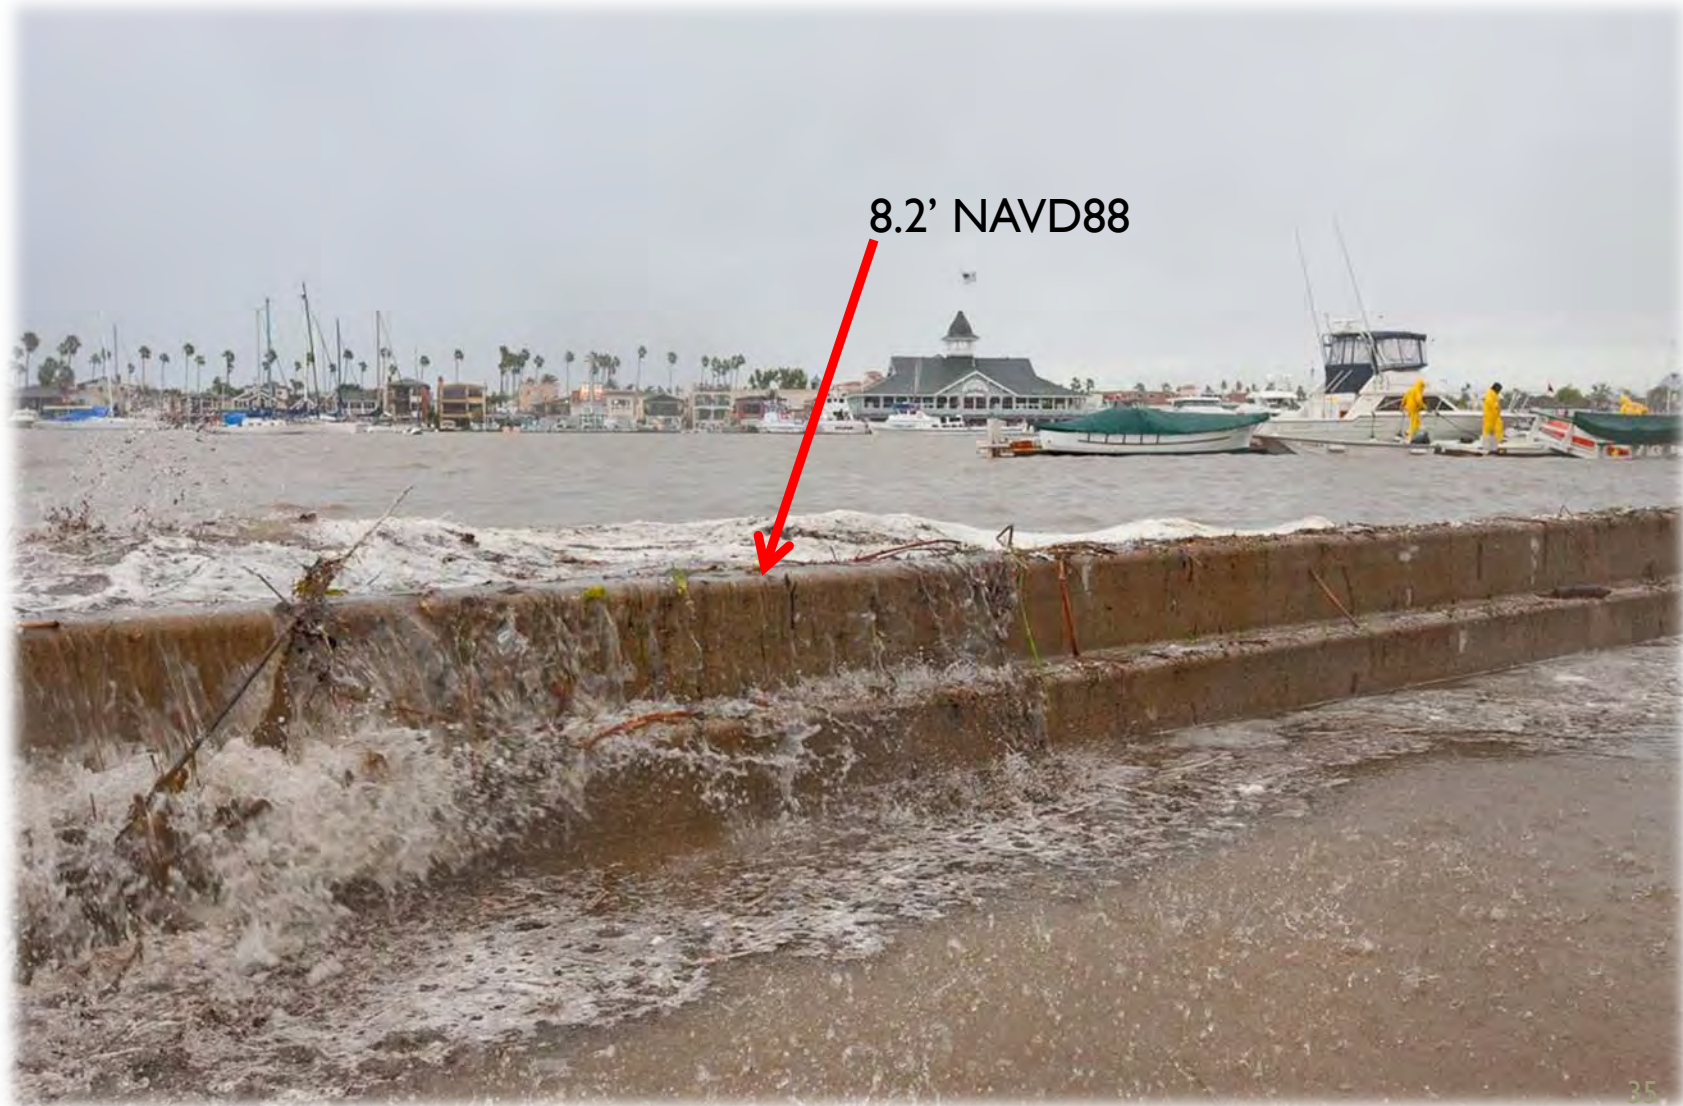
# Overtopping Due To High Tides and Wind/Boat Waves (South Bay Front, 2010)

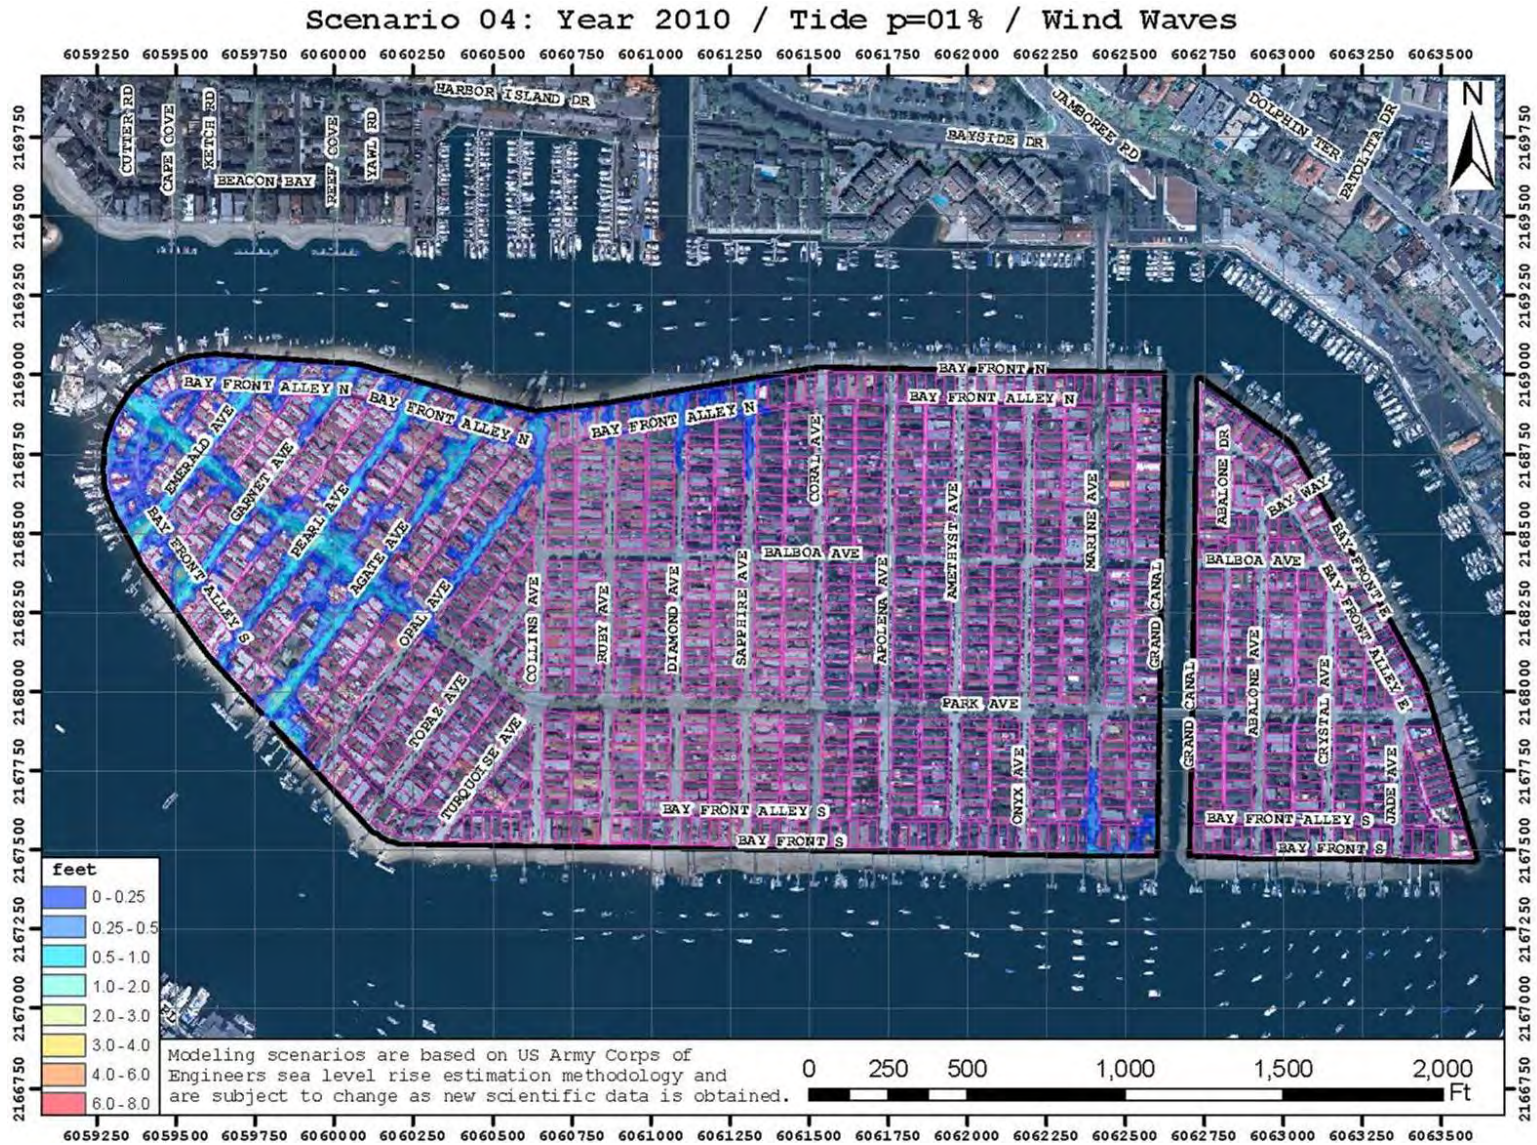
# Current Wall Heights - Flooding Potential: 2010 - Highest 1% (7) Tides with Wind Waves

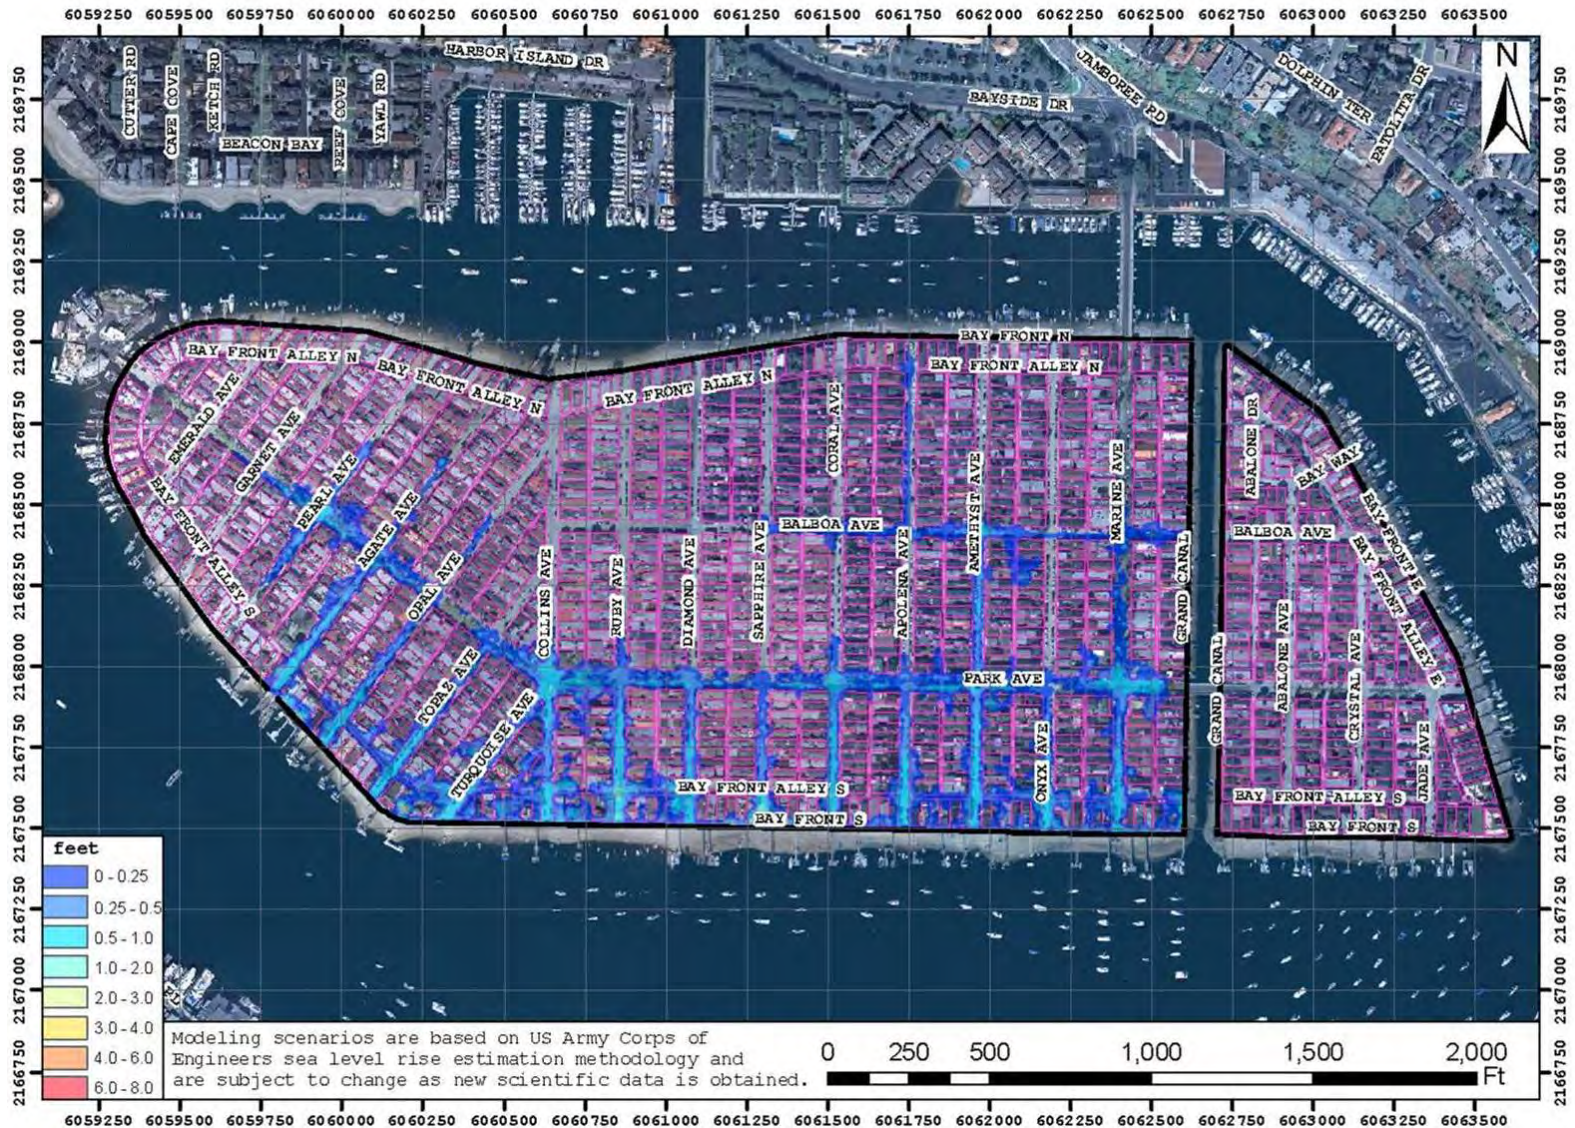
# Current Wall Heights - Flooding Potential: 2010 Highest 10% (70) Tides Ocean Swell

Scenario 03: Year 2010 / Tide p=10% / Ocean Swell

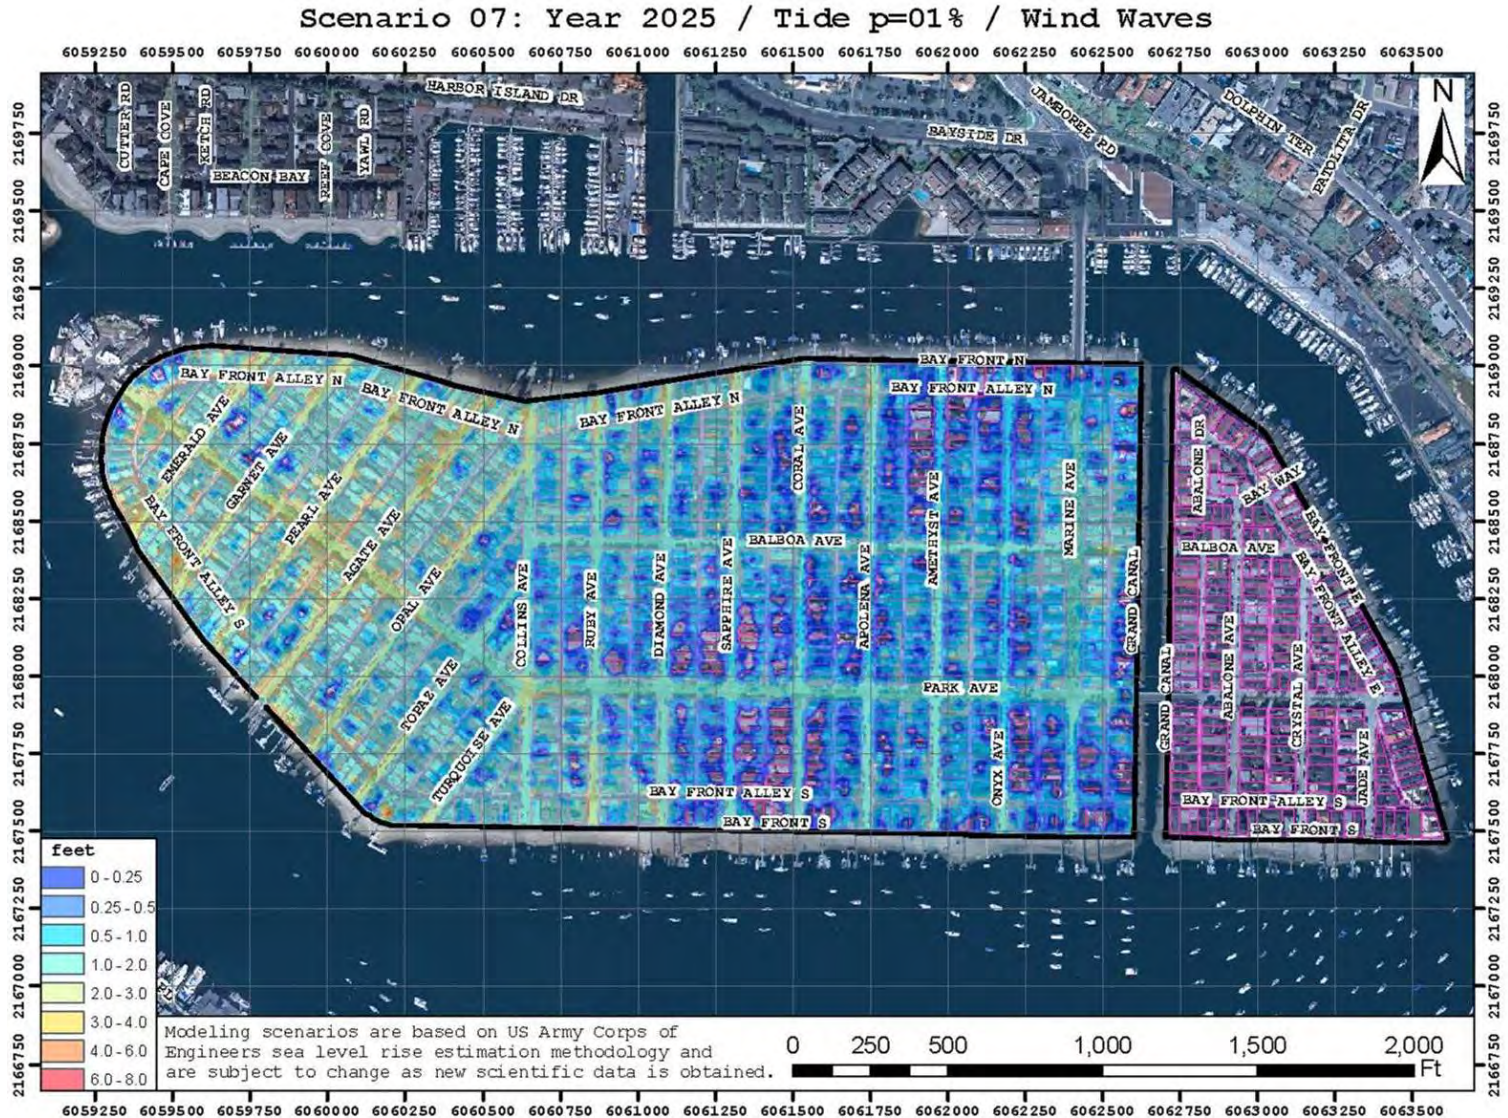
# Current Wall Heights - Flooding Potential: 2025 - Highest 1% Tides with Wind Waves

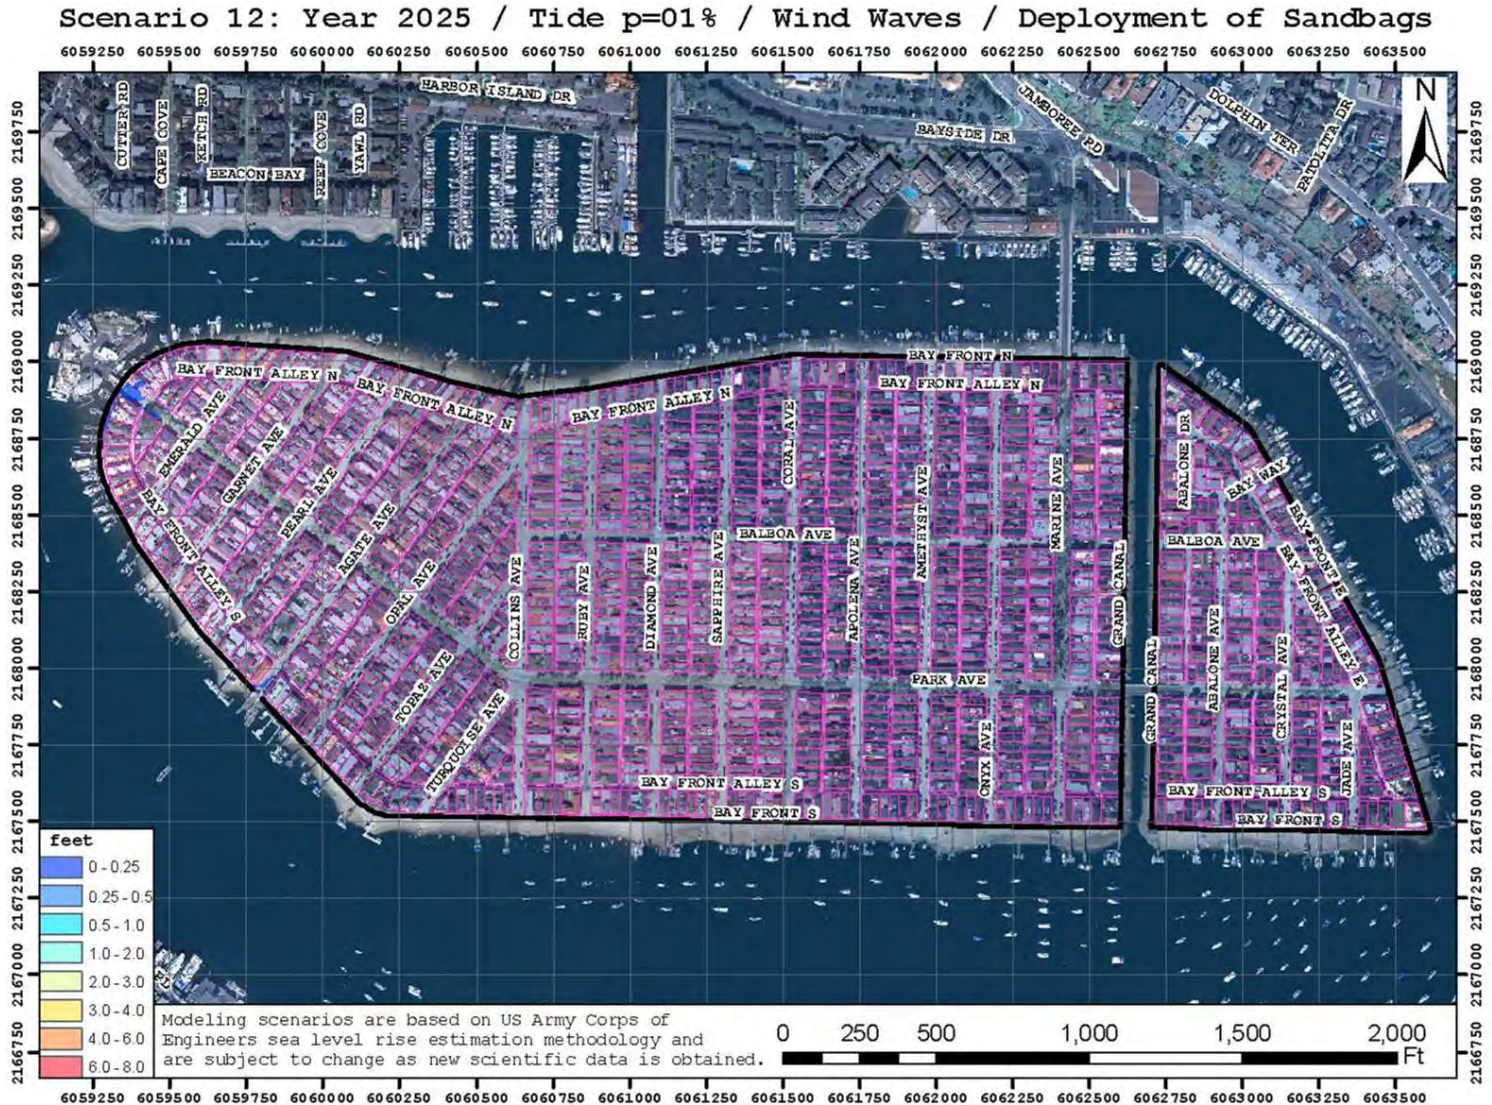
# Estimated Flooding Potential: 2025: Almost no flooding with 6" high sandbags.

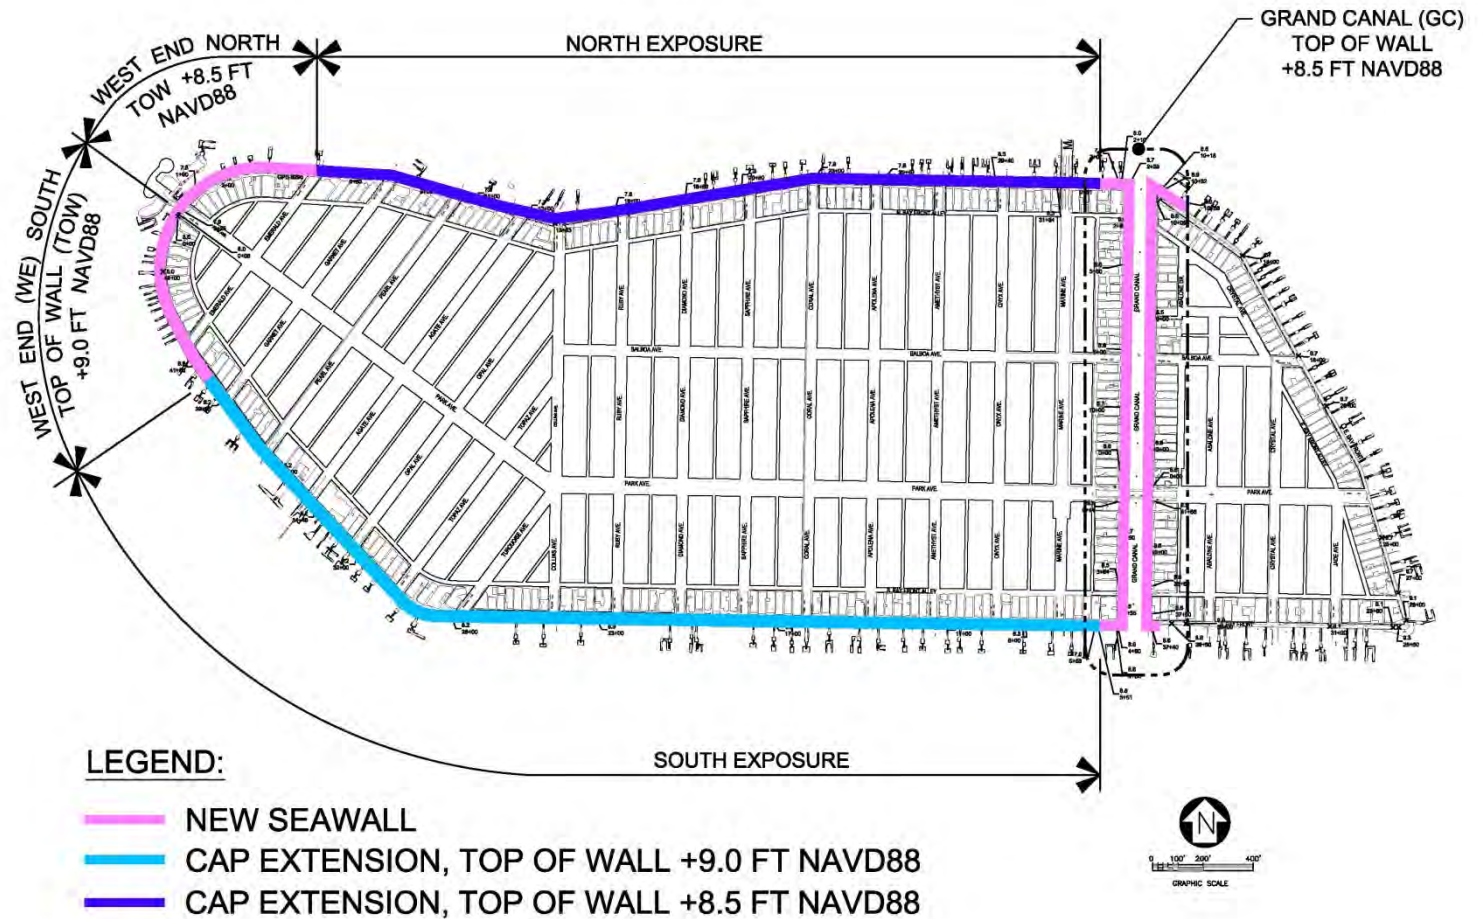
# Option B: New Seawalls at West End and Grand Canal. Cap Extensions on Remaining Walls.

## Option B: Summary of Improvements

- a. New seawalls along entire length of West End:  
South side - Elev. 9.0' and North Side - Elev. 8.5'.
- a. New seawalls on both side of the Grand Canal  
(Elevation 8.5').
- a. Raise seawall cap on South side of Balboa Island to  
Elevation 9.0'.
- b. Raise seawall cap on North side of Balboa Island to  
Elevation 8.5'.

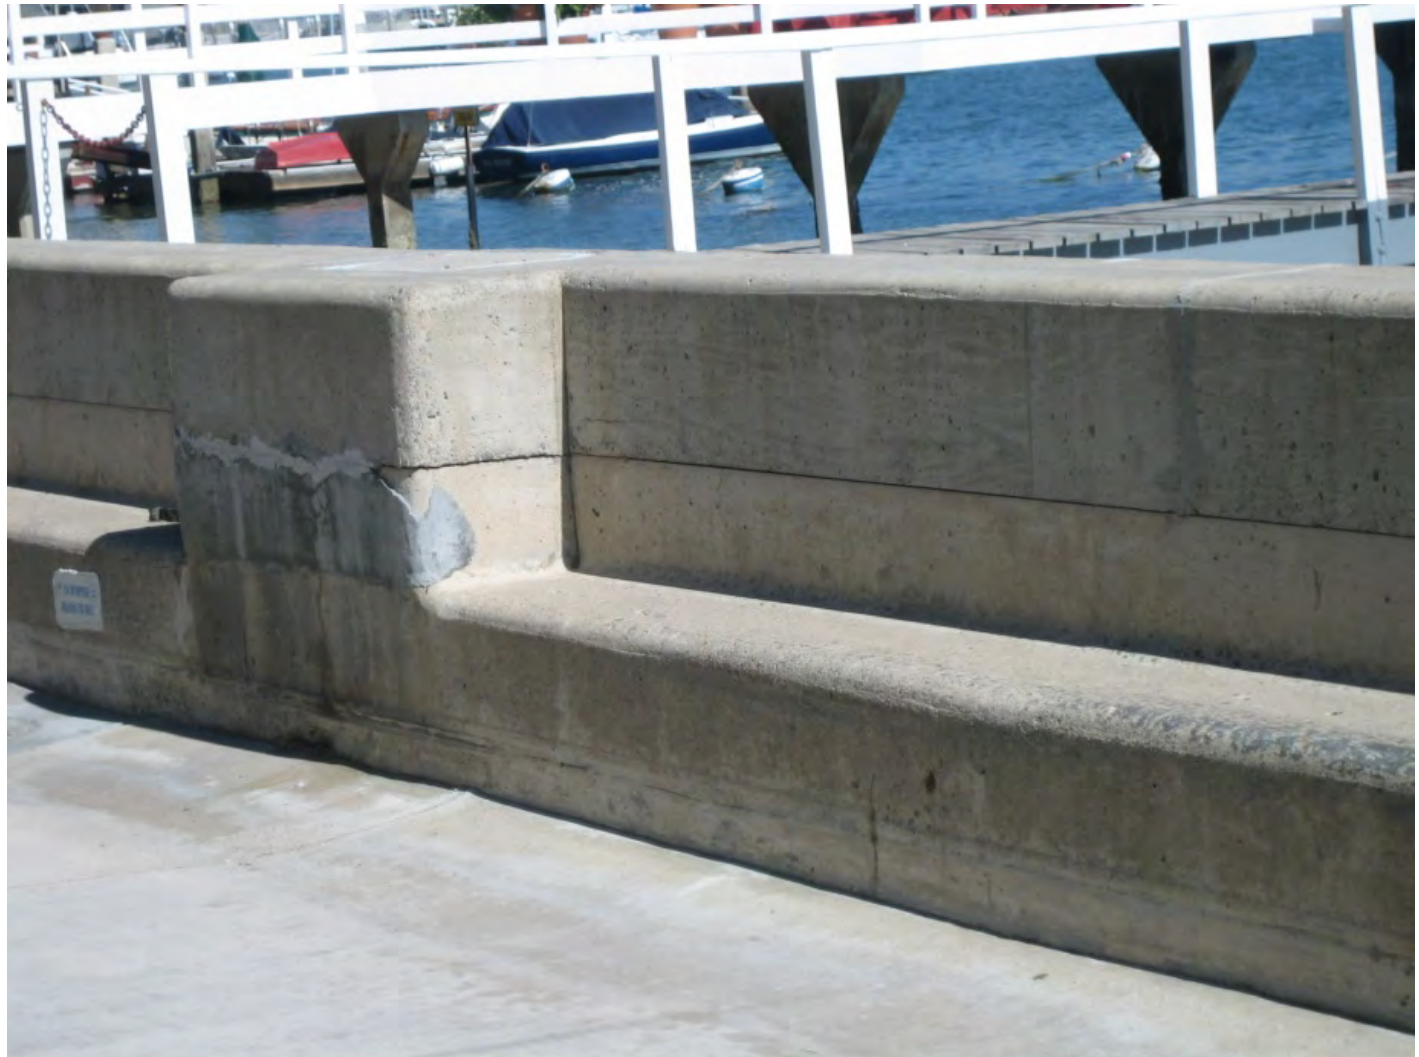
# Option B: Seawall Cap Extension Example on Little Balboa Island

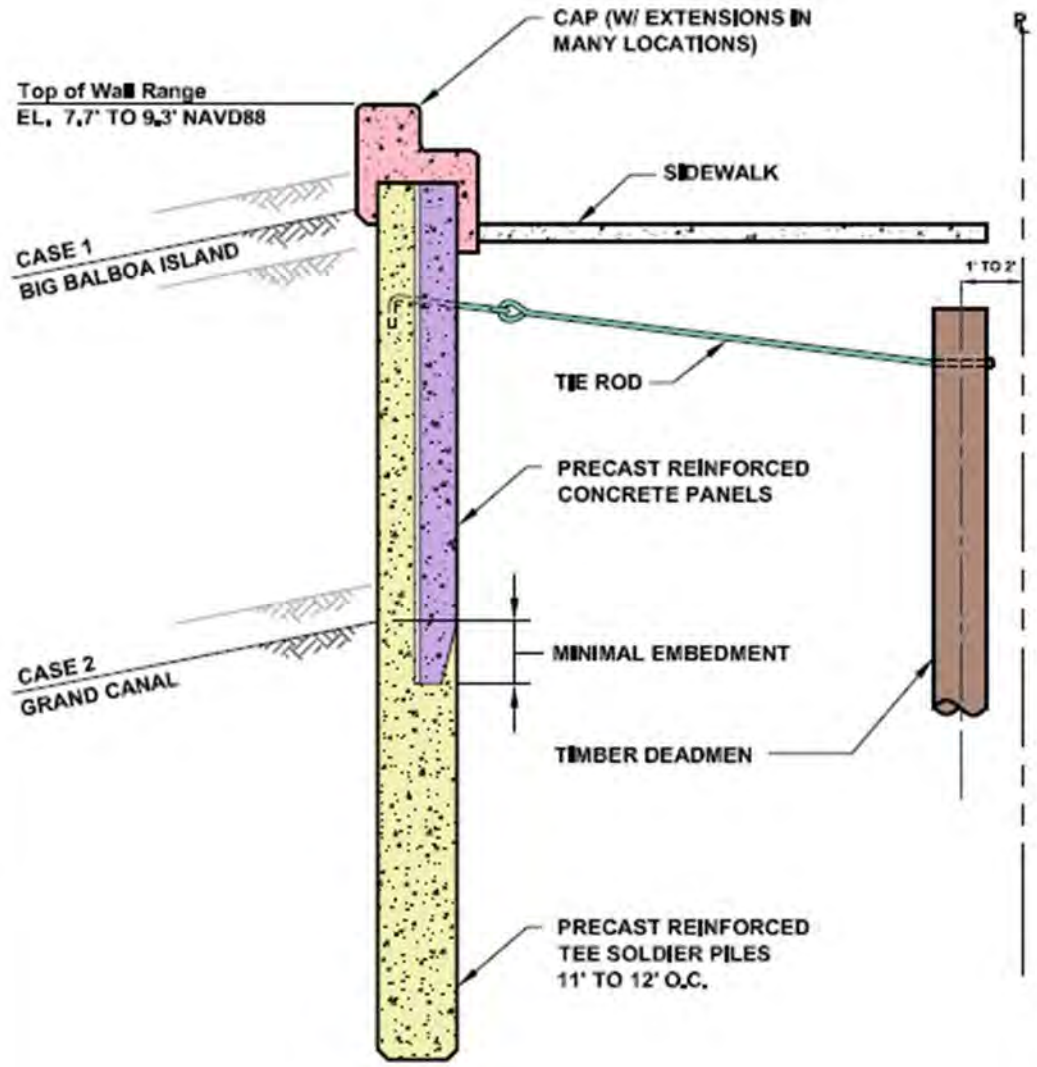
# Grand Canal As-Built Condition

**TYPICAL WALL CASES<sup>(1)</sup>**

<sup>(1)</sup> OTHER NON-TYPICAL CONDITIONS EXIST

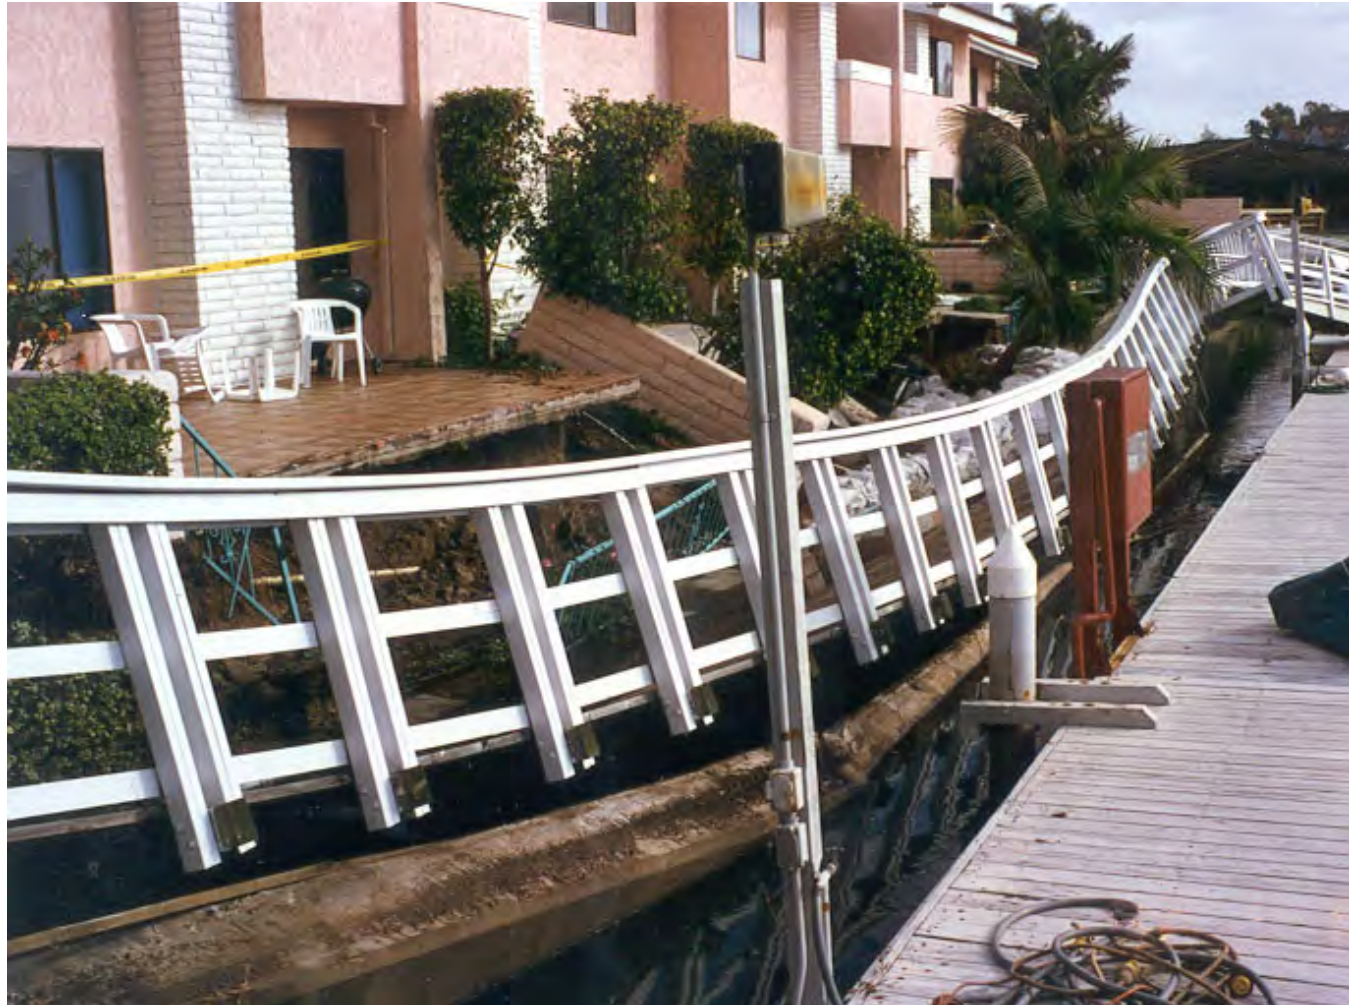
# Newport Marina Villas Townhomes ~1995

## Seawall Failure – Shallow Pile Embedment

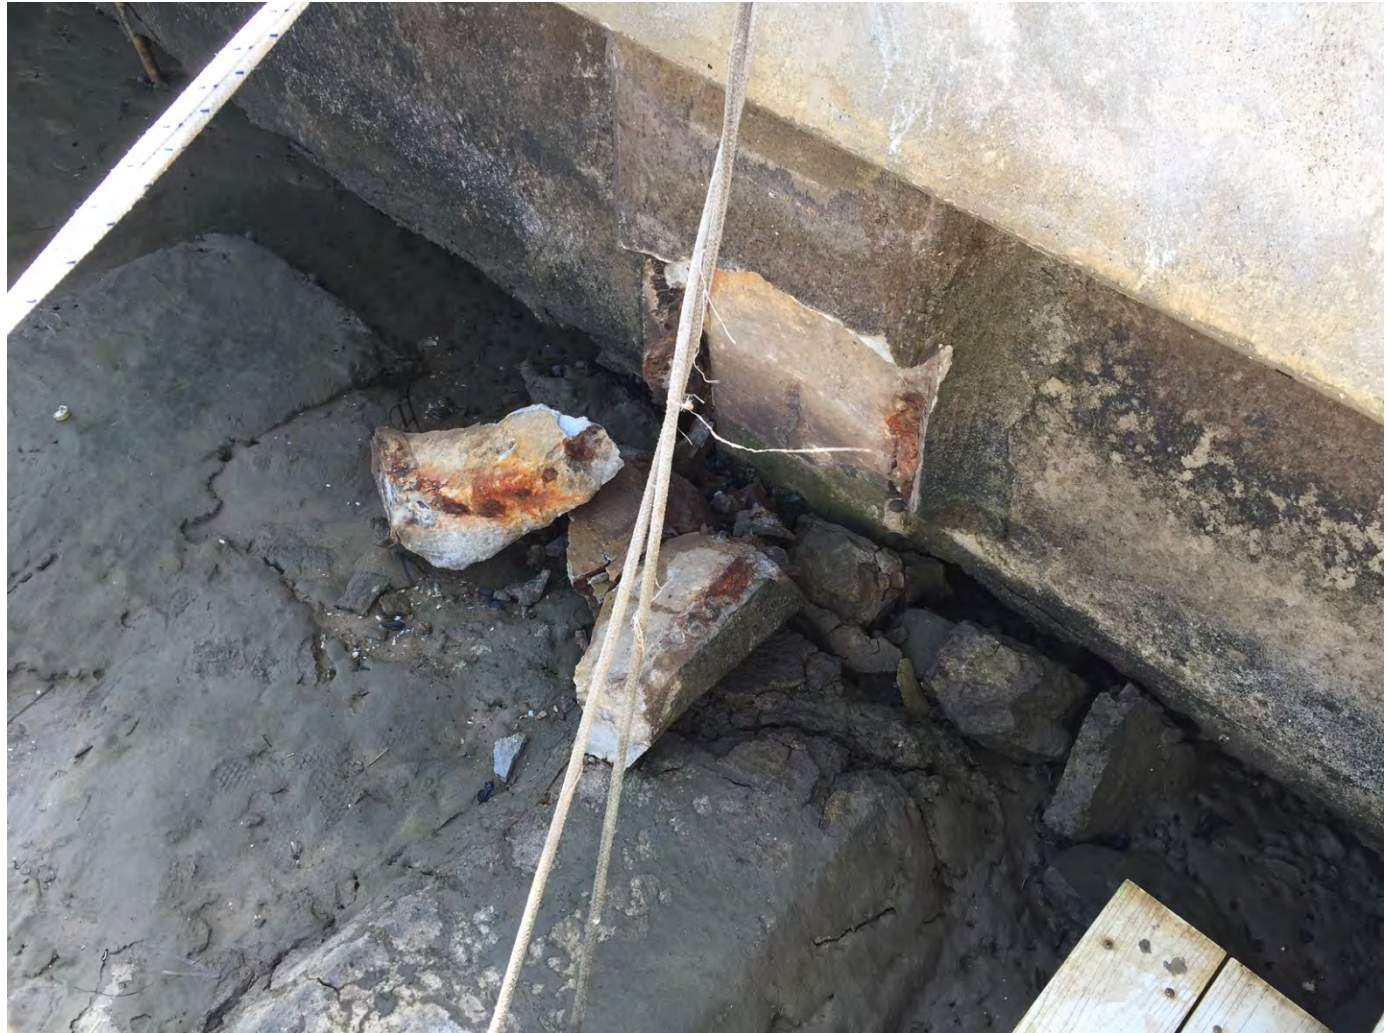
# Grand Canal: Cap Veneer Spalled

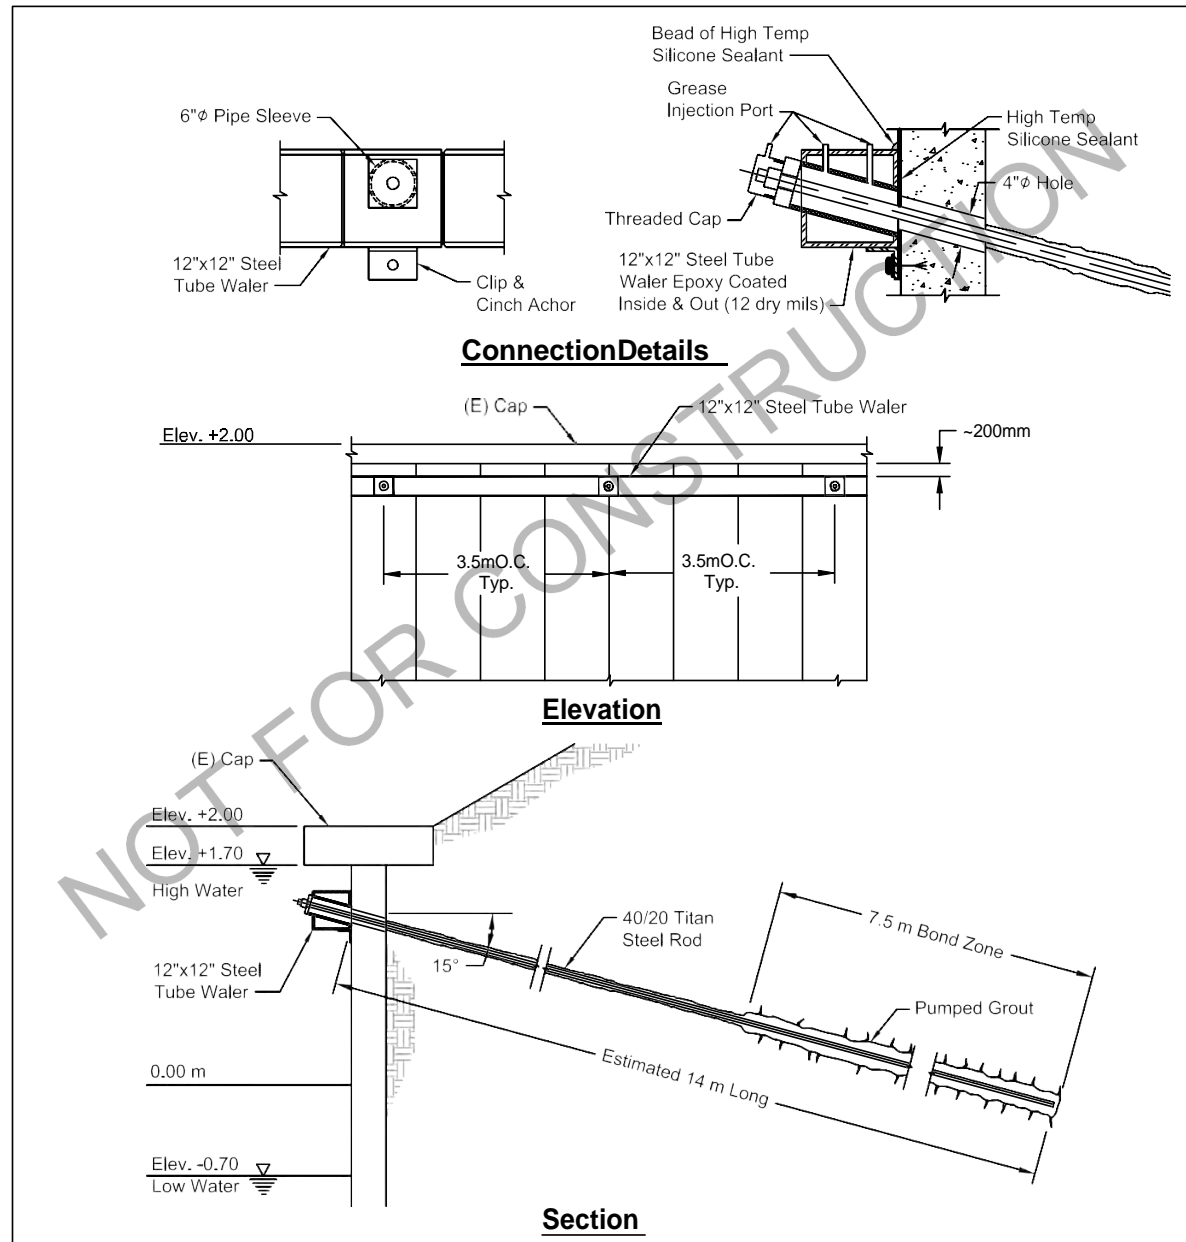
# Option C: Earth Anchor and Tube Waler

# Option C: Anchor installation requires easement.

**NOTE:** As earth anchors are installed, grout is continuously pumped through the drill head, therefore no voids are created during installation.

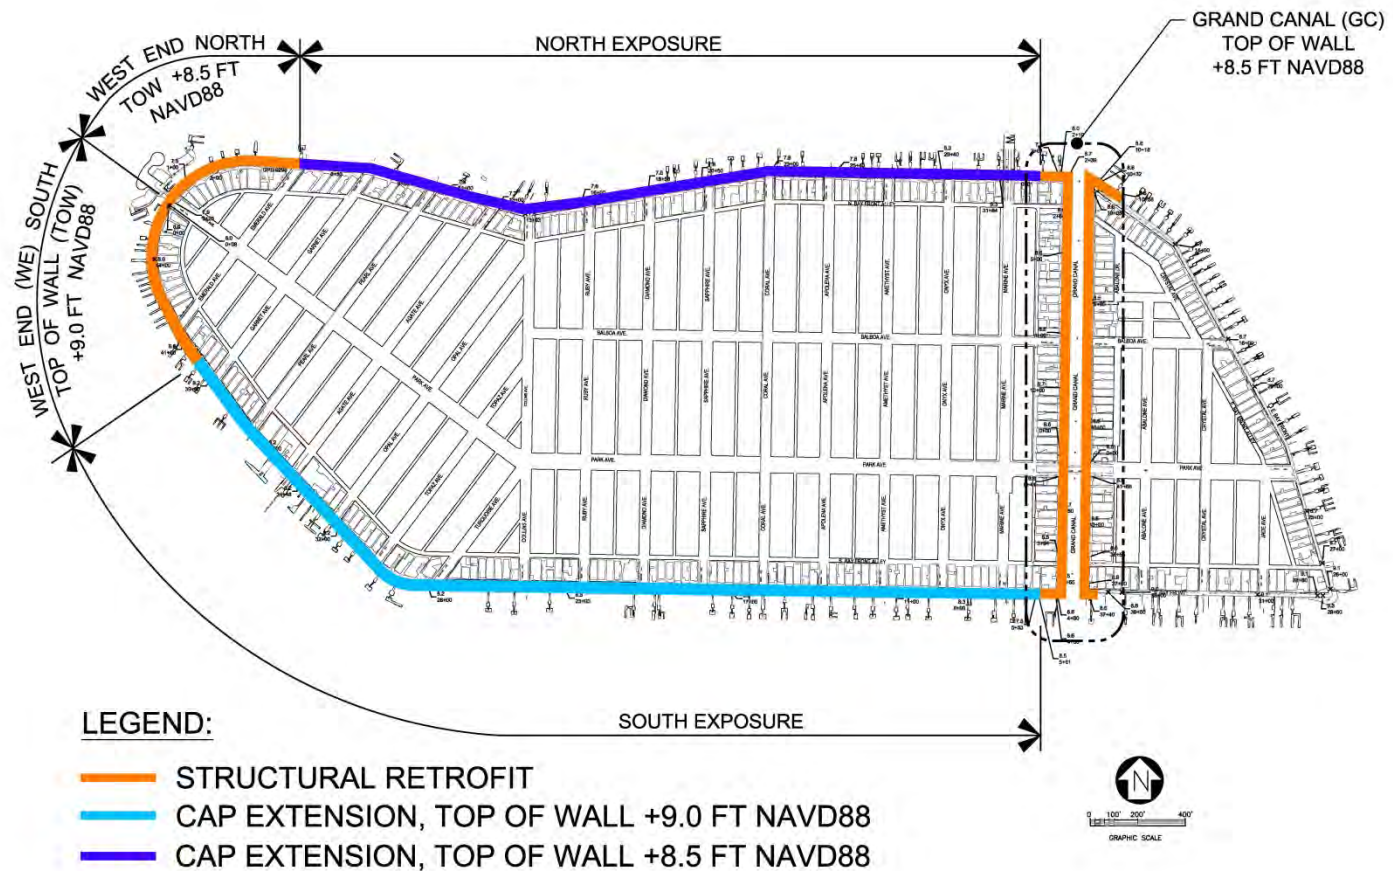
# Option D: Seawall rehabilitation in Grand Canal and West End. Cap extensions for the remaining walls.
