# Balboa Islands Seawall Rehabilitation Project

## Rehabilitation Options

City Council Study Session  
July 14, 2015

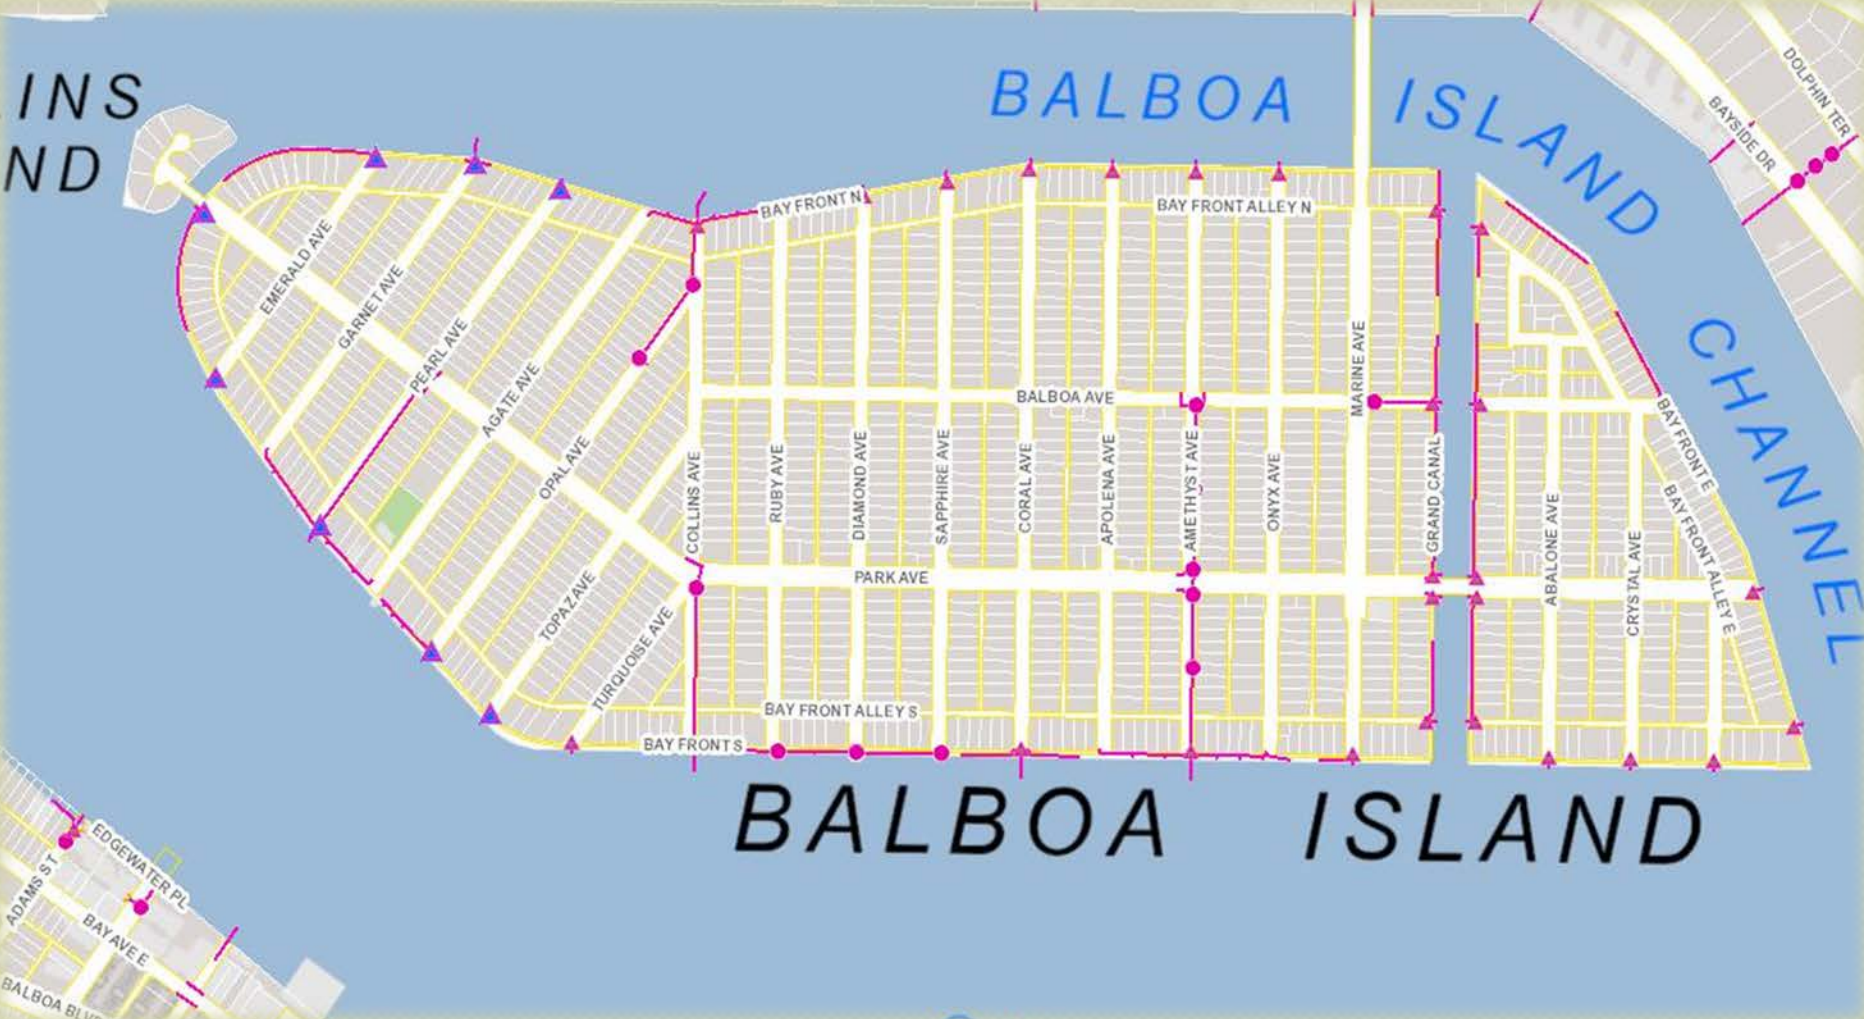
# Existing Drainage System on Balboa Island

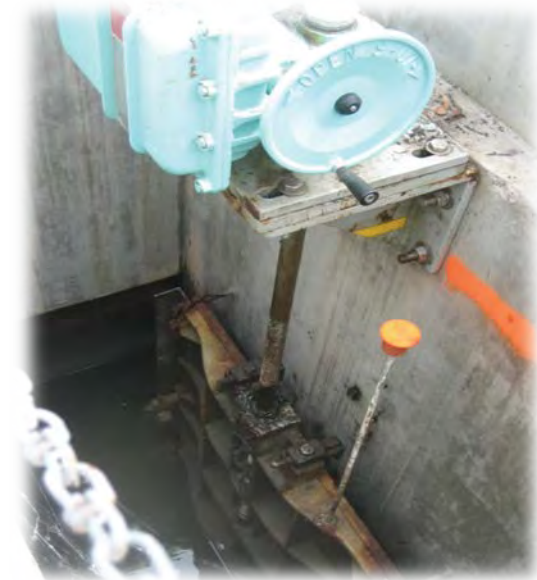
# Tide Valves

Protects the Island from Flooding due to High Tides  
Currently Manually Operated

Manually Operated  
with Valve Key

Power Assisted with  
Manually Operated Up/Down Switch

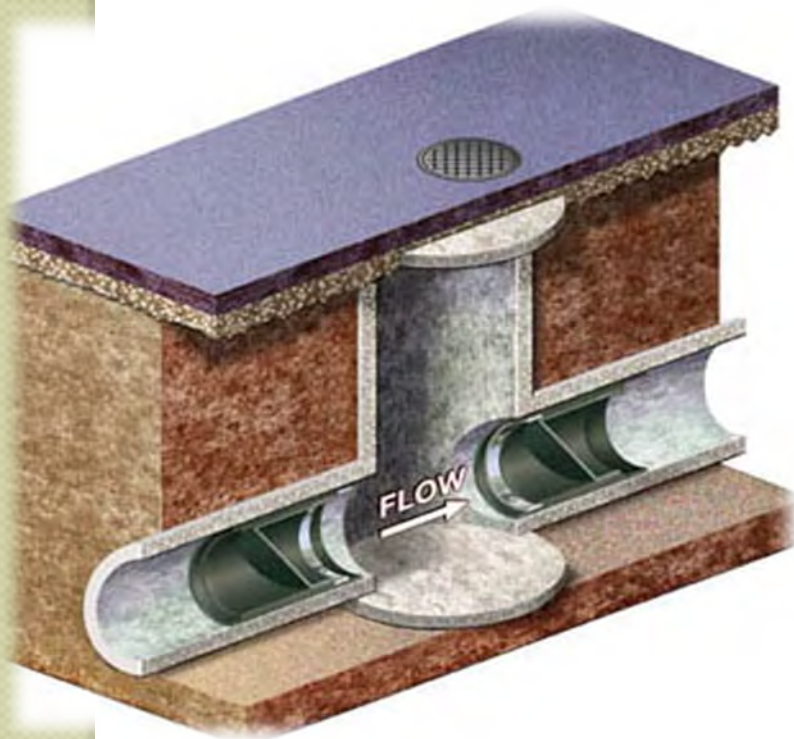
# New Rubber Tide Valve (Check Valve)

- No Moving Mechanical Parts - Silent, Non-Slamming
- Non-Corrosive - Durable Rubber Construction
- Minimal Maintenance and Periodic Inspection Needed
- Around 1" of Water Pressure Opens Valve helping Eliminate Standing Water
- Simple Installation. Estimated 25-Year Life

Low Flow Open

Full Flow Open

Closed Against Tide
