<b>ACTIVITY</b> Balboa Island Bulkhead Inspection	<b>CASH &amp; ASSOCIATES</b> Engineering and Architecture

Cash & Associates Engineering and Architecture 1712 Ave. 100 Mission Viejo, CA
<b>STREET LOCATION</b> Grand Canal East Between South Bay Front and Park Ave	INSPECTOR: ASSISTANT:	CTM	INSPECTION DATE: December 21, 2004	REVISION

The City of Newport Beach retained COWI North America (COWI) to perform a Condition Assessment Inspection of the bulkhead wall at the West End of Balboa Island, City of Newport Beach Contract No. 8088-1. The reach of the wall extended from Emerald Avenue at North Bay Front, west and south, then southeast to Emerald Avenue at South Bay Front as indicated by the highlighted area in the figure below.

Figure 1 - Inspection Location and Limits, West End of Balboa Island, Newport Beach, CA

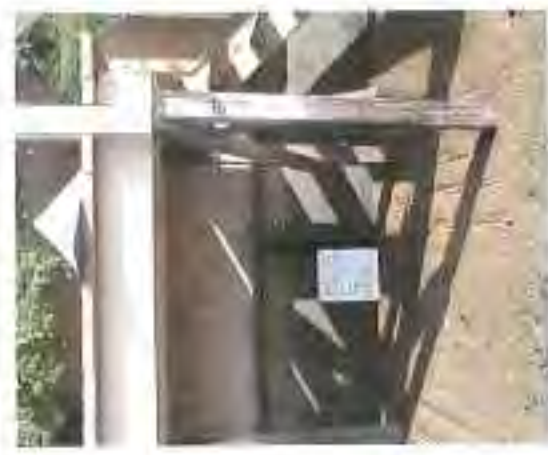
Grand Canal East, 100 ft South of Balboa

10	100' South of Balboa Avenue	Waterside, shotcrete at pile face spalled off
11	111' South of Balboa Avenue	Waterside, shotcrete at pile face spalled off
12	123' South of Balboa Avenue	Waterside, shotcrete at pile face spalled off
13	128' South of Balboa Avenue	Landside, crack at top of cap rebar exposed 120" long
14	130' - 153' South of Balboa Avenue	Landside, crack at lower step
15	135' South of Balboa Avenue	Waterside, shotcrete at pile face spalled off
16	146' South of Balboa Avenue	Waterside, shotcrete at pile facing and sides cracked, 48" long x 1/8" wide
17	153' South of Balboa Avenue	Construction joint, waterside and landside sealant cracked and split
18	158' South of Balboa Avenue	Waterside, shotcrete cover at pile loose and cracked 4 square feet
19	170' South of Balboa Avenue	Waterside, shotcrete cover at pile loose and cracked 6 square feet
20	181' South of Balboa Avenue	Waterside, shotcrete at pile facing and sides cracked, 48" long x 1/8" wide

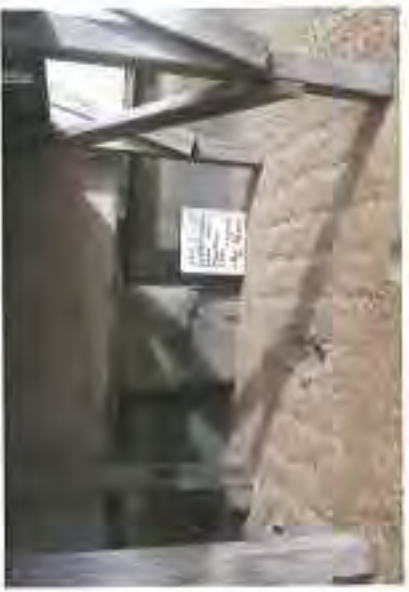
Grand Canal East, 192 ft South of Balboa

21	192' South of Balboa Avenue	Waterside, shotcrete at pile lost at mudline 2 square feet
22	205' South of Balboa Avenue	Waterside, shotcrete at pile lost at mudline 2 square feet
23	216' South of Balboa Avenue	Waterside, shotcrete cover cracked on south side 36" long x 1/8" wide
24	228' South of Balboa Avenue	Waterside, shotcrete at pile spalled at mudline 1 square foot
25	240' South of Balboa Avenue	Waterside, shotcrete at pile spalled at mudline 3 square foot
26	253' South of Balboa Avenue	Construction joint, waterside and landside sealant cracked and split
27	257' South of Balboa Avenue	Waterside, rust spots and cracking at bottom of cap 36" long x 5" wide
28	263' South of Balboa Avenue	Waterside, shotcrete cover cracked on south side 36" long x 1/32" wide
29	286' South of Balboa Avenue	Waterside, shotcrete cover cracked on south side and south face 48" long x 1/32" wide
30	298' South of Balboa Avenue	Waterside, spall at bottom of cap 120" long, rust stains through cap

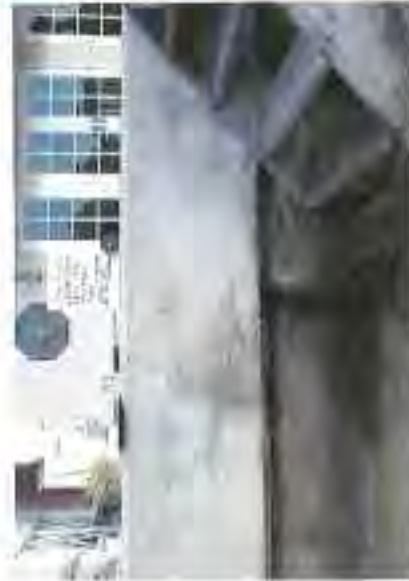
Grand Canal East, 298 ft South of Balboa

31	298'-305' South of Balboa Avenue	Landside, crack at lower step
32	314' South of Balboa Avenue	Waterside, spall at bottom of cap 120" long, rust stains through cap
33	323' South of Balboa Avenue	Waterside, shotcrete at pile cracked at front and south side, vertical cracks through cap
34	346' South of Balboa Avenue	Waterside, shotcrete at pile at mudline spalled 3 square feet

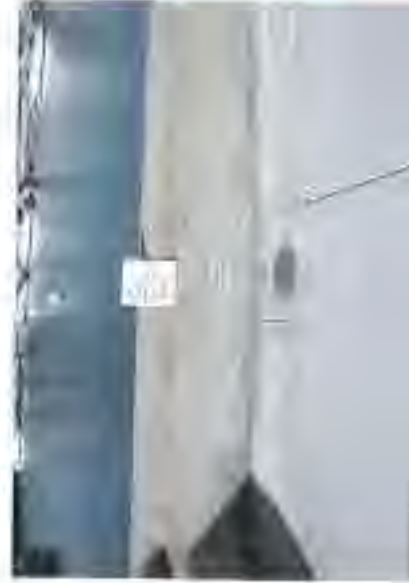
Grand Canal East at East Bay Front

1	Corner btwn N. Bay Front and Grand Canal East	Rust spots at middle to bottom of cap
2	0-17' South of East Bay Front	Landside, cracking at sidewalk level
3	3' - 13' South of East Bay Front	Waterside, cracking at bottom of cap, rust present
4	13' South of East Bay Front	Construction joint, waterside and landside sealant cracked and split
5	20' South of East Bay Front	Waterside, rust spots present no cracking
6	36' South of East Bay Front	Waterside, shotcrete pile cover cracked and spalled at mudline
7	41' South of East Bay Front	Waterside, shotcrete spall on wall 24" long x 4" high x 1/2" deep
8	49' South of East Bay Front	Waterside, shotcrete pile cover cracked 24" long x 1/8" wide
9	62' South of East Bay Front	Waterside, shotcrete pile cover loose and cracked
10	86' South of East Bay Front	Waterside, shotcrete pile cover cracked at face
11	98' South of East Bay Front	Construction joint, waterside and landside sealant cracked and split

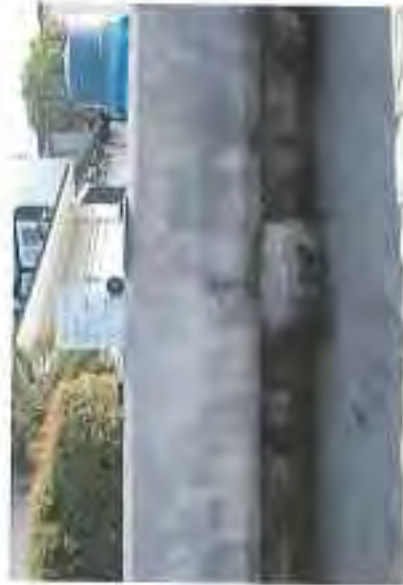
121 feet South of East Bay Front

12	121' South of East Bay Front	Waterside, shotcrete pile cover face and sides cracked
13	133' South of East Bay Front	Waterside, shotcrete pile cover face only cracked 24" long x 1/32" wide
14	144' South of East Bay Front	Waterside, shotcrete pile cover sides cracked 48" x 1/32" wide
15	168' South of East Bay Front	Waterside, shotcrete pile covering face and sides cracked
16	174' South of East Bay Front	Landside, transverse crack at top of cap
17	180' South of East Bay Front	Waterside, shotcrete pile covering sides only cracked 24" long x 1/32" wide
18	191' South of East Bay Front	Waterside, shotcrete pile covering face and sides cracking 60" long x 1/32" wide
19	204' South of East Bay Front	Construction joint, waterside and landside sealant cracked and split
20	215' South of East Bay Front	Waterside, shotcrete pile covering cracked 48" long x 1/32" wide
21	238' South of East Bay Front	Waterside, shotcrete pile covering cracked 48" long x 1/32" wide

Item	Description	QUANTITY		MATERIAL COST		LABOR COST		ENGINEERING ESTIMATE			
		Number	Unit	Unit Cost	Total	Unit Cost	Total	Unit Cost	Total	Unit Cost	Total
2	0-17' South of East Bay Front, crack injection	17	LF							\$70.00	\$1,190
3	3' - 13' South of East Bay Front, crack injection	13	LF							\$70.00	\$910
4	13' South of East Bay Front, sealant repair	6	LF							\$25.00	\$150
6	36' South of East Bay Front, shotcrete pile repair	6	SF							\$70.00	\$420
7	41' South of East Bay Front, spall repair	2	SF							\$70.00	\$140
8	49' South of East Bay Front, shotcrete pile repair	6	SF							\$70.00	\$420
9	62' South of East Bay Front, shotcrete pile repair	6	SF							\$70.00	\$420
10	86' South of East Bay Front, shotcrete pile repair	6	SF							\$70.00	\$420
11	98' South of East Bay Front, sealant repair	6	LF							\$25.00	\$150
12	121' South of East Bay Front, shotcrete pile repair	6	SF							\$70.00	\$420

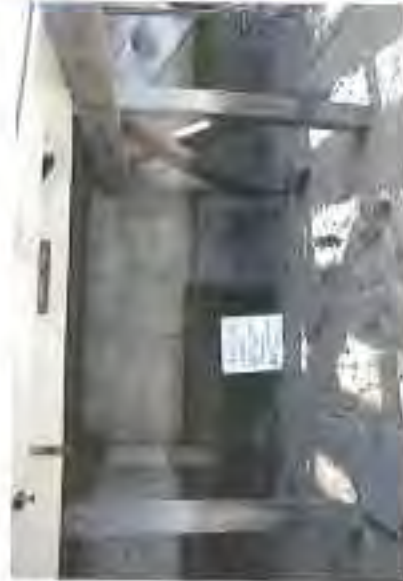
262 feet South of East Bay Front

22	262' South of East Bay Front	Waterside, shotcrete pile covering cracked on face and sides 60" long x 1/32" wide
23	304' South of East Bay Front	Landside, top of cap cracked 72" long x 1/16" - 1/4" wide
24	308' South of East Bay Front	Waterside, spall at bottom of cap 24" long x 4" high x 2" deep under cap
25	308' South of East Bay Front	Waterside, shotcrete pile covering cracked both sides
26	321' South of East Bay Front	Construction joint, waterside and landside sealant cracked and split
27	321' South of East Bay Front	Waterside, shotcrete pile covering side cracks 60" long x 1/32" wide
28	326' South of East Bay Front	Waterside, longitudinal cracks on sheet 98" long x 1/32" wide
29	343' South of East Bay Front	Waterside, face of cap peeling, 240" long x 18" high x surface
30	373' South of East Bay Front	Waterside, vertical crack through cap 30" long x 1/32" wide
31	373' South of East Bay Front	Landside, transverse crack through shotcrete

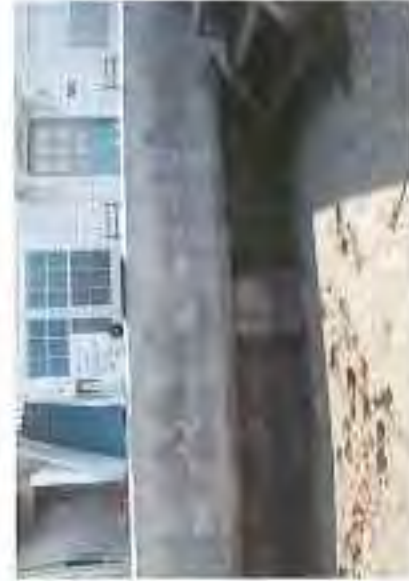
378 feet South of East Bay Front

32	378' South of East Bay Front	Waterside, face of cap peeling, 120" long x 18" high x surface
33	402' South of East Bay Front	Waterside, shotcrete pile covering face and sides cracking 60" long x 1/32" wide
34	437' South of East Bay Front	Waterside, shotcrete pile covering face and side cracked 60" long x 1/32" wide

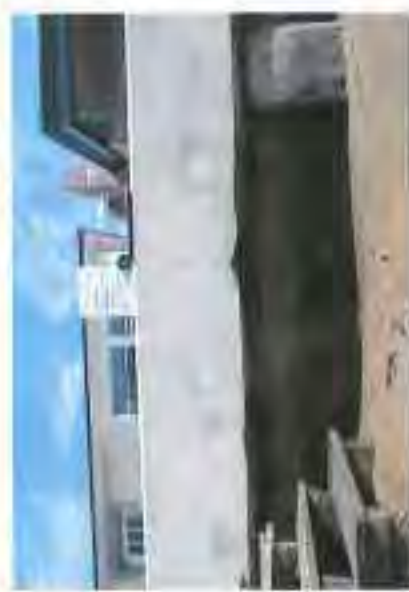
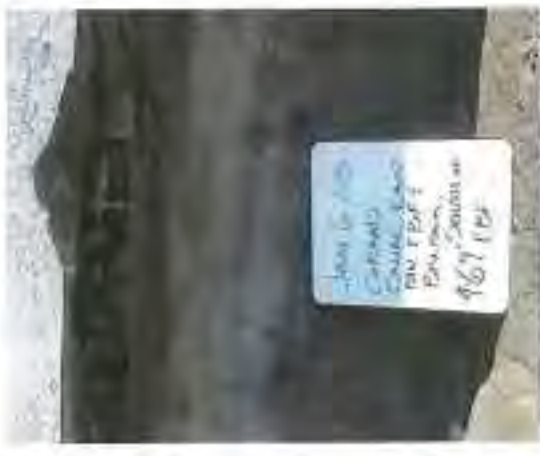
469 feet South of East Bay Front

35 437'-444' South of East Bay Front	Waterside, bottom of cap spalled and cracked
36 437'-510' South of East Bay Front	Landside, crack at lower step, longitudinal 876" long x 1/32" wide
37 469' South of East Bay Front	Waterside, bottom of cap spalled and reinforcing cage exposed
38 472' South of East Bay Front	Waterside, shotcrete pile covering face and sides cracked 60" long x 1/32" - 1/4" wide
39 479' South of East Bay Front	Waterside, bottom of cap spalled 96" long
40 496' South of East Bay Front	Waterside, shotcrete pile covering at bottom spalled north side, 2 square feet
41 519'-527' South of East Bay Front	Landside, crack at lower step, longitudinal 96" long x 1/32" wide
42 537' South of East Bay Front	Construction joint, waterside and landside sealant cracked and split
43 540'-550' South of East Bay Front	Landside, crack at lower step, longitudinal 120" long x 1/32" wide
44 543' South of East Bay Front	Waterside, shotcrete pile covering at mudline, spalled off

ACTIVITY		CASH & ASSOCIATES Engineering and Architecture		
Balboa Island Bulkhead Inspection				
STREET LOCATION				
Grand Canal East				
Between Balboa Ave and East Bay Front				
		INSPECTOR:	CTM	INSPECTION DATE: Jan 6, 2005
		ASSISTANT:		REVISION:
37	469' South of East Bay Front, spall repair	10	SF	\$700
38	472' South of East Bay Front, shotcrete pile repair	6	SF	\$420
39	479' South of East Bay Front, spall repair	8	SF	\$560
40	496' South of East Bay Front, shotcrete pile repair	6	SF	\$420
41	519'-527' South of East Bay Front, crack injection	8	LF	\$560
42	537' South of East Bay Front, sealant repair	6	LF	\$25.00
43	540'-550' South of East Bay Front, crack injection	10	LF	\$700
44	543' South of East Bay Front, shotcrete pile repair	6	SF	\$420
45	555' South of East Bay Front, shotcrete pile repair	6	SF	\$420
46	555' South of East Bay Front, crack injection	6	LF	\$420
47	579' South of East Bay Front, shotcrete pile repair	6	SF	\$420

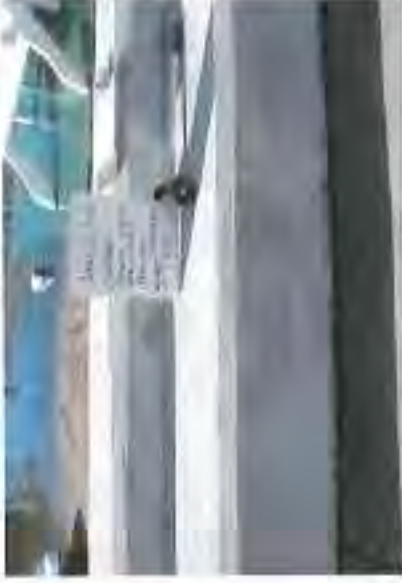
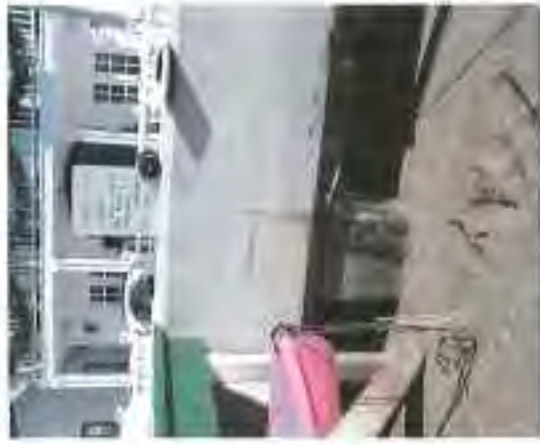
555 feet South of East Bay Front

45 555' South of East Bay Front	Waterside, shotcrete pile covering cracked at face and vertical through cap
46 555' South of East Bay Front	Landside, crack through cap
47 579' South of East Bay Front	Waterside, shotcrete pile covering cracked 60" long x 1/32" wide
48 584' South of East Bay Front	Centerline of Balboa Avenue

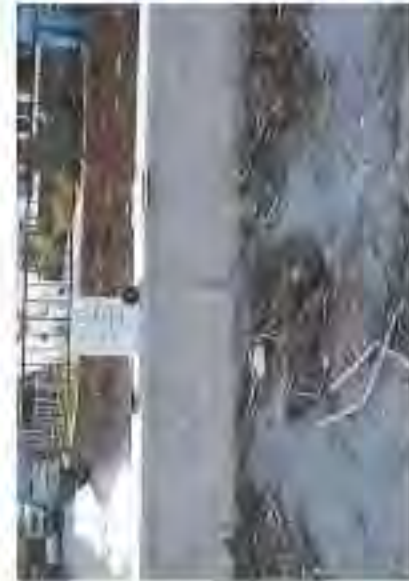
34 feet North of Balboa Avenue

Item	Location	Description
1	6' North of Balboa Avenue	Landside, crack at lower step 36" long
2	34' North of Balboa Avenue	Waterside, crack at bottom of cap 30" long
3	40' North of Balboa Avenue	Waterside, crack at bottom of cap 30" long
4	65' North of Balboa Avenue	Waterside, crack at bottom of cap 24" long
5	89' North of Balboa Avenue	Waterside, spall at bottom of cap 48" long x 12" high x 2" deep
6	95' North of Balboa Avenue	Waterside, crack at bottom of cap 72" long under pier decking
7	113' North of Balboa Avenue	Waterside, crack at bottom of cap 96" long
8	117' North of Balboa Avenue	Construction joint, sealant landside and waterside cracked and split
9	122' North of Balboa Avenue	Waterside, crack at bottom of cap 84" long
10	145' North of Balboa Avenue	Pullbox, transverse crack through box
11	153' North of Balboa Avenue	Waterside, crack at bottom of cap 60" long
12	173' North of Balboa Avenue	Waterside, crack at bottom of cap 264" long

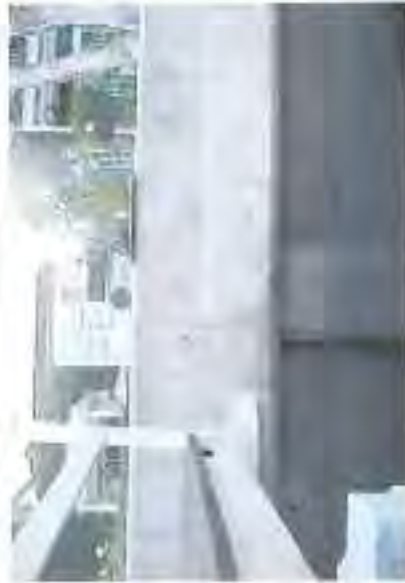
644 feet North of Balboa Avenue

44 644' North of Balboa Avenue	Waterside, crack at bottom of cap 24" long	
45 668' North of Balboa Avenue	Construction joint, sealant landside and waterside cracked and split	
46 676' North of Balboa Avenue	Waterside, crack at bottom of cap above pile, 48" long	
47 691' North of Balboa Avenue	Waterside, crack at bottom of cap 120" long with rust	
48 703' North of Balboa Avenue	Waterside, crack and spill at bottom of cap, 46" long x 3" high x 2" deep rust present	
49 714' North of Balboa Avenue	Waterside, crack/spill at bottom of cap 48" long x 7" high x 2" deep (1/8" wide)	
50 725' North of Balboa Avenue	Waterside, crack/spill at bottom of cap 132" long x 6" high x 2" deep (1/16" wide) previous repair	
51 737' North of Balboa Avenue	Beginning of shotcrete bottom of wall and bottom of piles exposed.	
52 746' North of Balboa Avenue	Waterside, pile spill at mudline	
53 761' North of Balboa Avenue	Waterside, pile spill at mudline

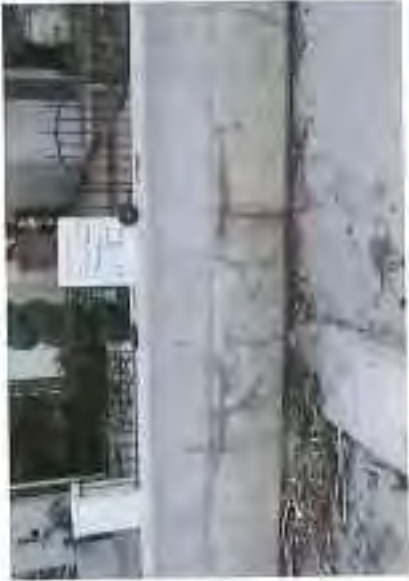
109 feet North of Park Avenue

12	120' North of Park Avenue	Waterside, crack at bottom of cap 84" long
13	109' North of Park Avenue	Waterside, vertical crack at corner 16" high
14	125' North of Park Avenue	Landside, vertical crack at drain lower step
15	138' North of Park Avenue	Waterside, crack at bottom of cap 48" long
16	138' North of Park Avenue	Waterside, mooring anchor insert, rusted
17	159' North of Park Avenue	Waterside, crack at bottom of cap 48" long
18	183' North of Park Avenue	Construction joint, sealant waterside and landside cracked and split
19	249' North of Park Avenue	Lightpole, waterside two transverse vertical cracks at either side of pole
20	249' North of Park Avenue	Lightpole, waterside one transverse vertical cracks at north side of pole
21	252' North of Park Avenue	Landside, hole in cap 2" wide x 1" high x 14" deep
22	299' North of Park Avenue	Construction joint, sealant waterside and landside cracked and split

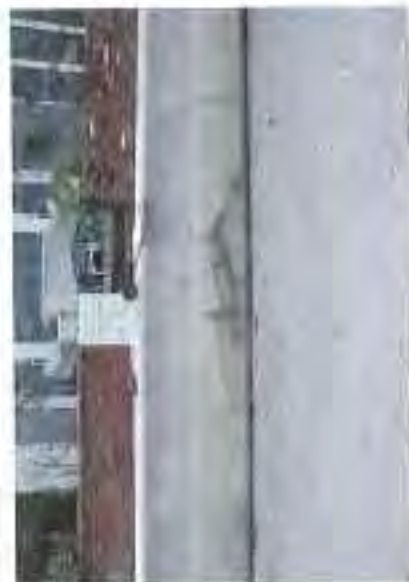
364 feet North of Park Avenue

23	364' North of Park Avenue	Waterside, crack at bottom of cap 60" long site of previous repair.
24	383' North of Park Avenue	Waterside, crack at bottom of cap 60" long site of previous repair.
25	405' North of Park Avenue	Pullbox, transverse crack through top of cap across pullbox
26	416' North of Park Avenue	Construction joint, sealant waterside and landside cracked and split
27	427' North of Park Avenue	Waterside, crack at bottom of cap 216" long
28	440' North of Park Avenue	Waterside, crack at bottom of cap above pile 48" long x 7" high x 2" wide
29	440' North of Park Avenue	Landside, crack at bottom of step 48" long
30	443' North of Park Avenue	Landside, top of cap transverse crack through cap
31	450'-488' North of Park Avenue	Waterside, crack at bottom of cap 456" long
32	473' North of Park Avenue	Landside, lower step cracked 18" long x 2" high x 6" wide
33	468' North of Park Avenue	Landside, lower step cracked 16" long x 2" high x 6" wide

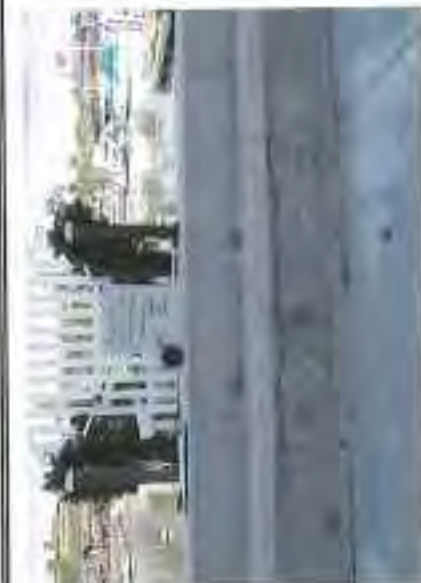
492 feet North of Park Avenue

34	492' North of Park Avenue	Landside, lower step spalled 60" long x 2" high x 6" wide

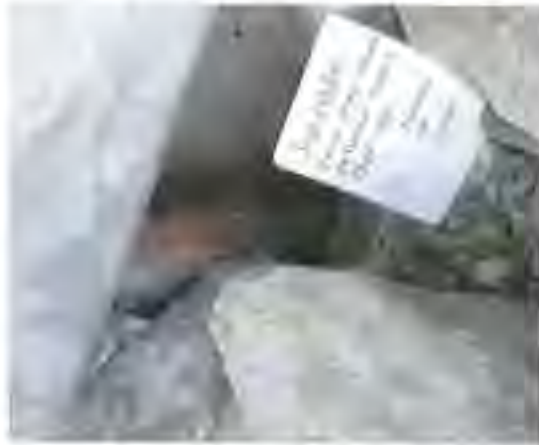
0 feet North of South Bay Front

1	0' North of South Bay Front	Waterside, pile cracked vertically, rust present
2	1' North of South Bay Front	Landside, cracking on lower inside step of cap 24" long
3	4' North of South Bay Front	Landside, crack through top of cap 12" long x 12" high x 1/32" wide
4	6' North of South Bay Front	Landside, crack through top of cap 12" long x 12" high x 1/32" wide
5	8' North of South Bay Front	Landside, lower corner of step damaged
6	8' North of South Bay Front	Landside, spall 24" long x 15" high rebar rust present
7	8' North of South Bay Front	Landside & waterside, cracking through cap
8	8' North of South Bay Front	Waterside, crack at bottom of cap
9	8' North of South Bay Front	Waterside, crack 12" long x 2" high x 10" wide
10	13' North of South Bay Front	Crack through top of cap
11	16' North of South Bay Front	Crack through top of cap
12	18' North of South Bay Front	Crack through top of cap
13	21' North of South Bay Front	Construction joint, sealant in good condition both sides

Item	Description	QUANTITY		MATERIAL COST		LABOR COST		ENGINEERING ESTIMATE	
		Number	Unit	Unit Cost	Total	Unit Cost	Total	Unit Cost	Total
1	0' North of South Bay Front, crack injection	2	LF					\$70.00	\$140
2	1' North of South Bay Front, crack injection	2	LF					\$70.00	\$140
3	4' North of South Bay Front, crack injection	3	LF					\$70.00	\$210
4	6' North of South Bay Front, crack injection	3	LF					\$70.00	\$210
5	8' North of South Bay Front, crack injection	1	LF					\$70.00	\$70
6	8' North of South Bay Front, crack injection	2	LF					\$70.00	\$140
7	8' North of South Bay Front, crack injection	3	LF					\$70.00	\$210
8	8' North of South Bay Front, crack injection	4	LF					\$70.00	\$280
9	8' North of South Bay Front, crack injection	1	LF					\$70.00	\$70
10	13' North of South Bay Front, crack injection	3	LF					\$70.00	\$210
11	16' North of South Bay Front, crack injection	3	LF					\$70.00	\$210
12	18' North of South Bay Front, crack injection	3	LF					\$70.00	\$210

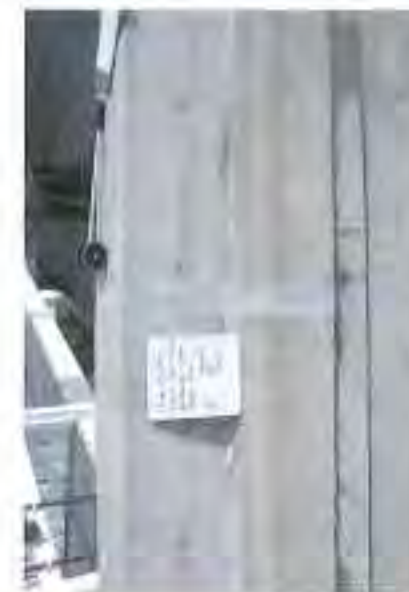
21 feet North of South Bay Front

14	21' North of South Bay Front	Waterside, crack on south side of construction joint 24" long
15	21' North of South Bay Front	Landside, crack at inside corner of step 30" long
16	45' North of South Bay Front	Waterside, crack at bottom of cap over pile 24" long
17	56' North of South Bay Front	Waterside, crack at bottom of cap over pile, rust present 12" long
18	67' North of South Bay Front	Waterside, crack at bottom of cap 36" long previous repair cracked and potential for movement
19	80' North of South Bay Front	Construction joint, sealant landside and waterside cracked and split
20	80' North of South Bay Front	Waterside, crack at south side of construction joint, 36"
21	80' North of South Bay Front	Landside, ponding of water at sidewalk
22	80' North of South Bay Front	Landside, crack at inside corner of step 120" long south of const. joint (CJ), 252" long north of CJ
23	90' North of South Bay Front	Waterside, crack at bottom of cap over pile 54" long

14	21' North of South Bay Front, crack injection	2	LF					\$70.00	\$140
15	21' North of South Bay Front, crack injection	3	LF					\$70.00	\$210
16	45' North of South Bay Front, crack injection	2	LF					\$70.00	\$140
17	56' North of South Bay Front, crack injection	1	LF					\$70.00	\$70
18	67' North of South Bay Front, crack injection	3	LF					\$70.00	\$210
19	80' North of South Bay Front, crack injection	6	LF					\$25.00	\$150
20	80' North of South Bay Front, crack injection	3	LF					\$70.00	\$210
22	80' North of South Bay Front, crack injection	31	LF					\$70.00	\$2,170
23	90' North of South Bay Front, crack injection	5	LF					\$70.00	\$350
24	102' North of South Bay Front, crack injection	4	LF					\$70.00	\$280
25	114' North of South Bay Front, crack injection	7	LF					\$70.00	\$490
26	117' North of South Bay Front, crack injection	20	LF					\$70.00	\$1,400
27	123' North of South Bay Front, crack injection	1	LF					\$70.00	\$70

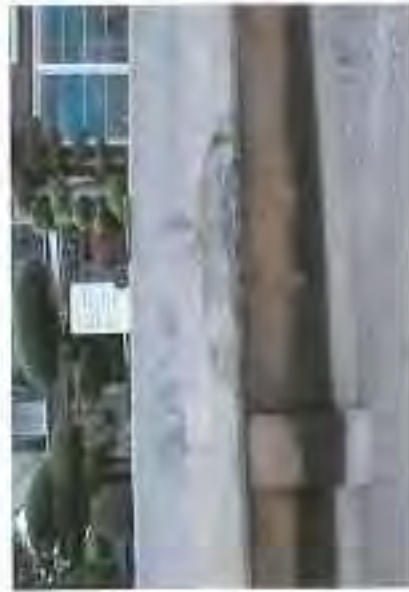
185 feet North of South Bay Front

34	185' North of South Bay Front	Waterside, crack at bottom of cap 72" long rust present from previous repair

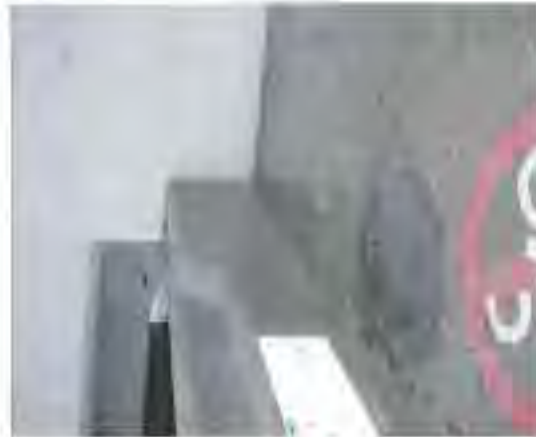
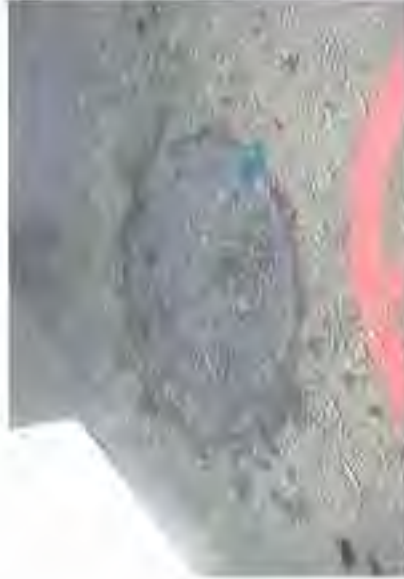
1	Grand Canal West at Park Avenue	Leaking through storm drain manhole cover, "whelling through holes"
2	East Bay Front 73 feet South of Grand Canal East	Leak through wall at base
3	East Bay Front 128 ft South of Grand Canal East	Construction joint leak
4	East Bay Front 245 ft South of Grand Canal East	Construction joint leak
5	East Bay Front 326 ft South of Grand Canal East	Construction joint leak and three feet North
6	East Bay Front 80 ft North of South Bay Front	Construction joint leak
7	East Bay Front 8 feet North of South Bay Front	Corner leak and electrical box leaking
8	South Bay Front 12 ft West of East Bay Front	Leaking at cap
9	South Bay Front 129 ft West of East Bay Front	Construction joint leak
10	South Bay Front 13 ft East of Jade	Piping through sidewalk at cap
11	South Bay Front 6 feet East of Jade	Construction joint leak
12	South Bay Front 93 feet East of Abalone	Construction joint leak

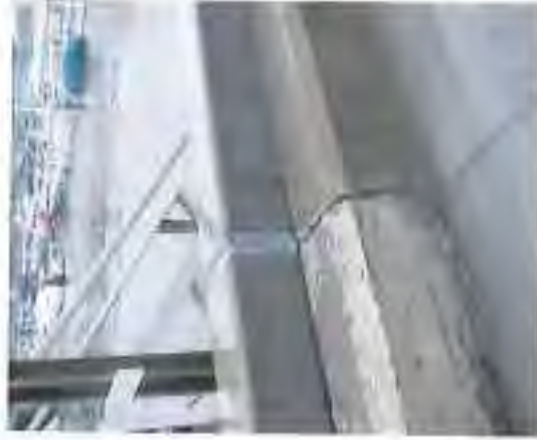
East Bay Front, 245 feet South of Grand

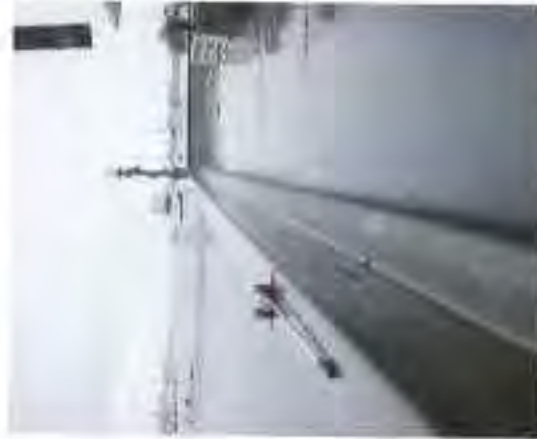
East Bay Front, 80 feet North of South Bay Front

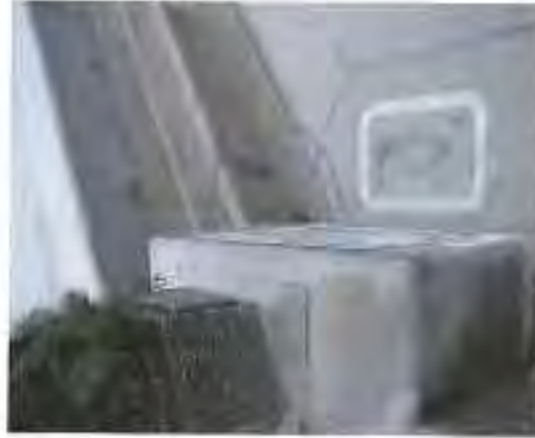
East Bay Front, at South Bay Front

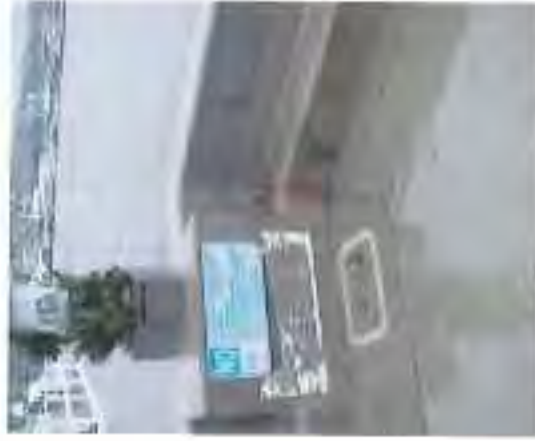
East Bay Front, at South Bay Front

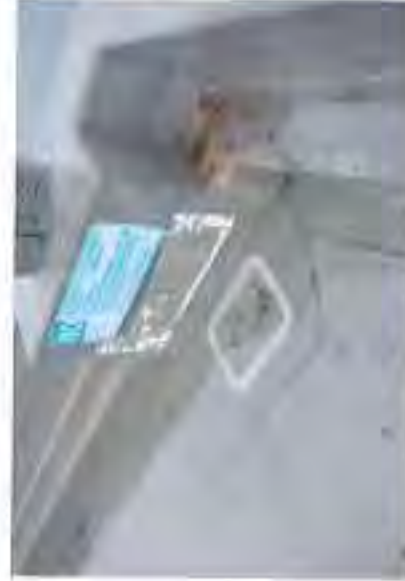
East Bay Front, at South Bay Front

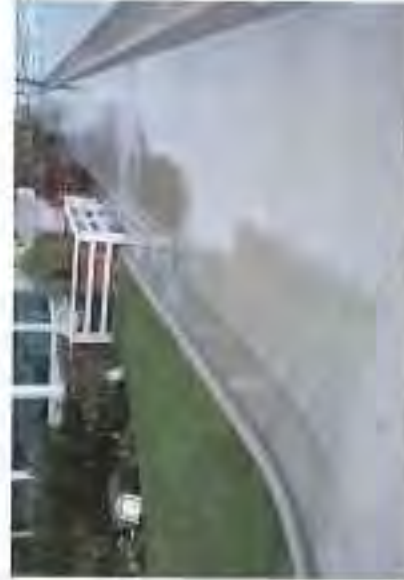
East Bay Front, 20 ft North of South Bay

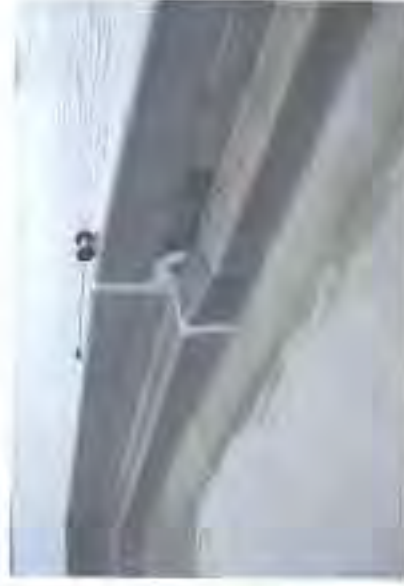
South Bay Front, 12 feet West of East Bay Front

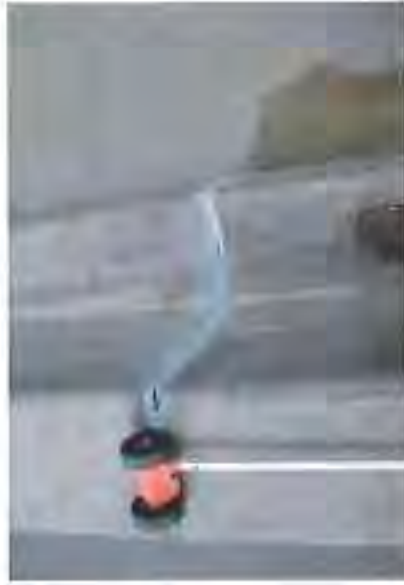
South Bay Front, 129 feet West of East Bay Front

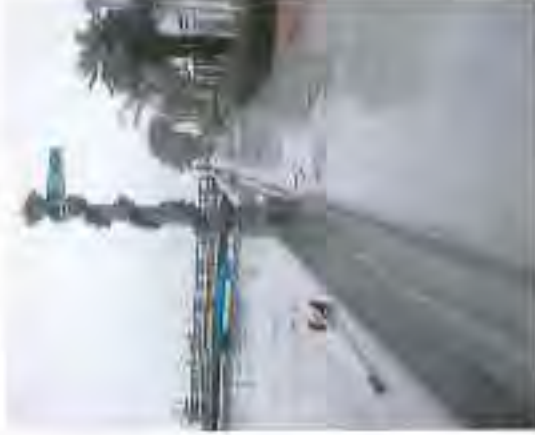
South Bay Front, 13 feet East of Jade

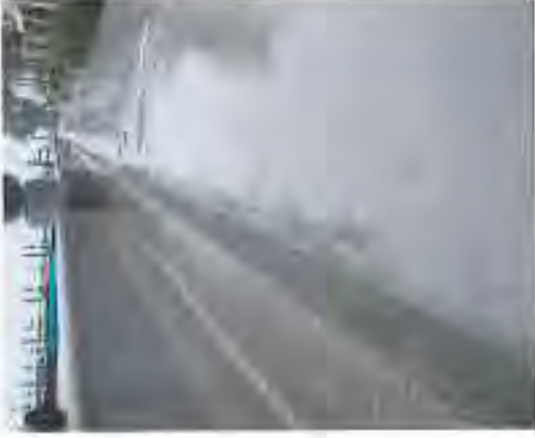
South Bay Front, 13 feet East of Jade

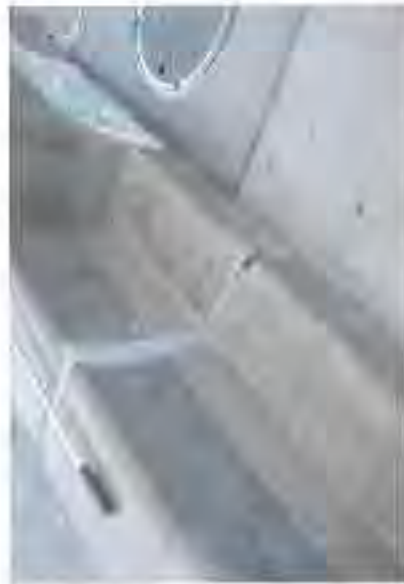
South Bay Front, 6 feet East of Jade

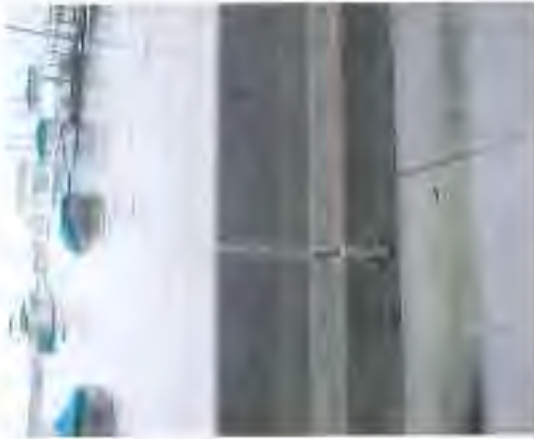
South Bay Front, 93 feet East of Abalone

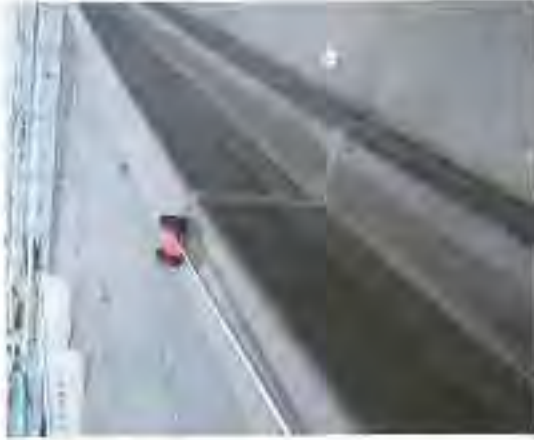
13	South Bay Front 48 feet East of Abalone	Construction joint leak
14	South Bay Front 24 feet West of Apalone	Piping through sidewalk at cap
15	South Bay Front 12 ft West of Grand Canal West	Construction joint leak
16	South Bay Front 130 ft East of Marine	Piping through sidewalk at cap
17	South Bay Front 107 feet West of Onyx	Leaking at cap
18	South Bay Front 31 feet West of Coral	Construction joint leak
19	South Bay Front 45 feet West of Sapphire	Construction joint leak
20	South Bay Front 162 feet West of Sapphire	Construction joint leak
21	South Bay Front 175 feet West of Diamond	Construction joint leak
22	South Bay Front 75 feet West of Ruby	Construction joint leak
23	South Bay Front 16 feet East of Topaz	Construction joint leak
24	South Bay Front 131 feet West of Opal	Construction joint leak
25	South Bay Front 182 feet West of Opal	Lealign through back of sidewalk at "Pilates by the Sea"
26	South Bay Front 93 feet West of Pearl	Construction joint leak and leaking from eletrical box

South Bay Front, 48 feet East of Abalone

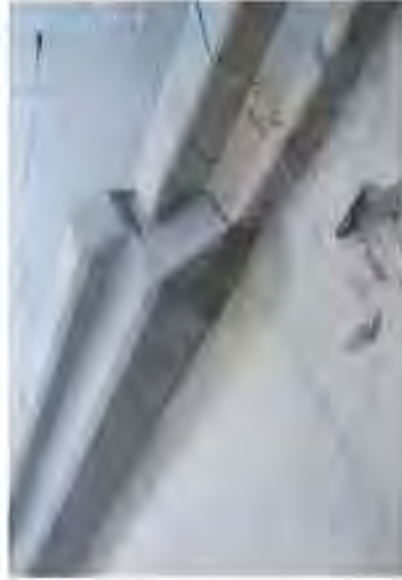
South Bay Front, 130 feet East of Marine

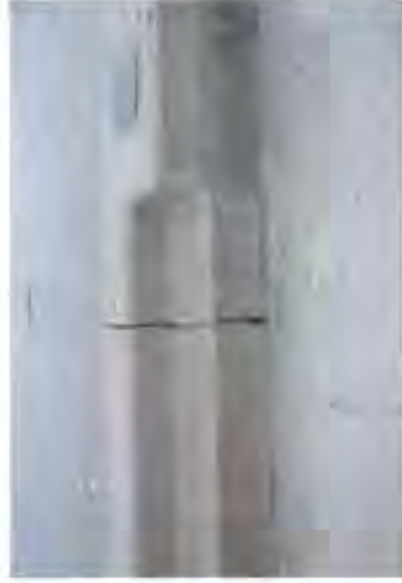
South Bay Front, 107 feet West of Onyx

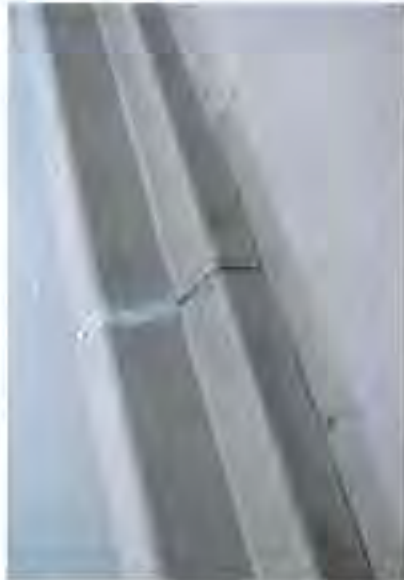
South Bay Front, 31 feet West of Coral

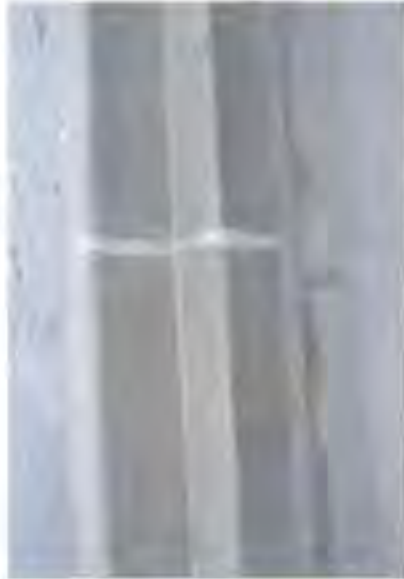
South Bay Front, 45 feet West of Sapphire

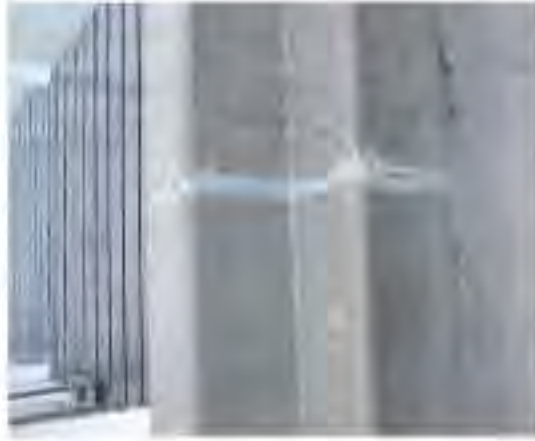
South Bay Front, 162 feet West of Sapphire

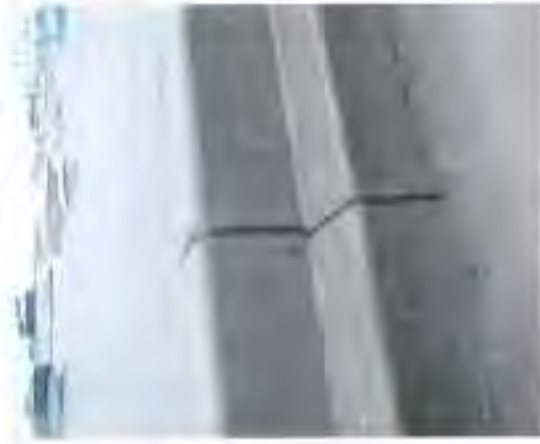
South Bay Front, 175 feet West of Diamond

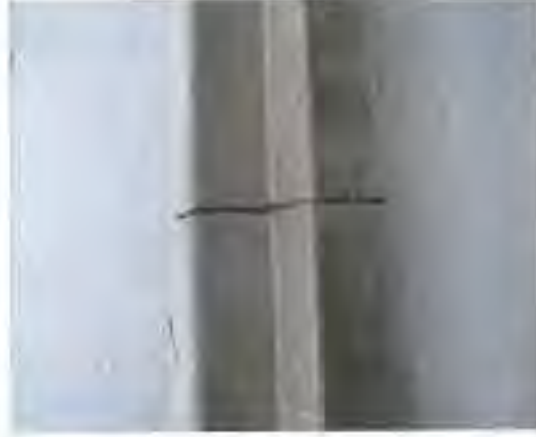
South Bay Front, 75 feet West of Ruby

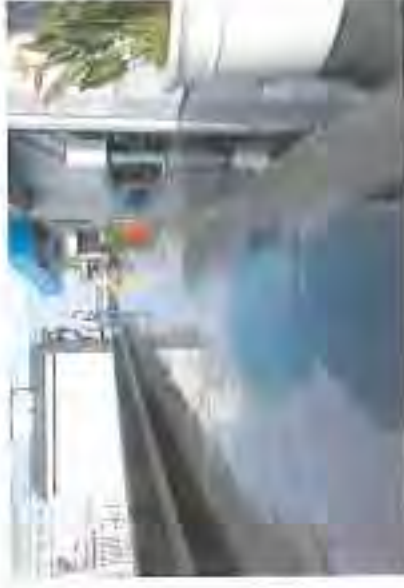
South Bay Front, 131 feet West of Opal

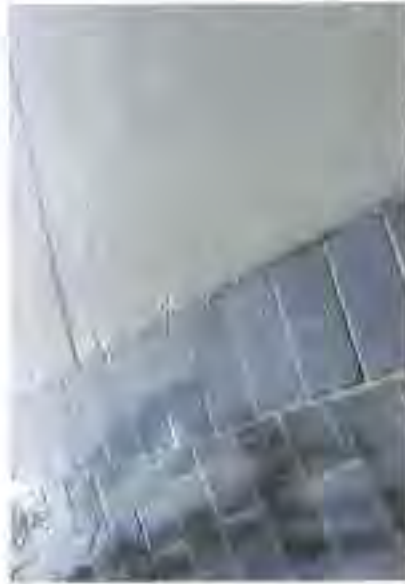
South Bay Front, 131 feet West of Opal

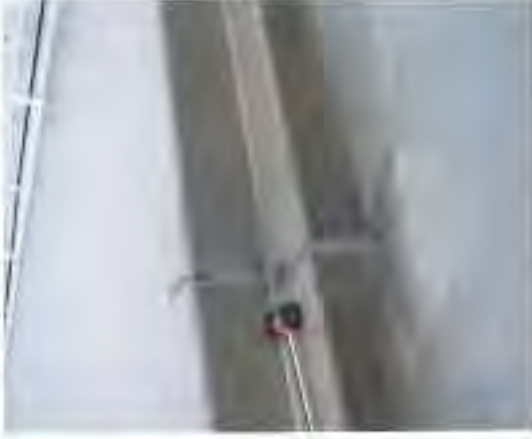
South Bay Front, 93 feet West of Pearl

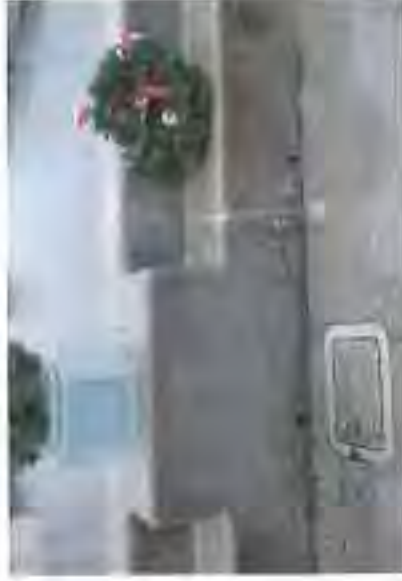
27	South Bay Front 100 feet West of Garnet	Construction joint leaking sediment present
28	South Bay Front 190 feet West of Emerald	Construction joint leaking at bottom
29	South Bay Front 270 feet West of Emerald	Piping through sidewalk at cap
30	South Bay Front 376 feet West of Emerald	Piping through sidewalk at cap
31	South Bay Front 406 feet West of Emerald	Piping through sidewalk at cap
32	South Bay Front 444 feet West of Emerald	Piping through sidewalk at cap
33	South Bay Front 460 feet West of Emerald	Piping through sidewalk at cap
34	South Bay Front 490 feet West of Emerald	Crack leaking at cap
35	North Bay Front Collins Island Bridge abutments	Construction joint leaking + 20 feet east of Park Avenue leaking at construction joint and sidewalk
36	North Bay Front 90 feet East of Park	Lealign on north side of bridge abutments
		Construction joint leaking

South Bay Front, 190 feet West of Emerald

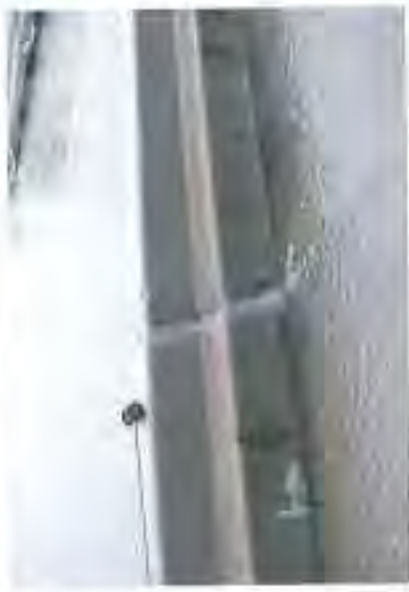
South Bay Front, 376 feet West of Emerald

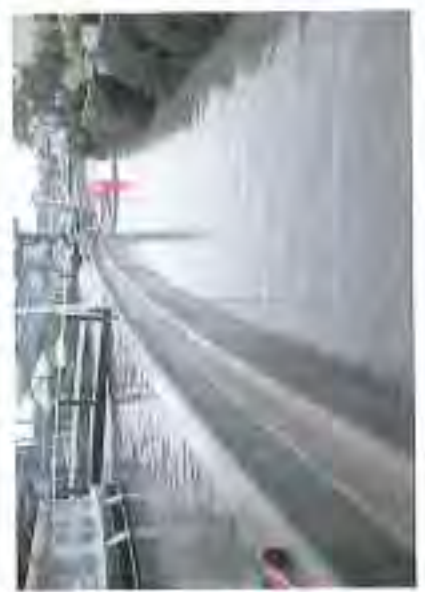
South Bay Front, 450 feet West of Emerald

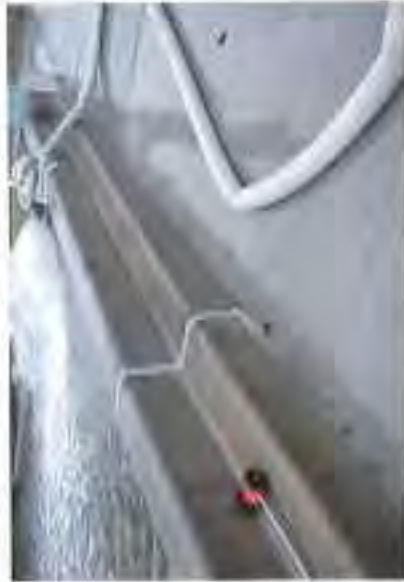
South Bay Front, 460 feet West of Emerald

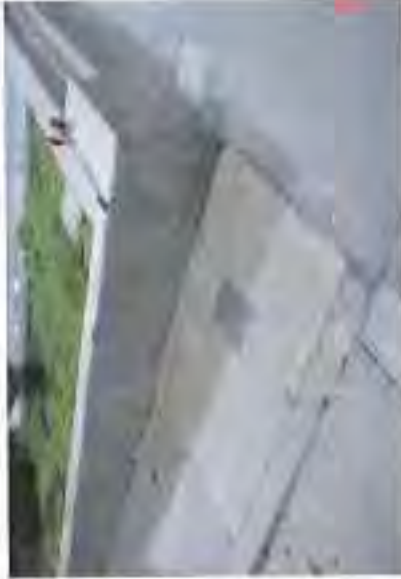
North Bay Front, 8 feet East of Park

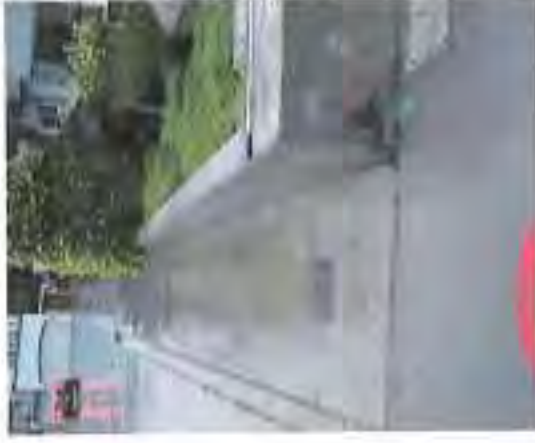
North Bay Front, 8 feet East of Park

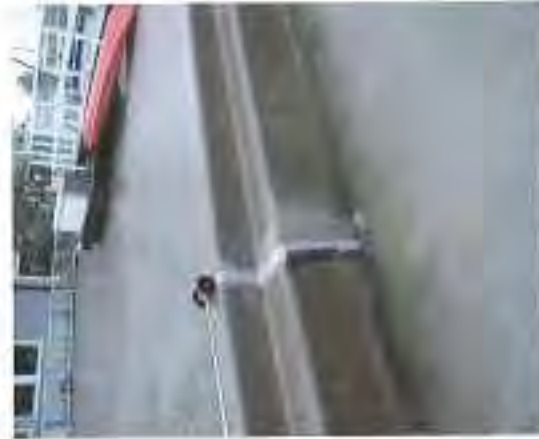
North Bay Front, 90 feet East of Park

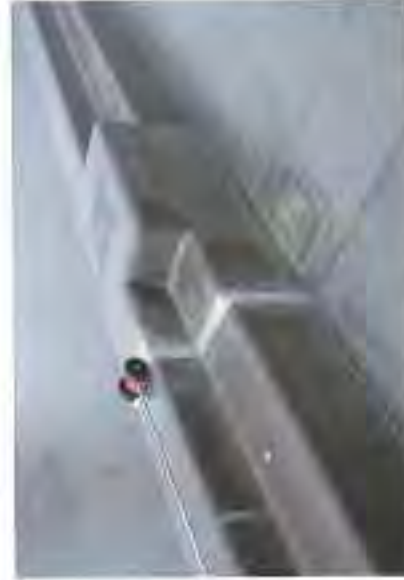
<small>CASH &amp; ASSOCIATES          ENGINEERING &amp; ARCHITECTURE          1741 BAYVIEW BLVD., SUITE 200          BALBOA, CA 94401          (415) 761-2111</small>
<b>STREET LOCATION</b> See Below	<b>INSPECTOR:</b> ASSISTANT:	<b>INSPECTION DATE:</b> January 10, 2005	<b>REVISION:</b>	
37 North Bay Front 209 feet East of Park				
Construction joint at sidewalk leaking

North Bay Front, 209 feet East of Park

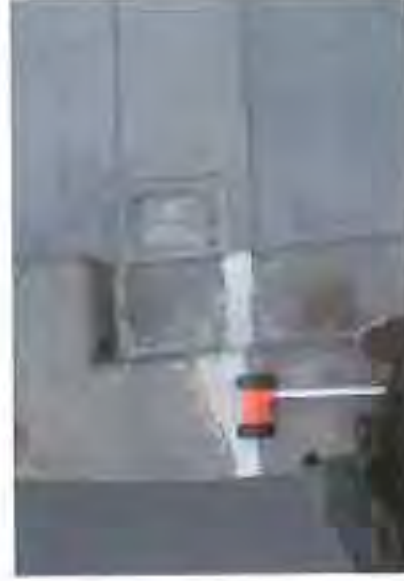
North Bay Front, 209 feet East of Park

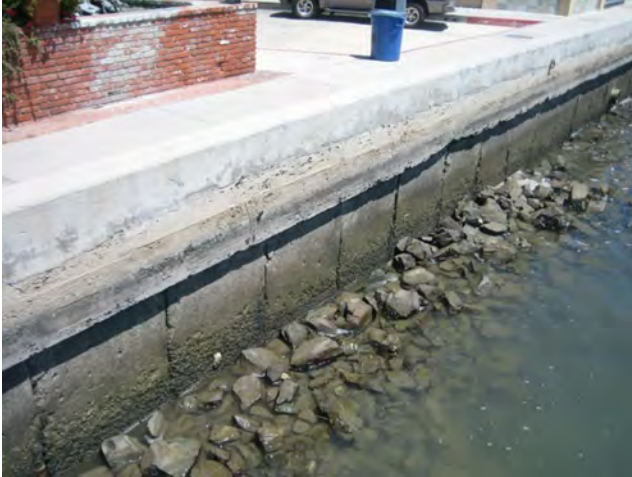
The 1985 Report prompted the City to stabilize the toe of the seawall at four locations around the Island by constructing rock revetments. These locations are at the three corners of Little Balboa and along the aforementioned 500-foot-long section of seawall at the western end of Big Balboa (see Photo 1). Rock revetments were also installed at the two corners of Big Balboa that form the Grand Canal. Observations also noted a separate seawall stabilization project performed along the seawall east of the Balboa Island Ferry Boat Landing. Earth anchors were installed, as shown in Photo 2, and a submerged concrete block revetment was placed at the toe of the seawall.

Photo 1: Rock revetment stabilization at western end of Big Balboa Island

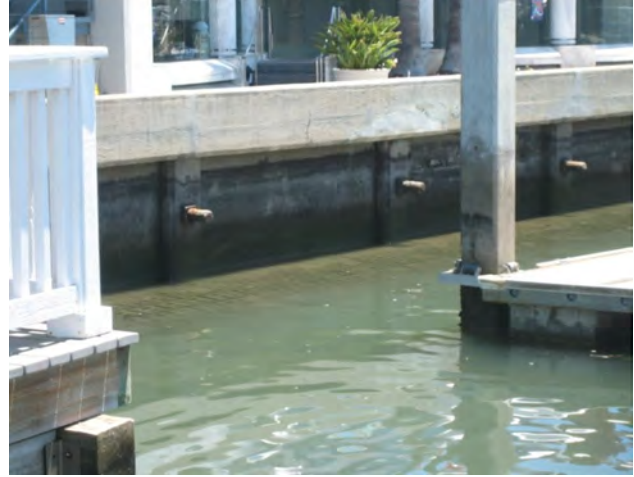
Photo 2: Earth anchors and concrete block revetment (submerged) at Balboa Island Ferry Boat Landing

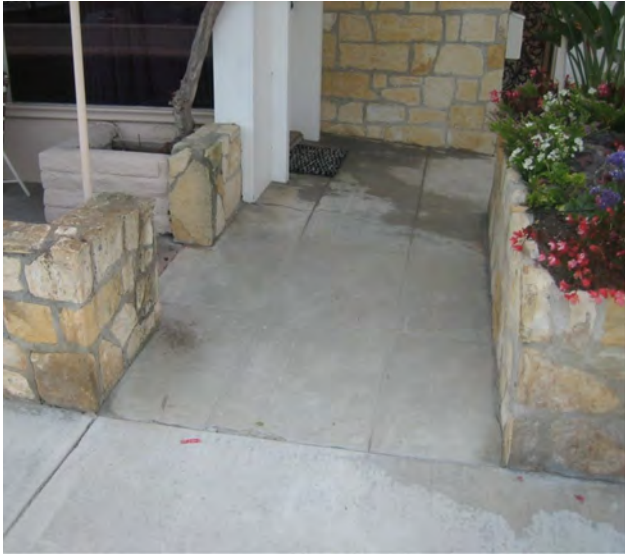
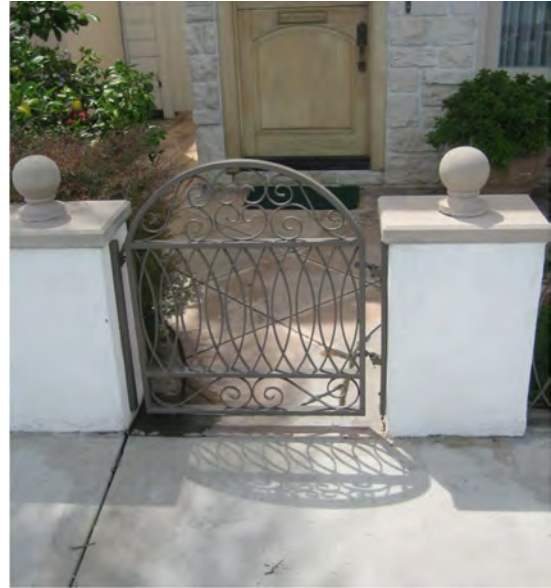
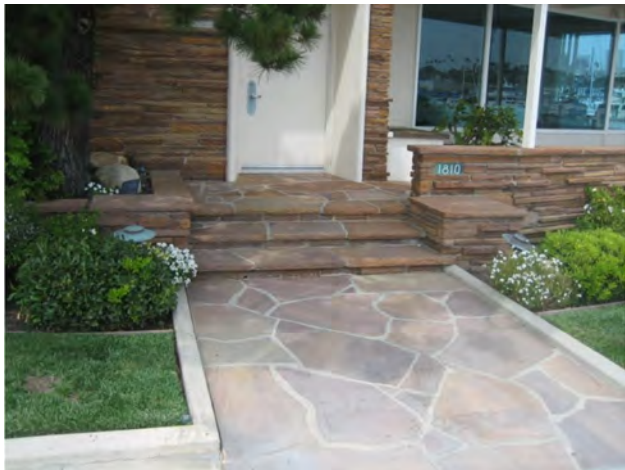
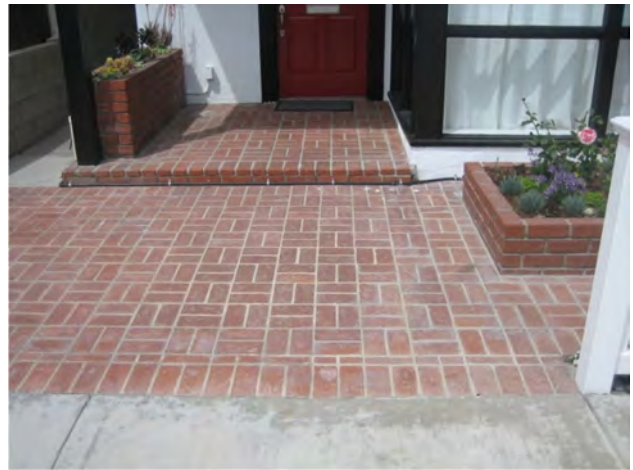
Residential finish floor elevations were also measured for a portion of houses along the Balboa Island boardwalks and along Pearl, Coral, and Crystal avenues. These elevations were taken at the home entry areas. The residential finish floor elevations ranged from 6.1 feet NAVD88, which is below the top of the seawall, to a maximum of 9.8 feet NAVD88, which is above both the top of wall and the current City of Newport Beach building code elevation for Special Flood Hazard Areas. This City requirement is currently set at 9.0 NAVD88 (9.18 feet MLLW NTDE 83-01). A sampling of

residential finish floor elevations can be seen in Photos 5 through 8. Note that some home entry areas are at sidewalk level.

Photo 5: Residential finish floor transition to sidewalk

Photo 6: Residential finish floor transition to sidewalk

Photo 7: Residential finish floor transition to sidewalk

Photo 8: Residential finish floor transition to sidewalk

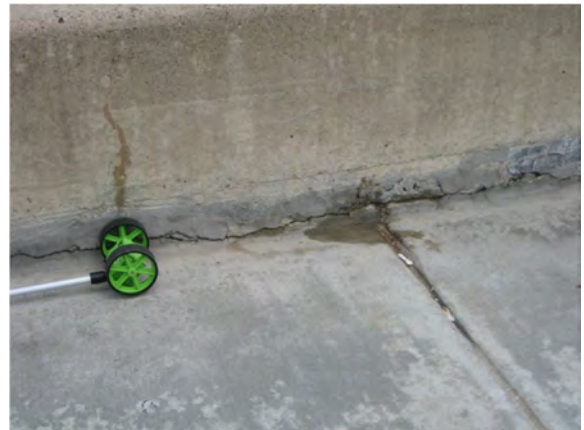
Photo 16: Close-up of Photo 15 (above)

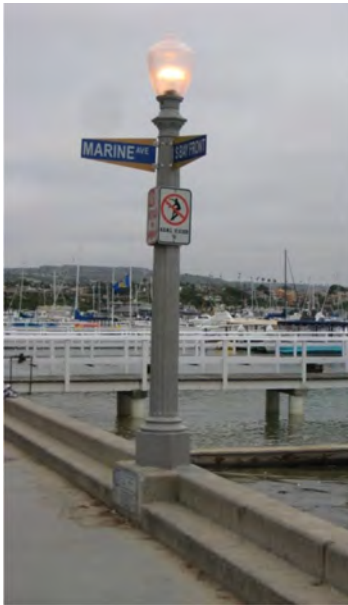
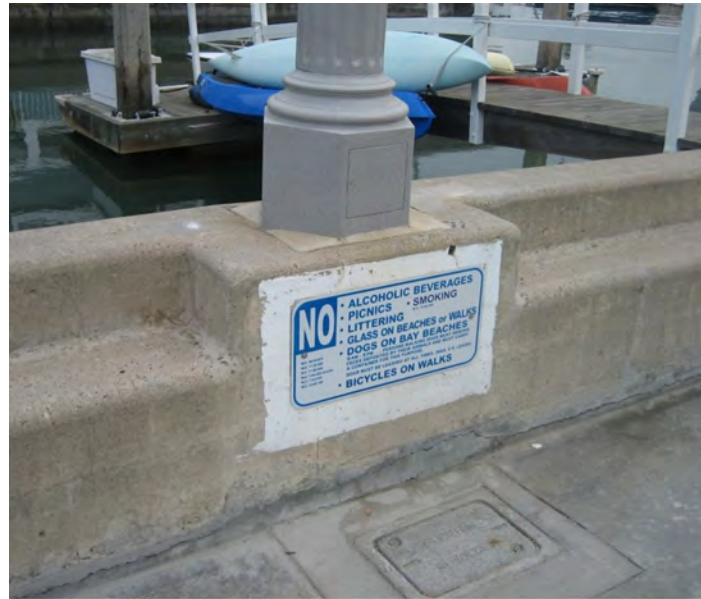
It appears that the wall was designed with lampposts cast into the seawall concrete cap at approximately 100-foot intervals as shown in Photos 17 and 18. At some point in time, every other lamppost was removed from the seawall, leaving only the lampposts at the street ends as well as a few intermittent locations. A junction box exists in the boardwalk adjacent to each lamppost, with a

conduit bending through the cap into the base of said lamppost. Lamppost locations and details would need to be part of any new plans to repair or replace the Balboa Island seawalls.

Photo 17: Lamppost on seawall

Photo 18: Lamppost base and junction box
