<b>ACTIVITY</b> Balboa Island Bulkhead Inspection	<b>CASH &amp; ASSOCIATES</b> Engineering and Architecture

Cash & Associates Engineering and Architecture 1712 Ave. 100 Mission Viejo, CA
<b>STREET LOCATION</b> Grand Canal East Between South Bay Front and Park Ave	INSPECTOR: ASSISTANT:	CTM	INSPECTION DATE: December 21, 2004	REVISION

The City of Newport Beach retained COWI North America (COWI) to perform a Condition Assessment Inspection of the bulkhead wall at the West End of Balboa Island, City of Newport Beach Contract No. 8088-1. The reach of the wall extended from Emerald Avenue at North Bay Front, west and south, then southeast to Emerald Avenue at South Bay Front as indicated by the highlighted area in the figure below.

Figure 1 - Inspection Location and Limits, West End of Balboa Island, Newport Beach, CA

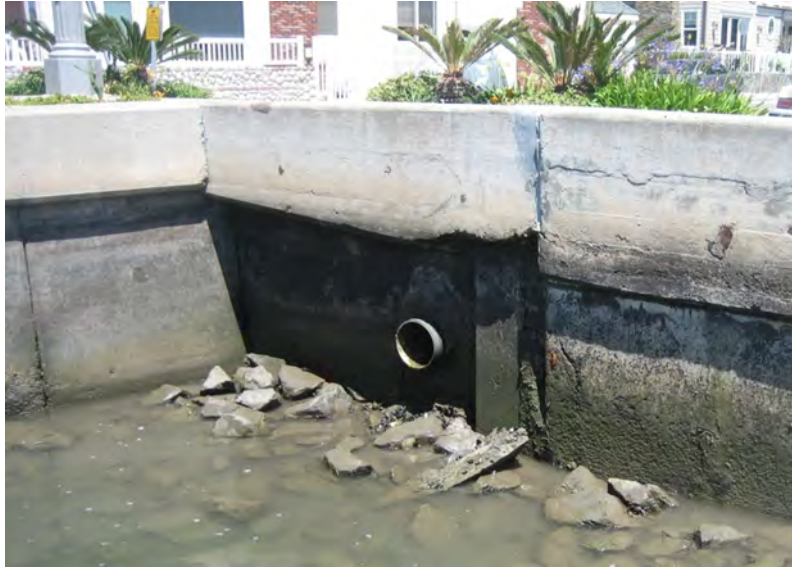
Storm drain outlets that drain through the seawall and into Newport Bay (see Photo 19) have existed for decades at the street ends of Balboa Island, based on the 1935 record drawings and the recent visual survey. In the 1980's as part of the boardwalk reconstruction, a storm water drainage system with 4- to 6-inch diameter drains was constructed landward of and parallel to the seawall. These drains connect to the City's storm drain system outlets at the street ends and were designed to keep water from ponding along the seawall and from spilling onto private property.

Photo 19: Storm drain outlet through seawall

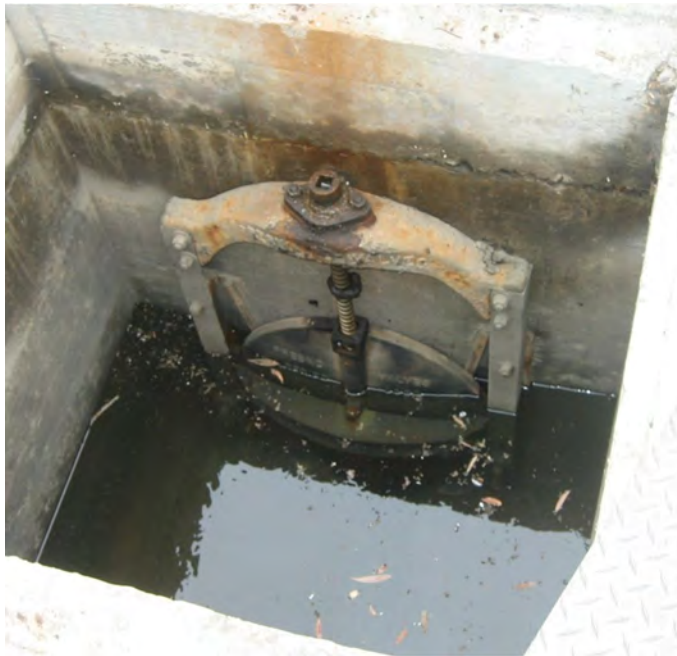
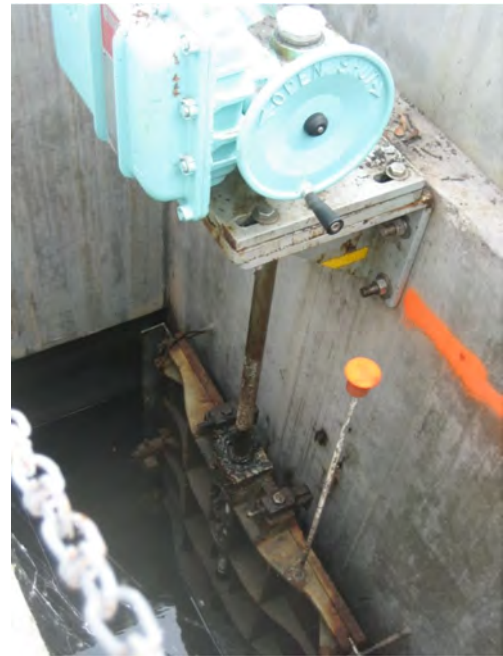
This drainage system would not have functioned without the installation of gate valves at all storm water outlets on Balboa Island, as shown in Photos 20 and 21. These valves are closed during high water events to prevent seawater from flooding low lying spots on the Island. Prior to the valve installation, the storm drain outlets were a major source of flooding during high water events.

Photo 20: Hand-operated gate valve in storm drain manhole

Photo 21: Actuated gate valve in storm drain vault

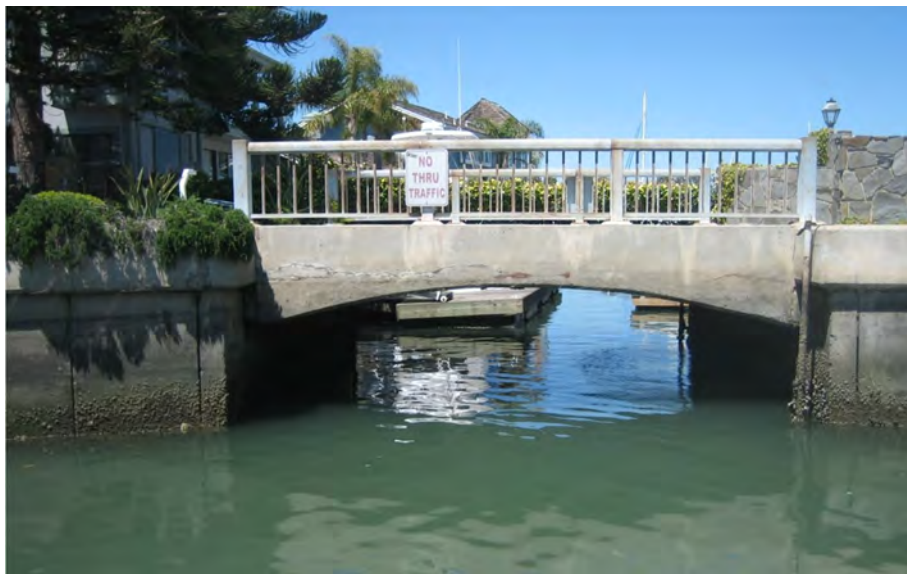
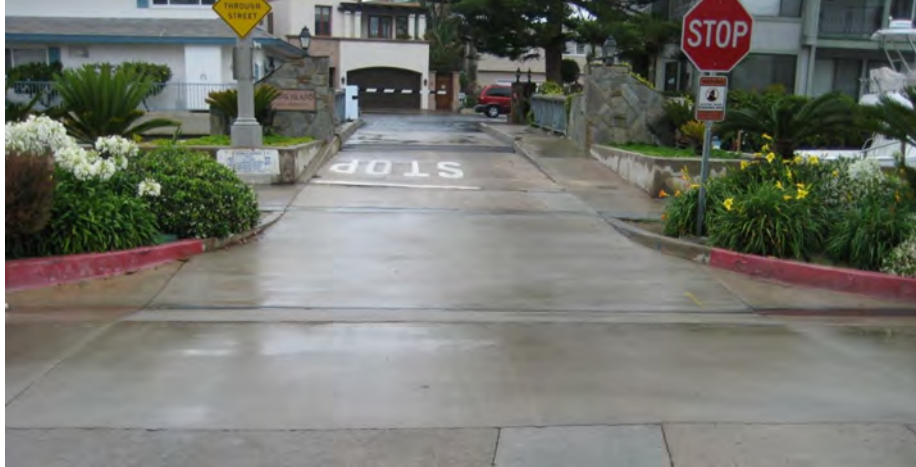
The Collins Island Bridge cuts through the seawall, has an open metal rail wall (as seen in Photo 27) and a peak roadway elevation of 7.3 feet NAVD88. This bridge will require thorough waterproofing as well as solid concrete parapet (side) walls sealed to the seawall to prevent it from becoming a source of flooding. The seawalls on Collins Island will need to be retrofitted or replaced in concert with Balboa Island, to prevent flooding of that island and to prevent seawater from flanking the Balboa Island barriers (see Figure 4). The Collins Island Bridge is shown in Photos 27 and 28.

Photo 27: Collins Island Bridge interface at seawall abutment

Photo 28: Collins Island Bridge as viewed from Big Balboa

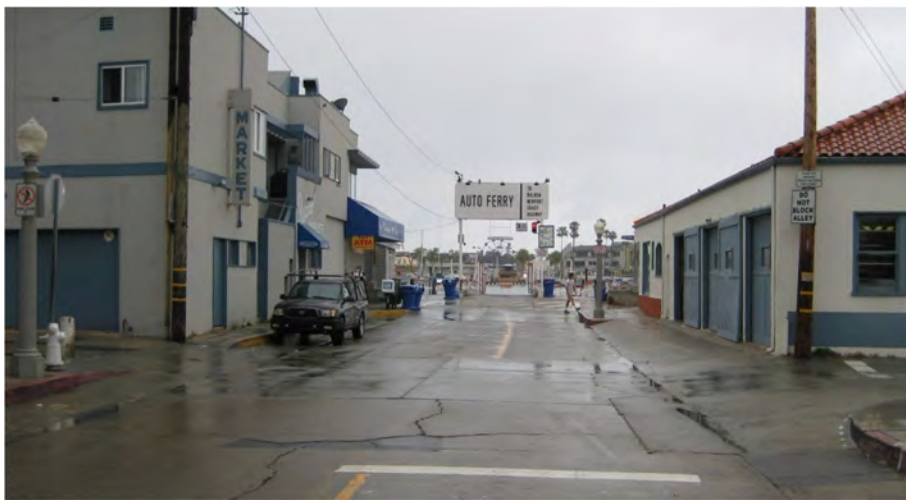
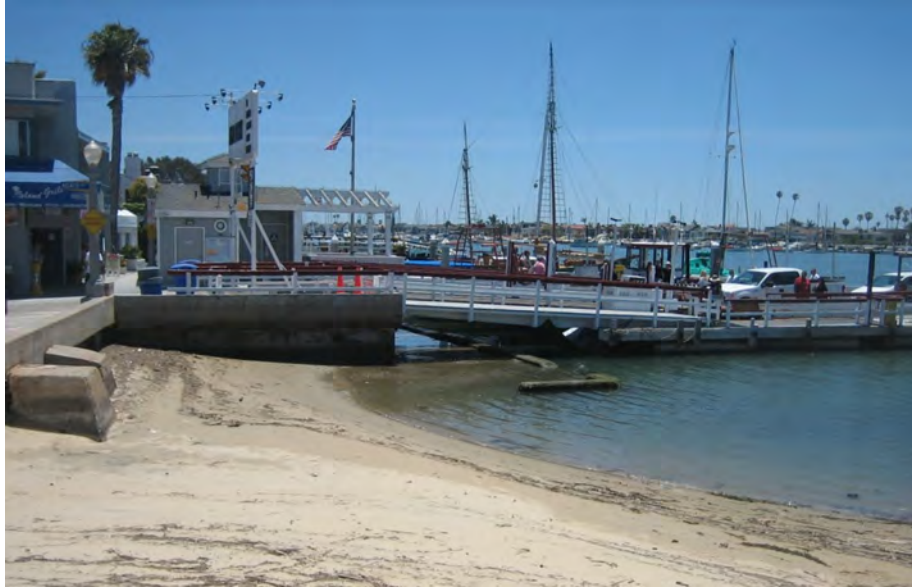
The approach to the Balboa Island Ferry Boat Landing also breaches the seawall, as shown in Photo 29, allowing a path for water to enter the Island. In addition, the Ferry Boat Launch Ramp is particularly low in its current configuration as shown in Photo 30. The approach elevation is 6.6 feet NAVD88 (6.78 feet MLLW NTDE 83-01) at the seawall opening and 7.0 feet NAVD88 (7.18 feet MLLW NTDE 83-01) at the ramp leading to the ferry boat dock. During high water events, the launch ramp must be shut-down until water recedes.

Photo 29: Balboa Island Ferry Boat Landing approach

Photo 30: Balboa Island Ferry Boat Landing as viewed from side

If the dock and launch ramp are left in their basic current location, a major effort would be required to raise the launch ramp and the approach street, Agate Avenue. This would impact adjacent buildings and the intersecting boardwalk as shown on Figure 5. Two options are shown. Option 1 blocks the boardwalk at the intersection with the proposed ferry boat landing approach ramp. Pedestrians have to travel an additional 200 feet around the approach ramp to get from one side of the boardwalk to the other side. Option 1 only allows one-way traffic from the ferry to the intersection of the approach ramp and alleyway. Existing grade-level sidewalk and delivery access are maintained on Agate Avenue.

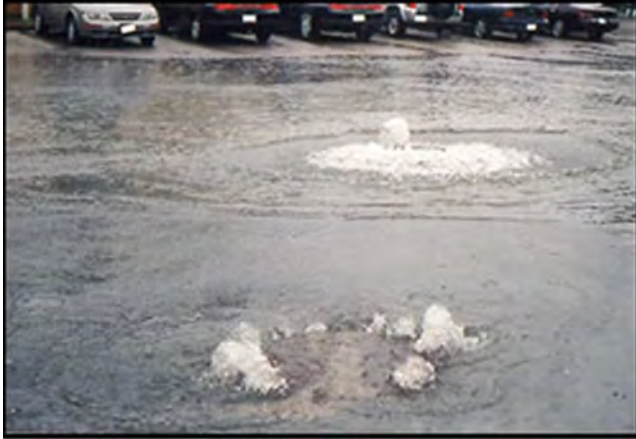
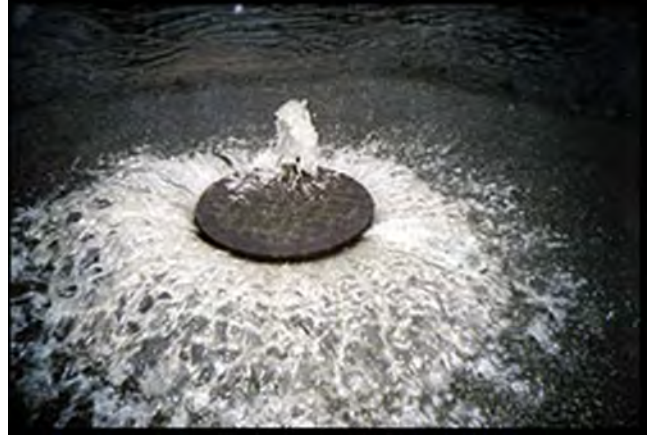
Public utilities may also be damaged during a flood. Sewers and storm drains are the most susceptible utilities. When streets become flooded, water infiltrates the sewer system, which then causes sewage to spill out in an event called a “sanitary sewer overflow” (SSO). People and the environment are thereby exposed to raw sewage. An example of an SSO is shown in Photos 32 and 33. Areas impacted by SSOs, including beaches and harbor waters, would need to be closed to direct human contact for a period of time to prevent disease. Such closures impact daily life and the economy. To prevent damage to both storm drain and sewer systems. During high water events, the City closes the storm drain outlets to Newport Bay to prevent sea water from flowing backwards through the storm water outlets and inundating Balboa Island. City personnel mobilize to pump out water that collects at the storm drain outlet junction structures located at bay-front street ends as seen in Photo 34.

Photo 32: Example of Sanitary Sewer Overflow

Photo 33: Example of Sanitary Sewer Overflow

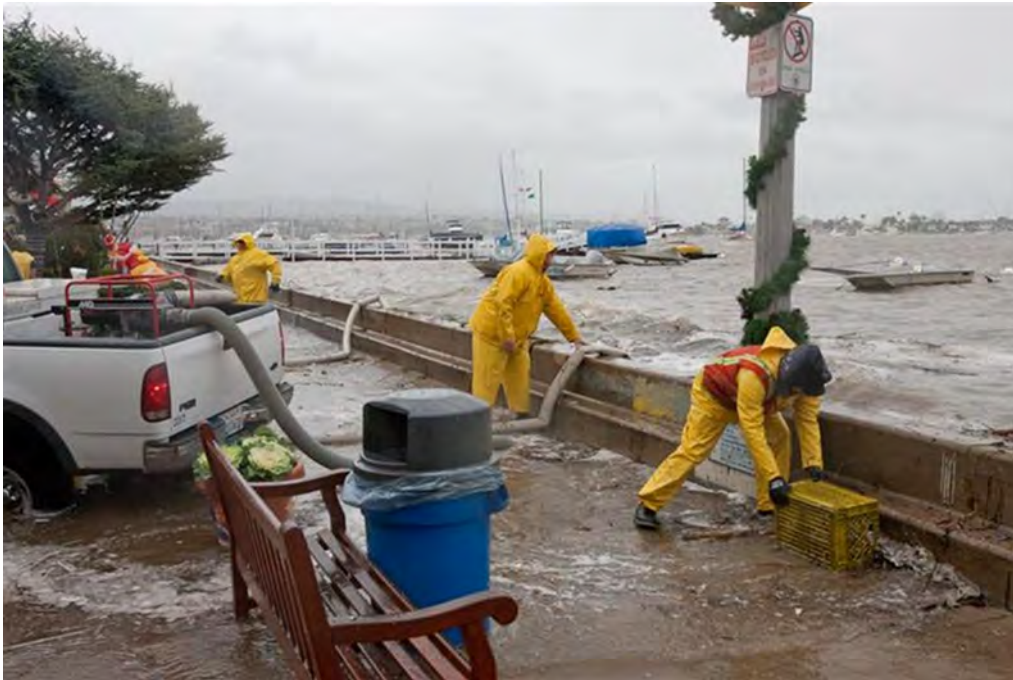
Photo 34: City of Newport Beach Personnel pumping flood water back into the Bay

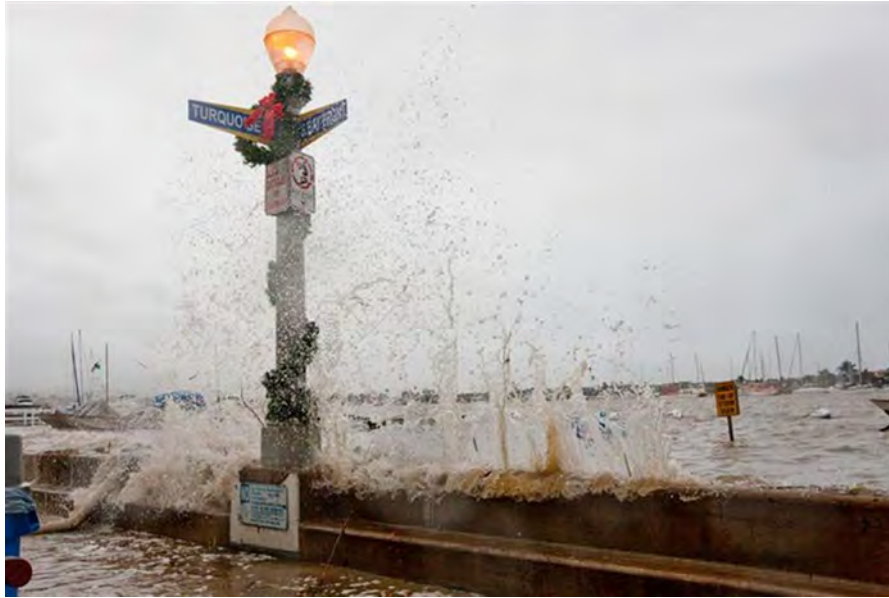
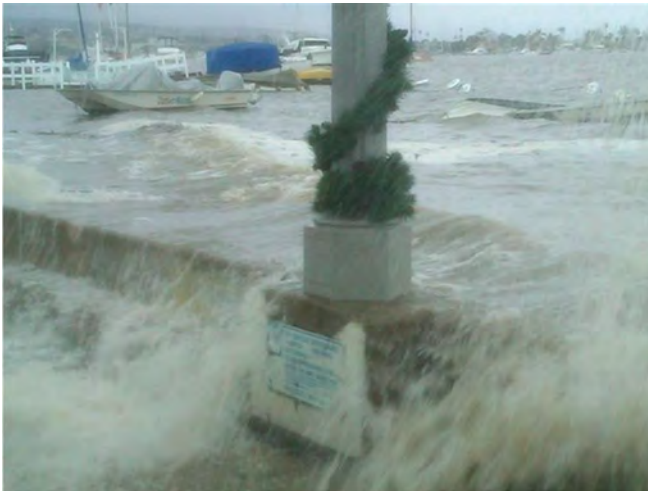
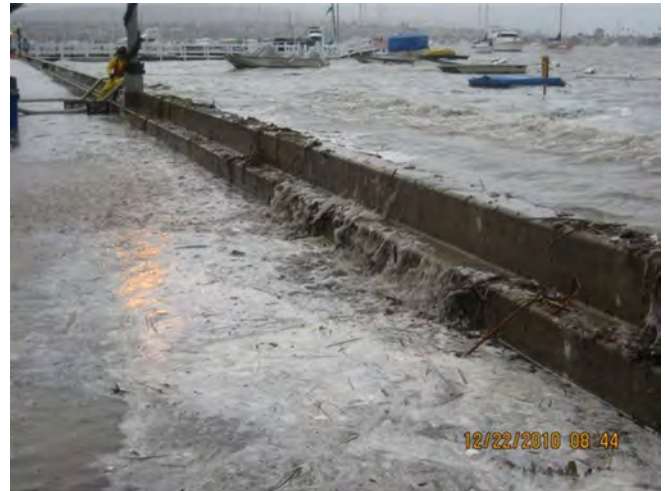
The preceding photograph was taken during a high water event in December 2010. The following are additional photos from this event depicting wave overtopping of the Balboa Island seawall and the resulting damage. As seen in Photos 35 through 37 water poured over the seawall flooding the boardwalk at Turquoise and South Bay Front. Flood waters spilled into adjacent streets as seen in Photo 38. Some businesses were inundated as can be seen in Photo 39. After the tide ebbed and the flood waters drained, the boardwalk was covered with sand and debris as shown in Photo 40, clogging the boardwalk drainage system.

Photo 35: Waves splashing over the Balboa Island seawall at Turquoise and South Bay Front

Photo 36: Seawater pouring over the seawall

Photo 37: Bay waters overtopping the seawall as City personnel struggle to keep pace

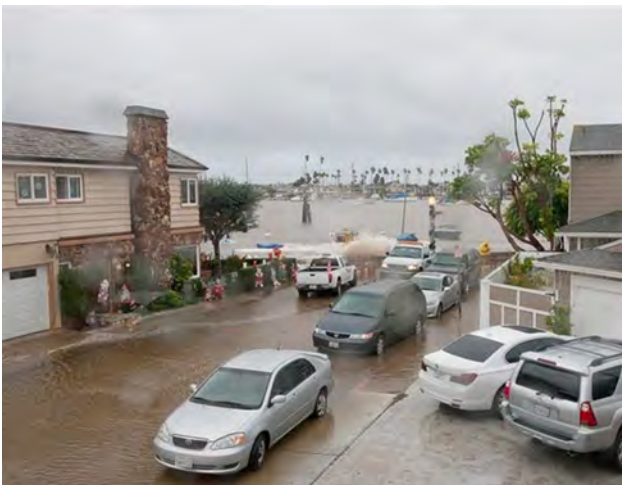
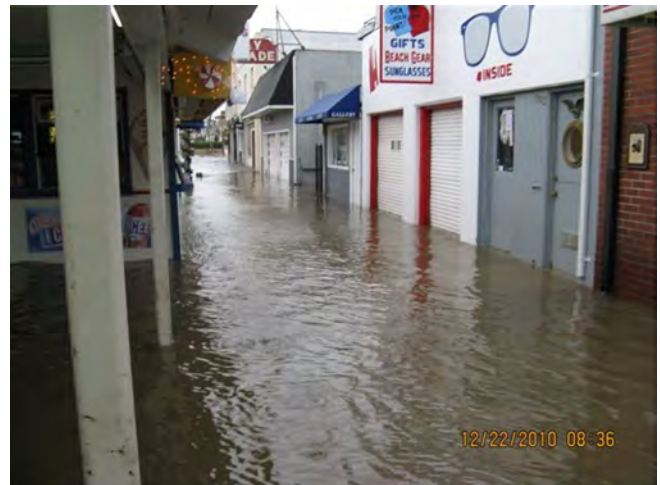
Photo 38: Street Flooding

Photo 39: Flooded Businesses

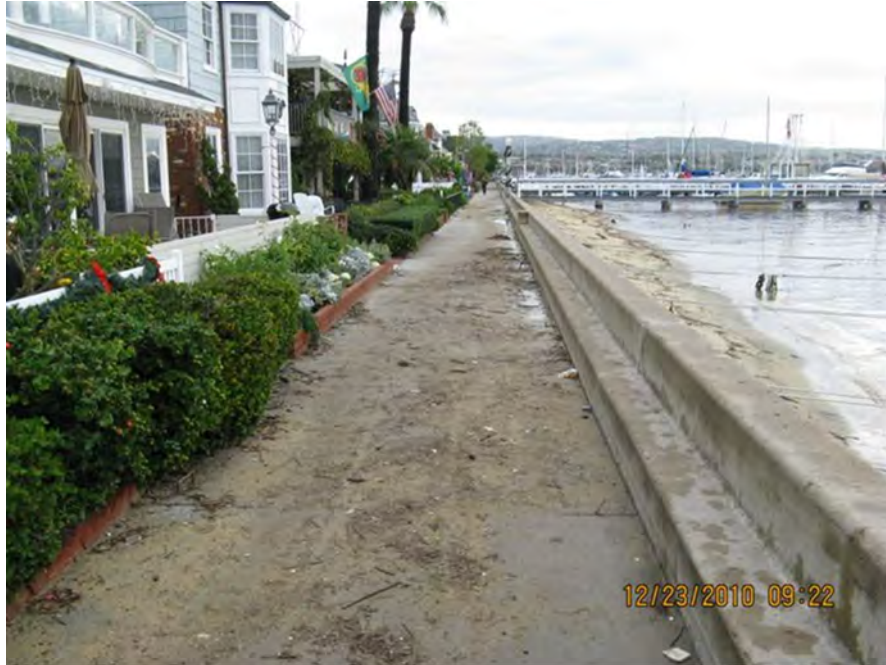
Photo 40: After the tide ebbs, the boardwalk is covered with sand and debris which to be cleaned up

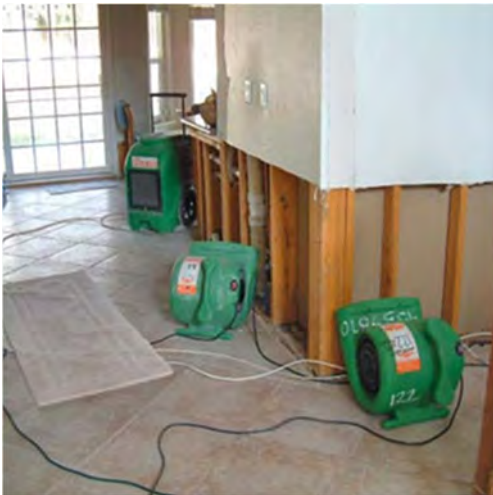
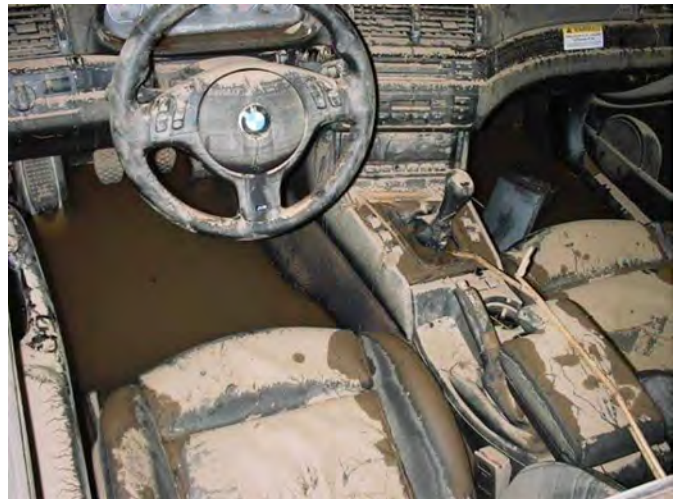
Photo 41 shows the repairs being performed to a flood damaged house. The waterlogged portions of drywall had to be removed. Photo 42 shows the aftermath of a flooded car interior.

Photo 41: Example of flood-damaged home repairs

Photo 42: Example of flood-damaged car interior

Balboa Island requires a short-term plan addressing current over-topping issues as well as a long-term mitigation plan if such damage and cleanup scenarios are to be avoided.

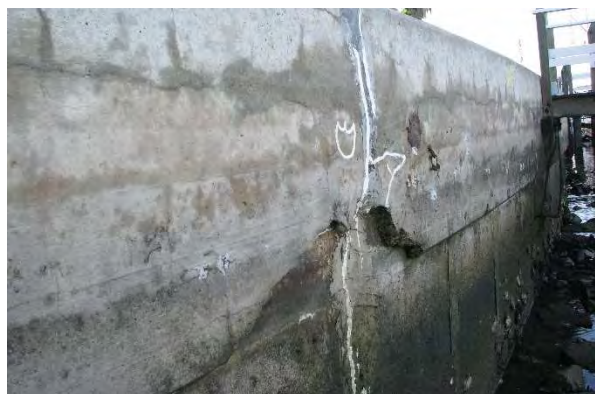
*Photo 5 – Coping spalled, both sides, above precast wall panel joint. Joint previously sealed with cementitious grout and flexible sealant. Station S3+62*

Spall	S3+62	IS	12	1016	Coping Type D	Wall	ATM	Major	48	12		CRACKS AND SPALLS THROUGH WALL
Cracks	S3+90	IS	12	1015	Coping Type D	Wall	ATM	Moderate	48	1/8		CRACK THROUGH COPING
Cracks	S3+94	IS		1029	Sidewalk	Sidewalk	ATM	Moderate				END OF CRACKS IN SIDEWALK GREATER THAN 1/16". CRACKS RUN TO HERE FROM APPROX STA 41+05
Cracks	S4+02	WS	0	42	Coping Type D	Wall	ATM	Minor	48	1/16		MINOR CRACKS AT TOP OF PREVIOUS PATCH
Cracks	S4+08	WS	36	41	Coping Type D	Wall	TZ	Minor	30	1/16		VERTICAL CRACK TO THE BOTTOM OF THE TYPE D COPING. NO RUST STAINS APPARENT. IT ENDS AT THE CONINUOUS HORIZONTAL JOINT WHERE THE TYPE D EXTENSION MEETS THE ORIGINAL CAP/COPING.
Cracks	S4+11	WS	36	40	Coping Type D	Wall	TZ	Minor	24	1/16		VERTICAL CRACK TO THE BOTTOM OF THE TYPE D COPING. NO RUST STAINS APPARENT. IT ENDS AT THE CONINUOUS HORIZONTAL JOINT WHERE THE TYPE D EXTENSION MEETS THE ORIGINAL CAP/COPING.
Cracks	S4+36	IS		1028	Sidewalk	Sidewalk	ATM	Moderate				BEGINNING OF CRACKS IN SIDEWALK GREATER THAN 1/16". CRACKS CONTINUE TO APPROX STA 40+63

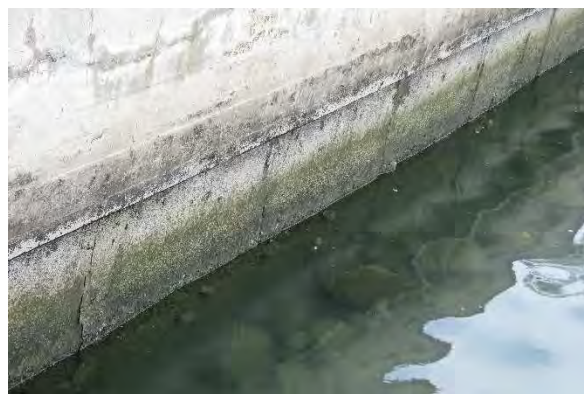
*Photo 6 – Typical cementitious precast panel joint sealing south of Collins Island Bridge*

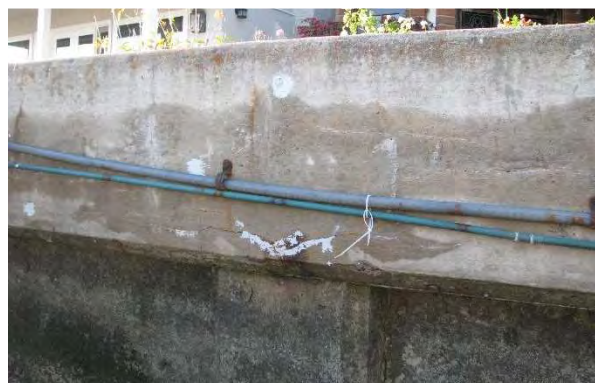
Photo 7 – Minor to Moderate cracking over soldier pile, with partial previous repair. Station N1+54

Cracks	N1+54	WS	19	25	Coping Type B	Wall	TZ	Minor	36	1/16		TYPICAL CRACK WITH NO STAINING IN COPING LOCATED OVER CONCRETE PILE. PREVIOUS REPAIR PRESENT
Cracks	N1+65	WS	12	24	Coping Type B	Wall	TZ	Minor	120	1/8		3 TYPICALLY SHAPED CRACKS WITH MINIMAL RUST STAINING IN COPING LOCATED OVER CONCRETE PILE. PREVIOUS REPAIR PRESENT (Length is approx)
Cracks	N2+00	WS	18	23	Coping Type B	Wall	TZ	Moderate	24	1/8		TYPICAL CRACK WITH SLIGHT RUST STAINING IN COPING LOCATED OVER CONCRETE PILE. PREVIOUS REPAIR PRESENT. EXPANSION JOINT AT STA 01+99
Open Spall	N2+02	WS	23	22	Coping Type B	Wall	TZ	Moderate	12	5	2	SPALL AT CONDUIT EGRESS
Cracks	N2+12	WS	14	21	Coping Type B	Wall	TZ	Moderate	18	1/8		TYPICAL CRACK WITH RUST STAINING IN COPING LOCATED OVER CONCRETE PILE. PREVIOUS REPAIR PRESENT
Cracks	N2+23	IS	12	1007	Coping Type B	Wall	ATM	ND	6	1/32		CRACK PREVIOUSLY REPAIRED
Cracks	N2+35	WS	20	20	Coping Type B	Wall	TZ	Moderate	18	1/8		NOT A TYPICAL CRACK - IT BEGINS AT THE BOTTOM OF THE COPING AND EXTENDS SOUTHWARD AND UPWARD.

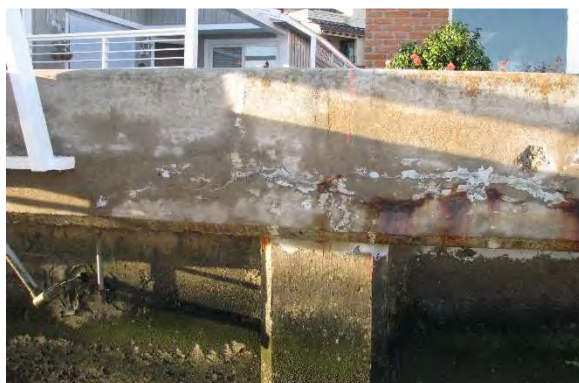
Photo 8 - Major cracking over soldier pile, with rust staining and previous repair. Station N2+70

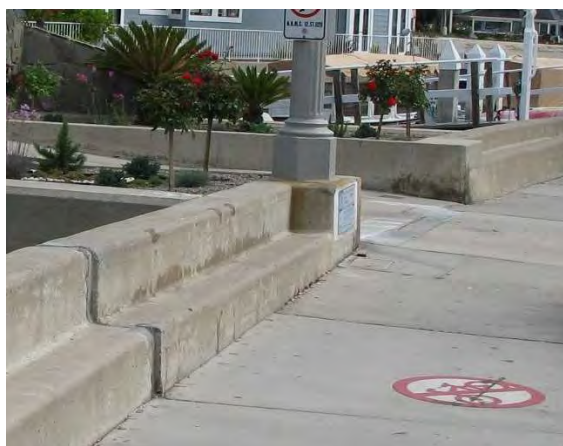
- There are 4 occurrences of open, closed, or impact spalls on the waterside face of the coping or wall panels.
- There is a horizontal offset in the bulkhead wall of approximately 1½" at the wall type transition roughly 20 feet south of the Collins Island Bridge. The Older portion of the wall appears to have displaced toward the water.

Photo 10 – Offset in wall at change in bulkhead construction. Station S+74

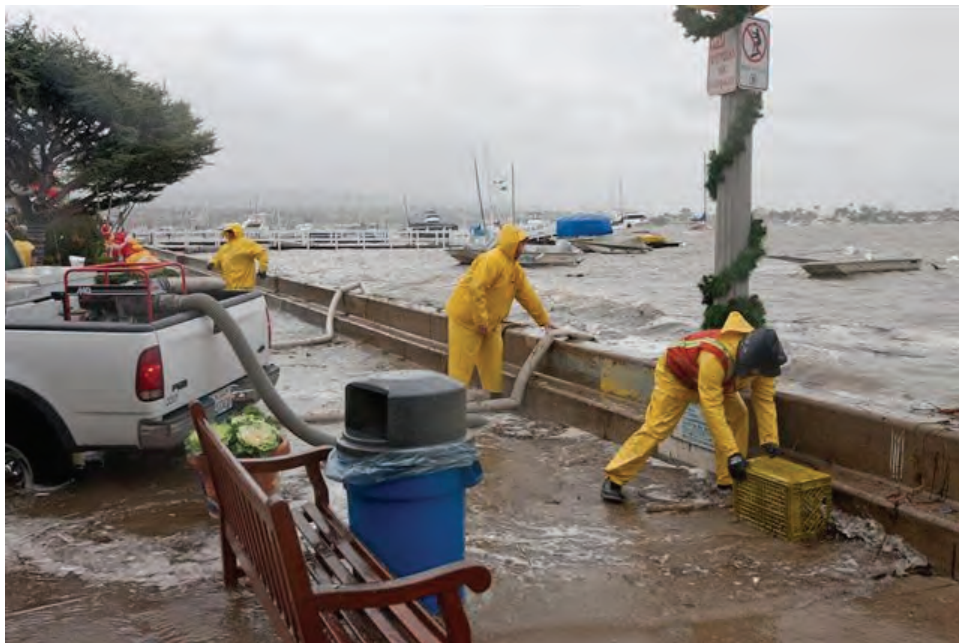
**Figure 1.2 City Personnel Pumping Flood Water Back into the Bay**

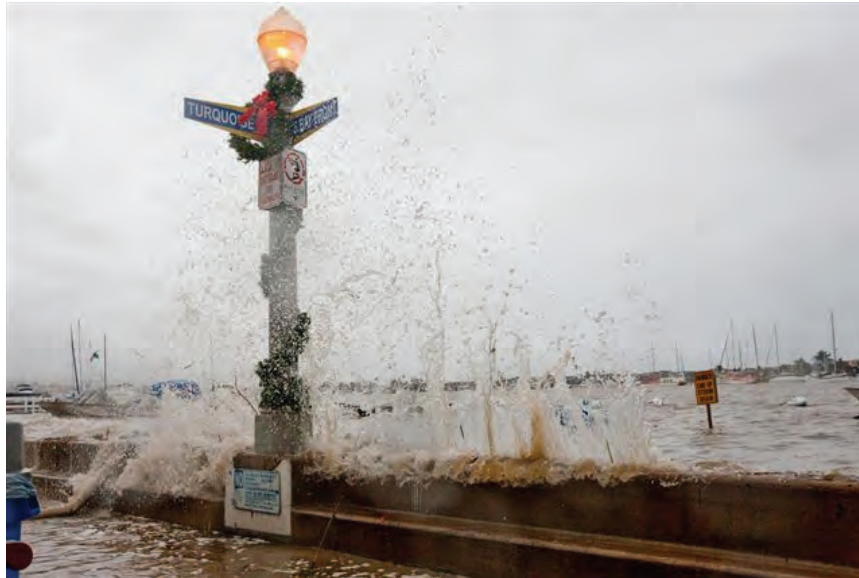
Additional photos from this event depicting wave overtopping and flooding of the Balboa Island seawall and the resulting damage are shown in Figures 1.3 to 1.7. As shown in Figure 1.3 and 1.4, water overtopped the seawall at Turquoise and South Bay Front flooding the boardwalk. Flood waters spilled into adjacent streets as seen in Figure 1.5 and some businesses were inundated as shown in Figure 1.6. After the tide ebbed and the flood waters drained, the boardwalk was covered with sand and debris as shown in Figure 1.7, clogging the boardwalk drainage system.

**Figure 1.3      Waves Splashing over the Balboa Island Seawall at  
Turquoise and South Bay Front**

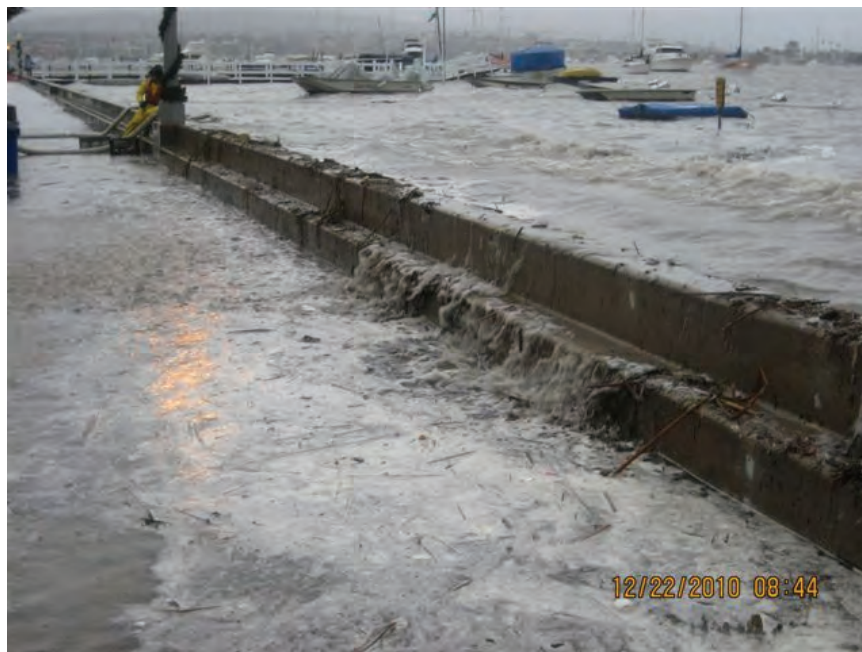
**Figure 1.4      Bay Waters Overtopping the Seawall**

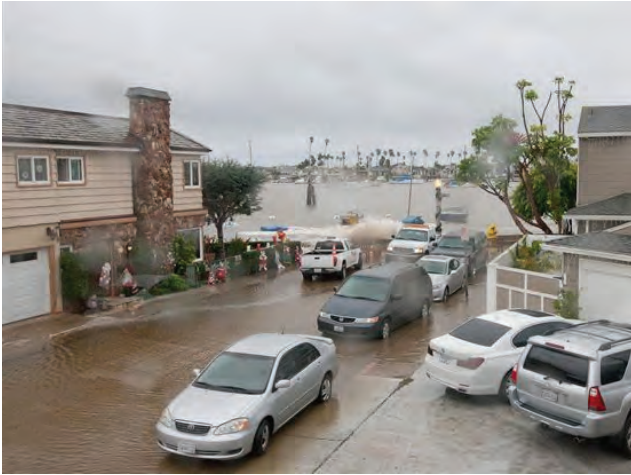
**Figure 1.5 Street Flooding**

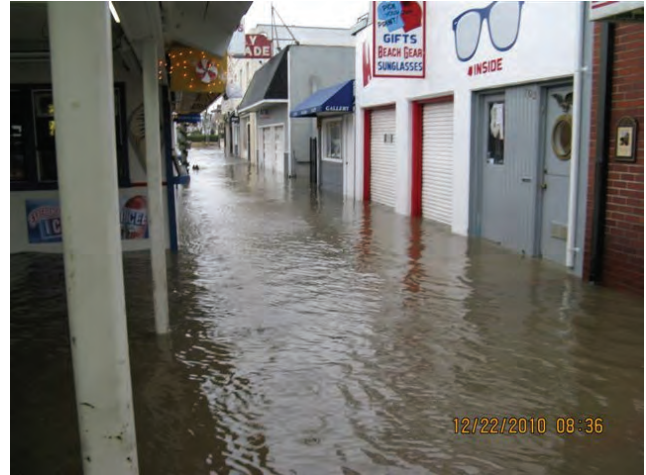
**Figure 1.6 Flooded Businesses**

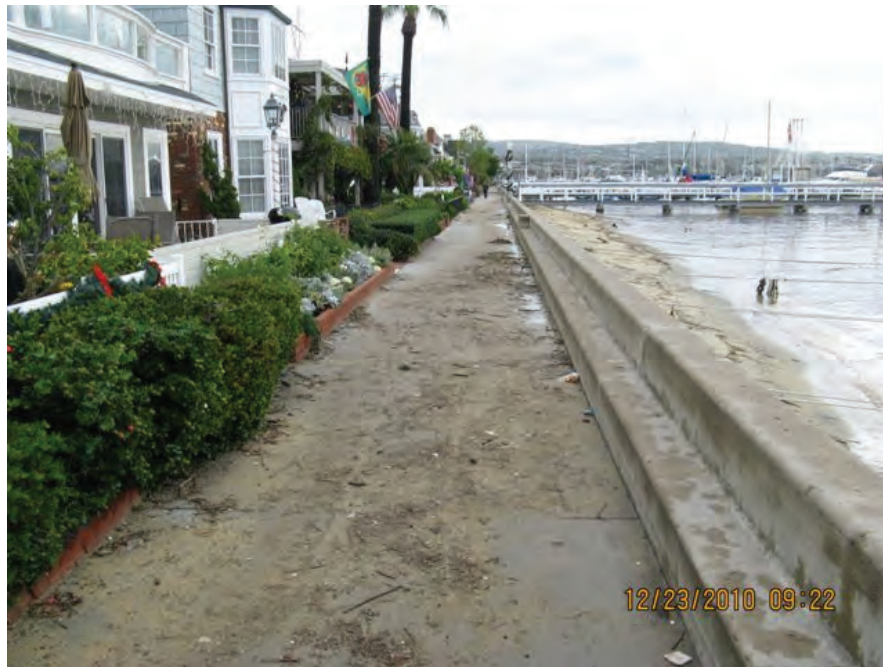
**Figure 1.7 Accumulated Sand and Debris, Post-Storm**
